# Asbestos Abatement Survey

**Job Order No.: R-97-004-20**

**109 E. Fayette Avenue**

**Effingham, Effingham County, IL 62401**

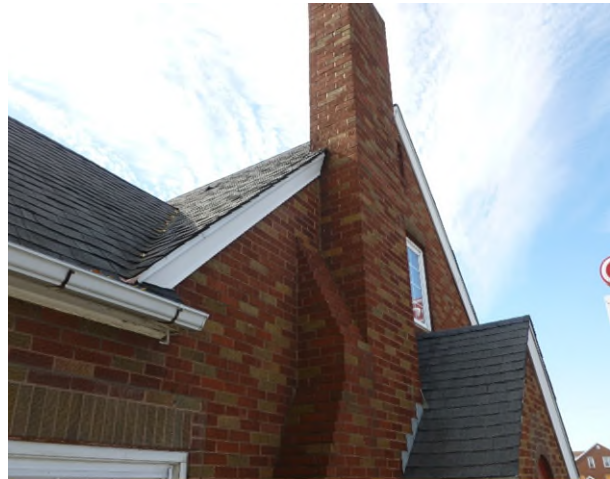
| HA No. | Material Description | Material Location | Sample Number | Condition | Friability | Asbestos Content | Estimated Quantity | Unit | Notes |
|---|---|---|---|---|---|---|---|---|---|
| 1 | Black Asphalt Shingle (layer 1) | Entire Roof including Addition to South and West | 1A, 1B, 1C | Good | Non-Friable | NAD | 2,800 | SF | Roof layer over wood substrate; penetrations have rubber boots; wood soffits. |
| 2 | Red Asphalt Shingle (layer 2) | Entire Roof including Addition to South and West | 2A, 2B, 2C | Good | Non-Friable | NAD | 2,800 | SF | Roof layer over wood substrate; penetrations have rubber boots; wood soffits. |
| 3 | Black Roofing Tar Paper (bottom layer) | Entire Roof including Addition to South and West | 3A, 3B, 3C | Good | Non-Friable | NAD | 2,800 | SF | Roof layer over wood substrate; penetrations have rubber boots; wood soffits. |

**HA-1: Black Asphalt Shingle (top layer)  
HA-2: Red Asphalt Shingle (middle layer)  
HA-3: Black Tar Paper (bottom layer)**

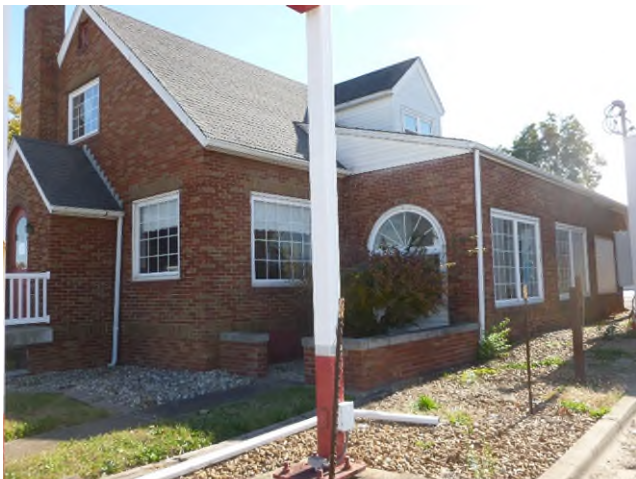
| HA No. | Material Description | Material Location | Sample Number | Condition | Friability | Asbestos Content | Estimated Quantity | Unit | Notes |
|---|---|---|---|---|---|---|---|---|---|
| 4 | Red Exterior Brick | Entire Building except Rear/South Addition End Wall | 4A, 4B, 4C | Good | Non-Friable | NAD | 2,000 | SF | End wall is wood siding |
| 5 | Gray Brick Mortar associated with HA-4 | Entire Building except Rear/South Addition End Wall | 5A, 5B, 5C | Good | Non-Friable | NAD | 2,000 | SF | End wall is wood siding |

**HA-4: Red Exterior Brick  
HA-5: Gray Brick Mortar associated with HA-4**

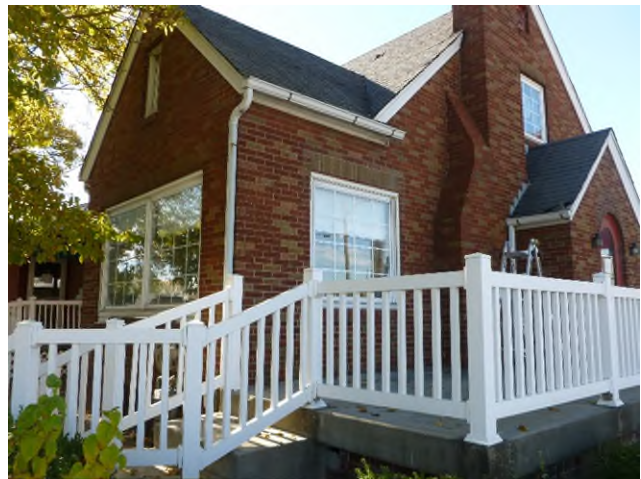
| HA No. | Material Description | Material Location | Sample Number | Condition | Friability | Asbestos Content | Estimated Quantity | Unit | Notes |
|---|---|---|---|---|---|---|---|---|---|
| 6 | White Exterior Window Caulk | Around Building Exterior Windows | 6A, 6B, 6C | Good | Non-Friable | NAD | 250 | LF | 13 Windows |

**HA-6: White Exterior Window Caulk**

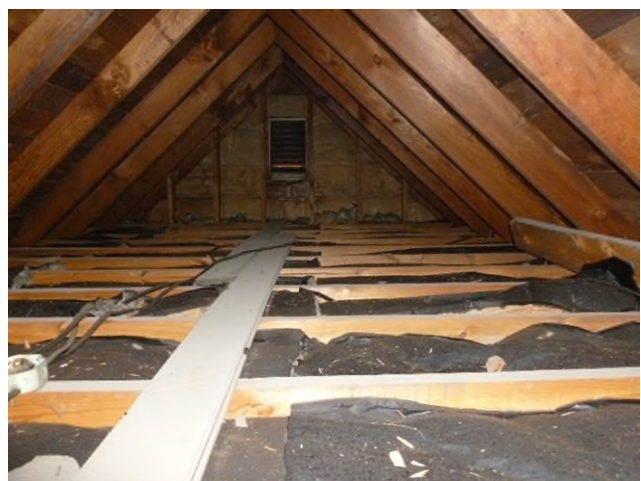
| HA No. | Material Description | Material Location | Sample Number | Condition | Friability | Asbestos Content | Estimated Quantity | Unit | Notes |
|---|---|---|---|---|---|---|---|---|---|
| 8 | Black Insulation Vapor Barrier | Throughout Attic, 1st and 2nd Floor Exterior Walls with Yellow Insulation | 8A, 8B, 8C | Good | Friable | NAD | 3,500 | SF | |

**HA-8: Black Insulation Vapor Barrier**

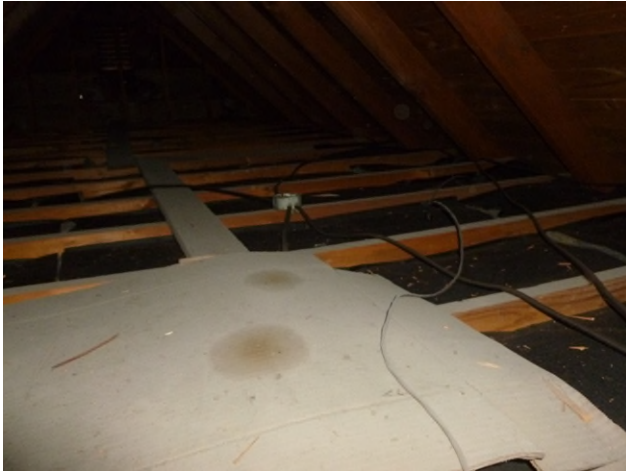
| HA No. | Material Description | Material Location | Sample Number | Condition | Friability | Asbestos Content | Estimated Quantity | Unit | Notes |
|---|---|---|---|---|---|---|---|---|---|
| 9 | Black Cloth Wiring Sheathing | Throughout Attic and 2nd Floor, Sporadic in Basement and 1st Floor | 9A, 9B, 9C | Good | Non-Friable | NAD | 350 | LF | |

**HA-9: Black Cloth Wiring Sheathing**

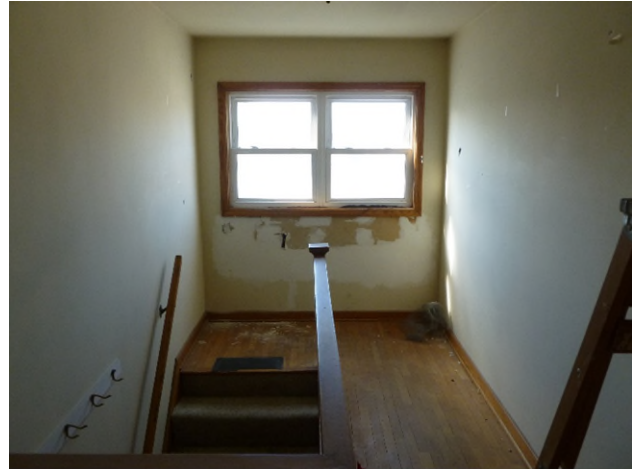
| HA No. | Material Description | Material Location | Sample Number | Condition | Friability | Asbestos Content | Estimated Quantity | Unit | Notes |
|---|---|---|---|---|---|---|---|---|---|
| 10 | White Gypsum Board | Patched in Areas Around 2nd Floor Windows | 10A, 10B, 10C | Good | Friable | NAD | 50 | SF | Walls are mainly plaster |
| 11 | White Joint Compound associated with HA-10 | Patched in Areas Around 2nd Floor Windows | 11A, 11B, 11C | Good | Friable | NAD | 50 | SF | Walls are mainly plaster |

**HA-10: White Gypsum Board**  
**HA-11: White Joint Compound associated with HA-10**

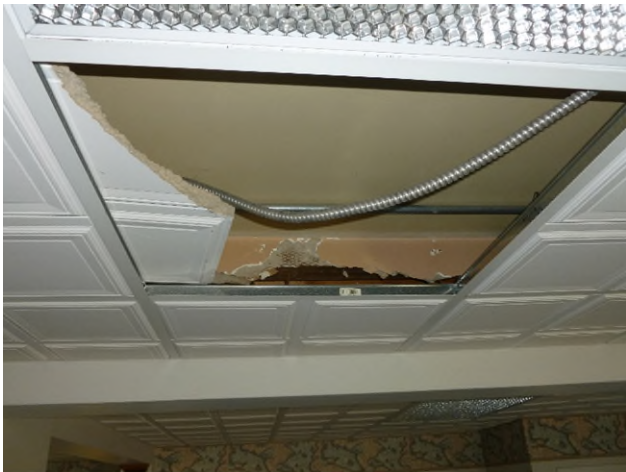
| HA No. | Material Description | Material Location | Sample Number | Condition | Friability | Asbestos Content | Estimated Quantity | Unit | Notes |
|---|---|---|---|---|---|---|---|---|---|
| 12 | White Wall/Ceiling Plaster Skimcoat | Throughout 1st and 2nd Floors | 12A, 12B, 12C, 12D, 12E, 12F, 12G | Good | Friable | NAD | 3,700 | SF | A few 1st floor renovated walls have gypsum board rather than plaster |
| 13 | Gray Wall/Ceiling Plaster Basecoat | Throughout 1st and 2nd Floors | 13A, 13B, 13C, 13D, 13E, 13F, 13G | Good | Friable | NAD | 3,700 | SF | A few 1st floor renovated walls have gypsum board rather than plaster |

**HA-12: White Plaster Skimcoat**  
**HA-13: Gray Plaster Basecoat**

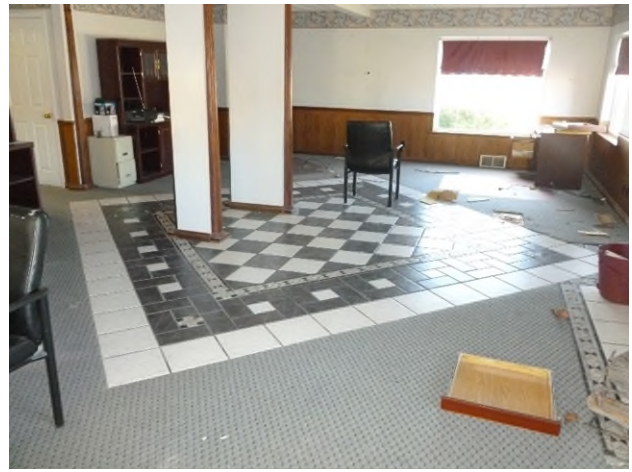
| HA No. | Material Description | Material Location | Sample Number | Condition | Friability | Asbestos Content | Estimated Quantity | Unit | Notes |
|---|---|---|---|---|---|---|---|---|---|
| 14 | Black 12" x 12" Ceramic Floor Tile | 1st Floor Center of Main Room | 14A, 14B, 14C | Good | Non-Friable | NAD | 150 | SF | Diamond pattern |
| 15 | Black Ceramic Floor Tile Grout associated with HA-14 | 1st Floor Center of Main Room | 15A, 15B, 15C | Good | Non-Friable | NAD | 150 | SF | |

| HA No. | Material Description | Material Location | Sample Number | Condition | Friability | Asbestos Content | Estimated Quantity | Unit | Notes |
|---|---|---|---|---|---|---|---|---|---|
| 16 | Gray Ceramic Floor Tile Adhesive associated with HA-14 | 1st Floor Center of Main Room | 16A, 16B, 16C | Good | Non-Friable | NAD | 150 | SF | |
| 17 | Gray Ceramic Floor Tile Backer Board associated with HA-14 | 1st Floor Center of Main Room | 17A, 17B, 17C | Good | Non-Friable | NAD | 150 | SF | Underlayment is cement board |

**HA-14: Black 12" x 12" Ceramic Floor Tile**  
**HA-15: Black Tile Grout associated with HA-14**  
**HA-16: Gray Tile Adhesive associated with HA-14**  
**HA-17: Gray Tile Backer Board associated with HA-14**

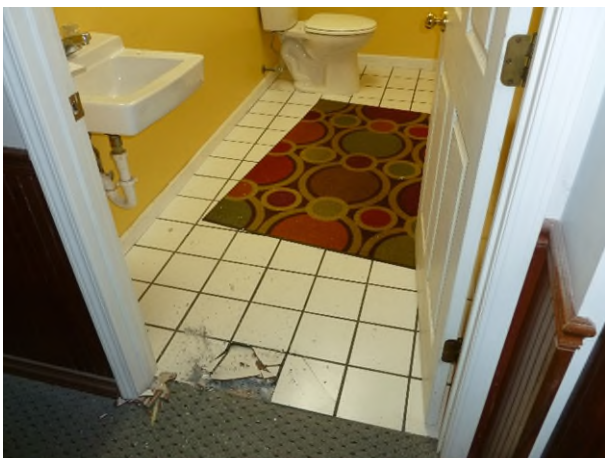
| HA No. | Material Description | Material Location | Sample Number | Condition | Friability | Asbestos Content | Estimated Quantity | Unit | Notes |
|---|---|---|---|---|---|---|---|---|---|
| 18 | White 8" x 8" Ceramic Floor Tile | 1st Floor Restroom | 18A, 18B, 18C | Good | Non-Friable | NAD | 50 | SF | Over wood flooring |
| 19 | Black Ceramic Floor Tile Grout associated with HA-18 | 1st Floor Restroom | 19A, 19B, 19C | Good | Non-Friable | NAD | 50 | SF | |
| 20 | Gray Ceramic Floor Tile Adhesive associated with HA-18 | 1st Floor Restroom | 20A, 20B, 20C | Good | Non-Friable | NAD | 50 | SF | |
| 21 | Gray Ceramic Floor Tile Backer Board associated with HA-18 | 1st Floor Restroom | 21A, 21B, 21C | Good | Non-Friable | NAD | 50 | SF | |

**HA-18: White 8" x 8" Ceramic Floor Tile**  
**HA-19: Black Tile Grout associated with HA-18**  
**HA-20: Gray Tile Adhesive associated with HA-18**  
**HA-21: Gray Tile Backer Board associated with HA-18**

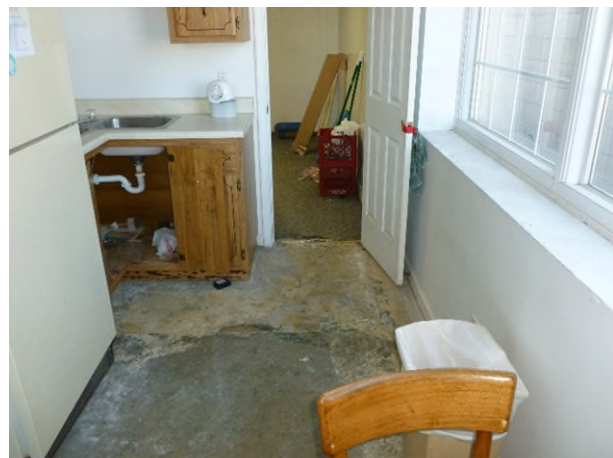
| HA No. | Material Description | Material Location | Sample Number | Condition | Friability | Asbestos Content | Estimated Quantity | Unit | Notes |
|---|---|---|---|---|---|---|---|---|---|
| 22 | Tan Carpet Glue/Adhesive | Main Floor Front Area, Back Storage Room off of Kitchen | 22A, 22B, 22C | Good | Non-Friable | NAD | 400 | SF | |

**HA-22: Tan Carpet Adhesive**

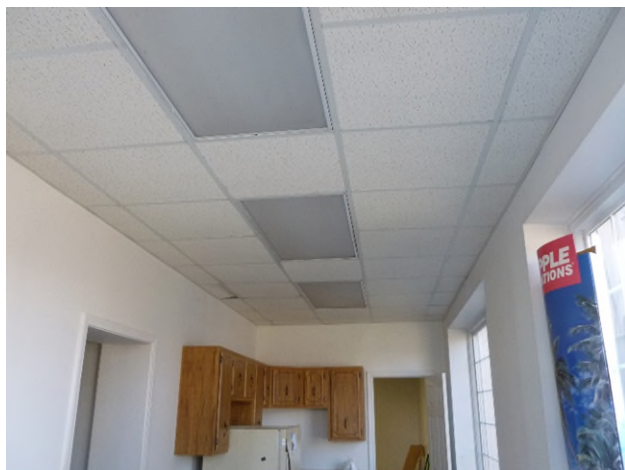
| HA No. | Material Description | Material Location | Sample Number | Condition | Friability | Asbestos Content | Estimated Quantity | Unit | Notes |
|---|---|---|---|---|---|---|---|---|---|
| 23 | White 2' x 4' Ceiling Tile | Restroom, Kitchen, Back Storage Room | 23A, 23B, 23C | Good | Friable | NAD | 350 | SF | |

**HA-23: White 2' x 4' Ceiling Tile**

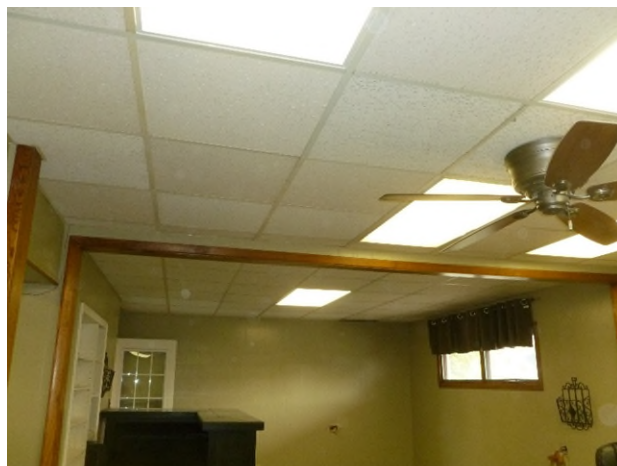
| HA No. | Material Description | Material Location | Sample Number | Condition | Friability | Asbestos Content | Estimated Quantity | Unit | Notes |
|---|---|---|---|---|---|---|---|---|---|
| 24 | White 2' x 2' Ceiling Tile (fissured) | Salon Area | 24A, 24B, 24C, | Good | Friable | NAD | 704 | SF | |

**HA-24: White 2' x 2' Ceiling Tile (fissured)**

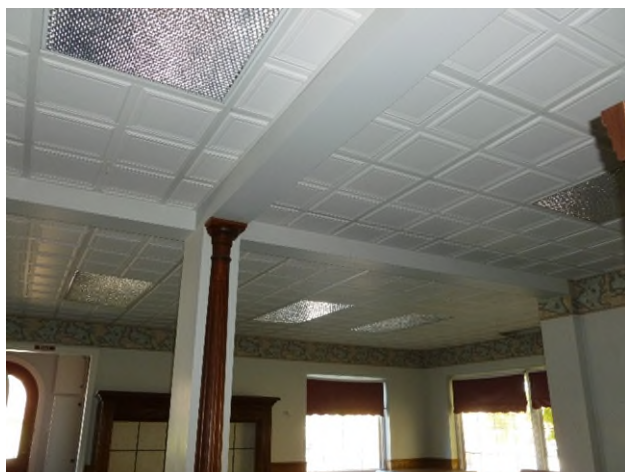
| HA No. | Material Description | Material Location | Sample Number | Condition | Friability | Asbestos Content | Estimated Quantity | Unit | Notes |
|---|---|---|---|---|---|---|---|---|---|
| 25 | White 2' x 2' Ceiling Tile (decorative pattern) | Main Front Room | 25A, 25B, 25C | Good | Friable | NAD | 664 | SF | |

**HA-25: White 2' x 2' Ceiling Tile (decorative pattern)**

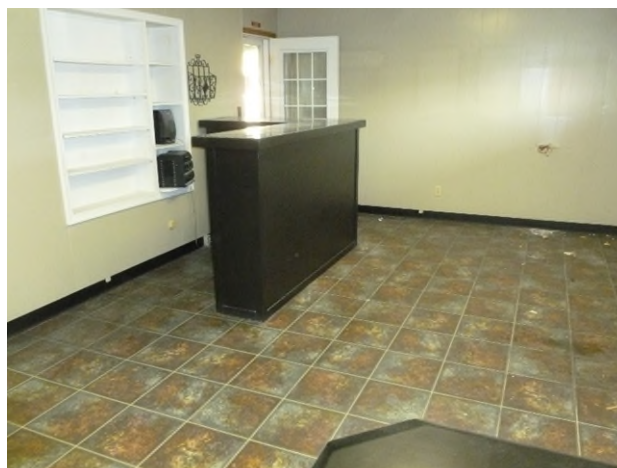
| HA No. | Material Description | Material Location | Sample Number | Condition | Friability | Asbestos Content | Estimated Quantity | Unit | Notes |
|---|---|---|---|---|---|---|---|---|---|
| 26 | Black Vinyl Cove Base | Salon Area | 26A, 26B, 26C | Good | Non-Friable | NAD | 132 | LF | |
| 27 | Tan Vinyl Cove Base Adhesive associated with HA-26 | Salon Area | 27A, 27B, 27C | Good | Non-Friable | NAD | 132 | LF | |

**HA-26: Black Vinyl Cove Base**  
**HA-27: Tan Adhesive associated with HA-26**

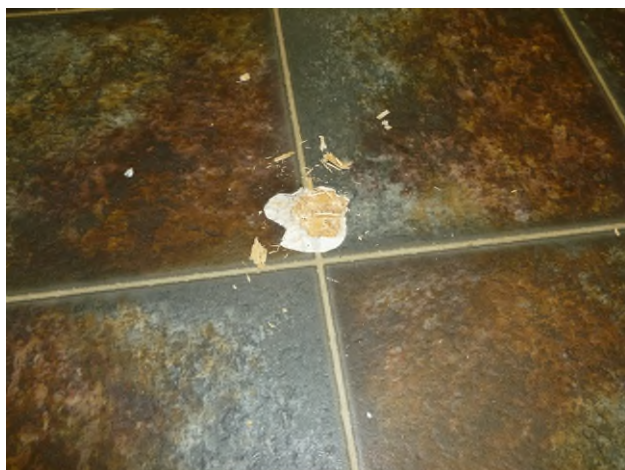
| HA No. | Material Description | Material Location | Sample Number | Condition | Friability | Asbestos Content | Estimated Quantity | Unit | Notes |
|---|---|---|---|---|---|---|---|---|---|
| 28 | Gray Vinyl Sheet Flooring | Salon Area | 28A, 28B, 28C | Good | Friable | NAD | 516 | SF | Paper backing over plywood substrate |
| 29 | Yellow Vinyl Sheet Flooring Adhesive associated with HA-28 | Salon Area | 29A, 29B, 29C | Good | Non-Friable | NAD | 516 | SF | |

**HA-28: Gray Vinyl Sheet Flooring**  
**HA-29: Yellow Adhesive associated with HA-28**

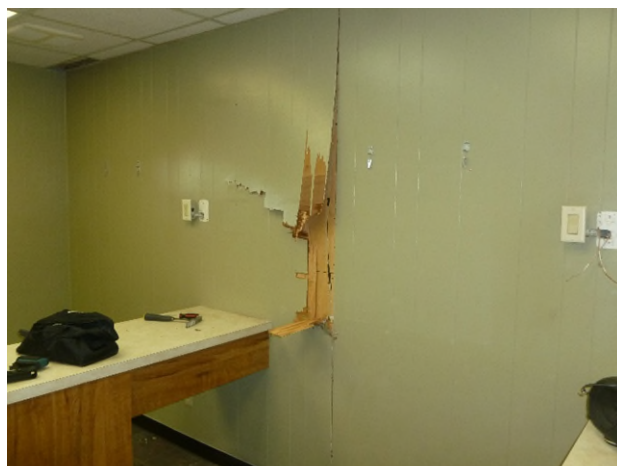
| HA No. | Material Description | Material Location | Sample Number | Condition | Friability | Asbestos Content | Estimated Quantity | Unit | Notes |
|---|---|---|---|---|---|---|---|---|---|
| 30 | White Gypsum Board | Salon Area behind Paneling, Kitchen Addition, Rear Storage Room, Restroom, Renovated Walls | 30A, 30B, 30C | Good | Friable | NAD | 1,872 | SF | |

**HA-30: White Gypsum Board**

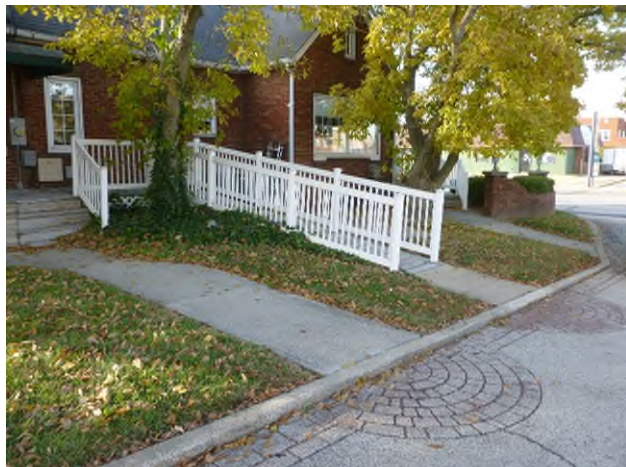
| HA No. | Material Description | Material Location | Sample Number | Condition | Friability | Asbestos Content | Estimated Quantity | Unit | Notes |
|---|---|---|---|---|---|---|---|---|---|
| 31 | Gray Concrete | Exterior Porch, Sidewalks, Basement Foundation and Floor | 31A, 31B, 31C | Good | Non-Friable | NAD | 2,910 | SF | |

**HA-31: Gray Concrete**

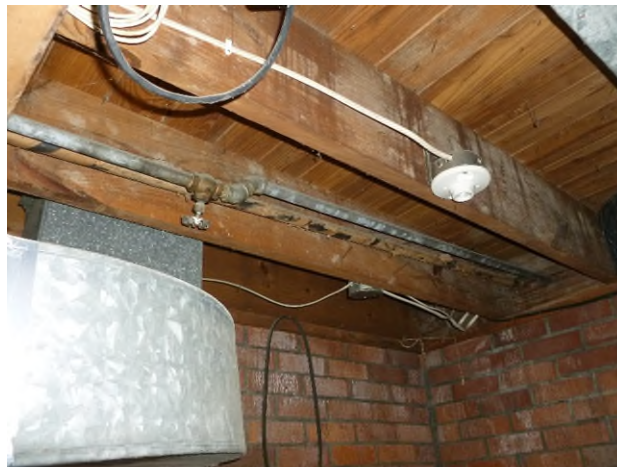
- HA-32: Black Pipe Coating Wrap on 1 ¼" Gas Line to Furnace in the Basement
- HA-34: Black Panel Adhesive in the Salon Area
- HA-36: Gray Sink Undercoat in the Kitchen

| HA No. | Material Description | Material Location | Sample Number | Condition | Friability | Asbestos Content | Estimated Quantity | Unit | Notes |
|---|---|---|---|---|---|---|---|---|---|
| 32 | Black Pipe Coating Wrap | 1 1/2" Gas Line to Furnace in Basement | 32A, 32B, 32C | Good | Friable | Chrysotile 1-5% | 8 | LF | Black mastic with paper layer |

**HA-32: Black Pipe Coating Wrap**

ACMs identified at the site that may be disturbed during demolition activities, must be removed by a licensed asbestos abatement contractor utilizing industry standard work procedures in accordance with all federal, state, and local regulations governing asbestos.

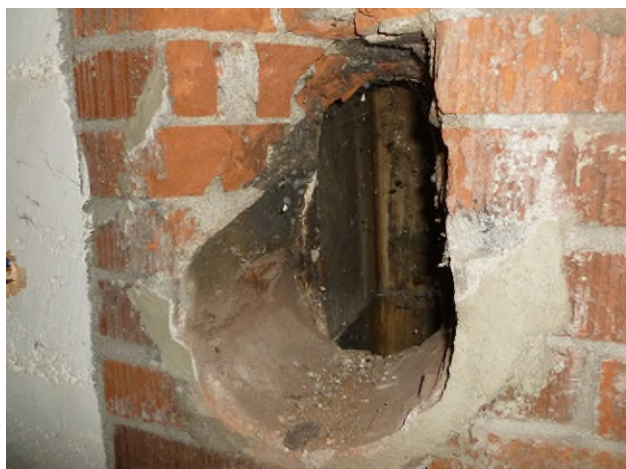
| HA No. | Material Description | Material Location | Sample Number | Condition | Friability | Asbestos Content | Estimated Quantity | Unit | Notes |
|---|---|---|---|---|---|---|---|---|---|
| 33 | Tan Flue Pipe | Basement Chimney | 33A, 33B, 33C | Good | Non-Friable | NAD | 30 | LF | Coal chute and flue pipe in chimney |

**HA-33: Tan Flue Pipe**

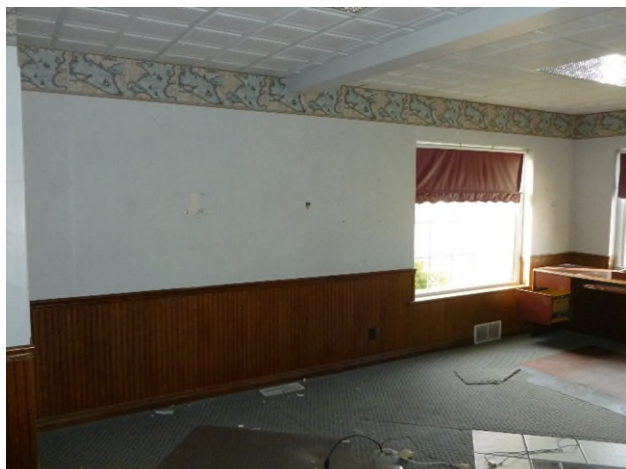
**HA-35: White Joint Compound associated with HA-30**

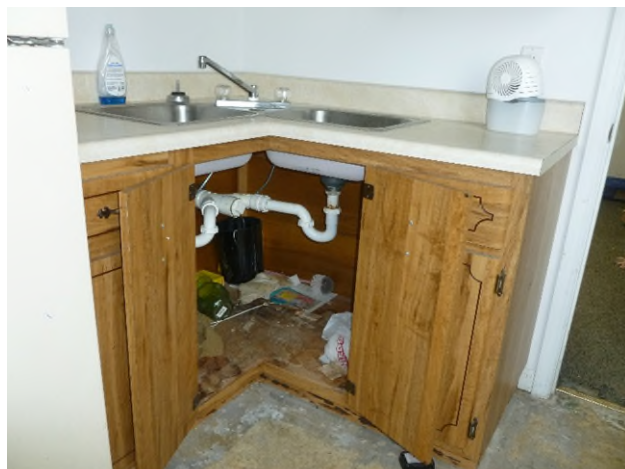
| HA No. | Material Description | Material Location | Sample Number | Condition | Friability | Asbestos Content | Estimated Quantity | Unit | Notes |
|---|---|---|---|---|---|---|---|---|---|
| 36 | Gray Sink Undercoat | Kitchen | 36A, 36B | Good | Non-Friable | Chrysotile 5-10% | 8 | SF | 2 sinks |

**HA-36: Gray Sink Undercoat**
