SN. 102-0041 IL.117 ovr
MILL CRK. S. of US24

STATE OF ILLINOIS
DEPARTMENT OF TRANSPORTATION

STRUCTURAL CONCRETE REPAIR DETAIL

RTE.	SECTION	COUNTY	TOTAL SHEETS	SHEET NO.
702	(114BR-1)I	WOODFORD	23	19
MISC. BRIDGE REPAIRS		CONTRACT NO. 68928		
FED. ROAD DIST. NO. 4	ILLINOIS	FED. AID PROJECT

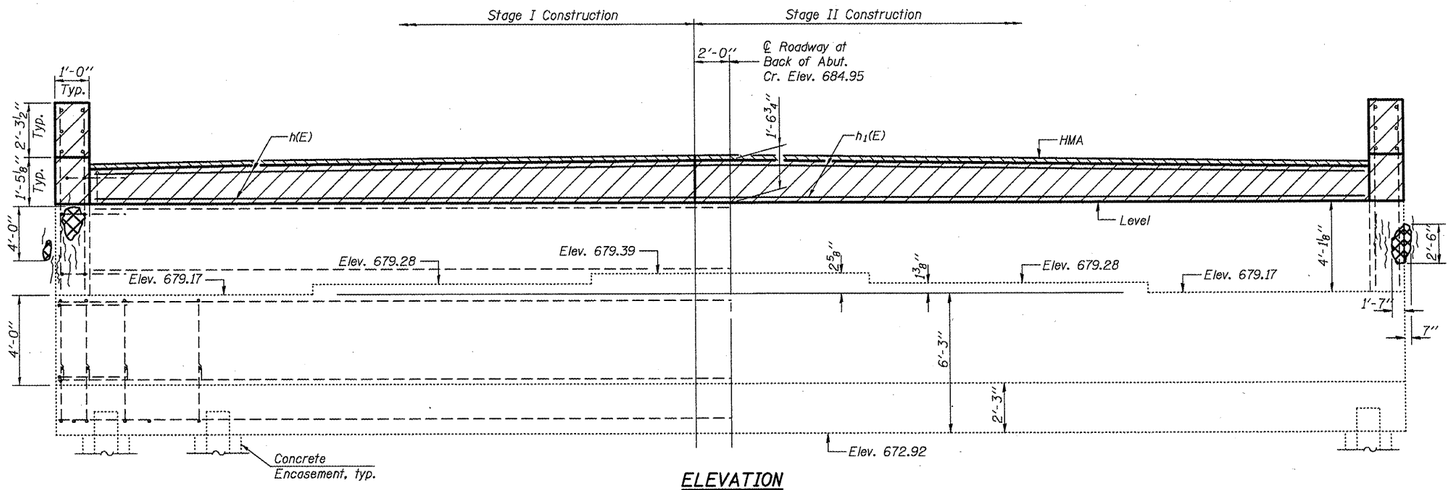
ELEVATION

(North Abutment, Looking North)

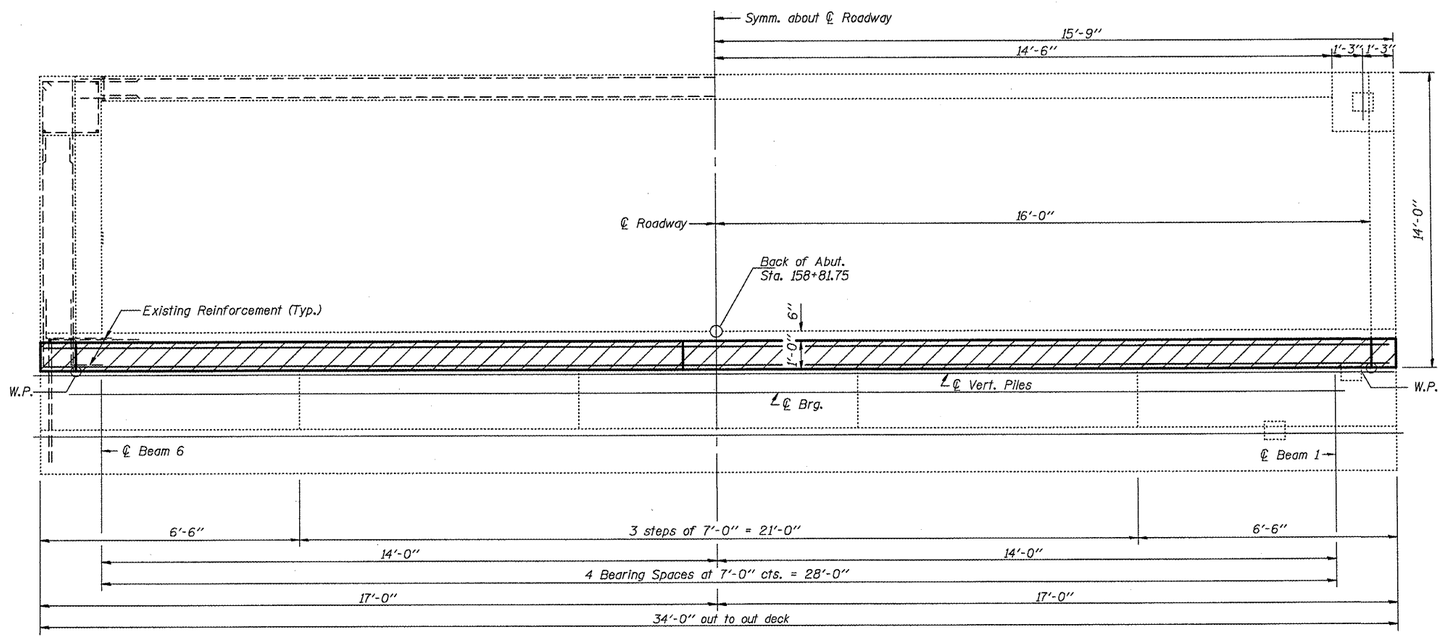
PLAN

(North Abutment)

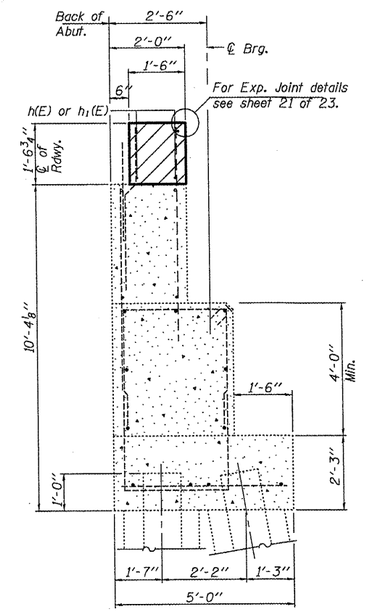
SECTION THRU ABUT.

(North Abutment)

Delaminated Concrete Area
