DESIGNED -	EXAMINED	DATE -	STATE OF ILLINOIS DEPARTMENT OF TRANSPORTATION	REPAIRS TO – PIER NUMBER 14 – COLUMNS STRUCTURE NO. 060–0255 SHEET NO. 39 OF 48 SHEETS
CHECKED -	ENGINEER OF STRUCTURAL SERVICES			
DRAWN Rod	PASSED			
CHECKED MNM	ENGINEER OF BRIDGES AND STRUCTURES

F.A.P. RTE.	SECTION	COUNTY	TOTAL SHEETS	SHEET NO.
304	1008-1DS-1	MADISON	58	49
		CONTRACT NO. 76E73		
		ILLINOIS FED. AID PROJECT

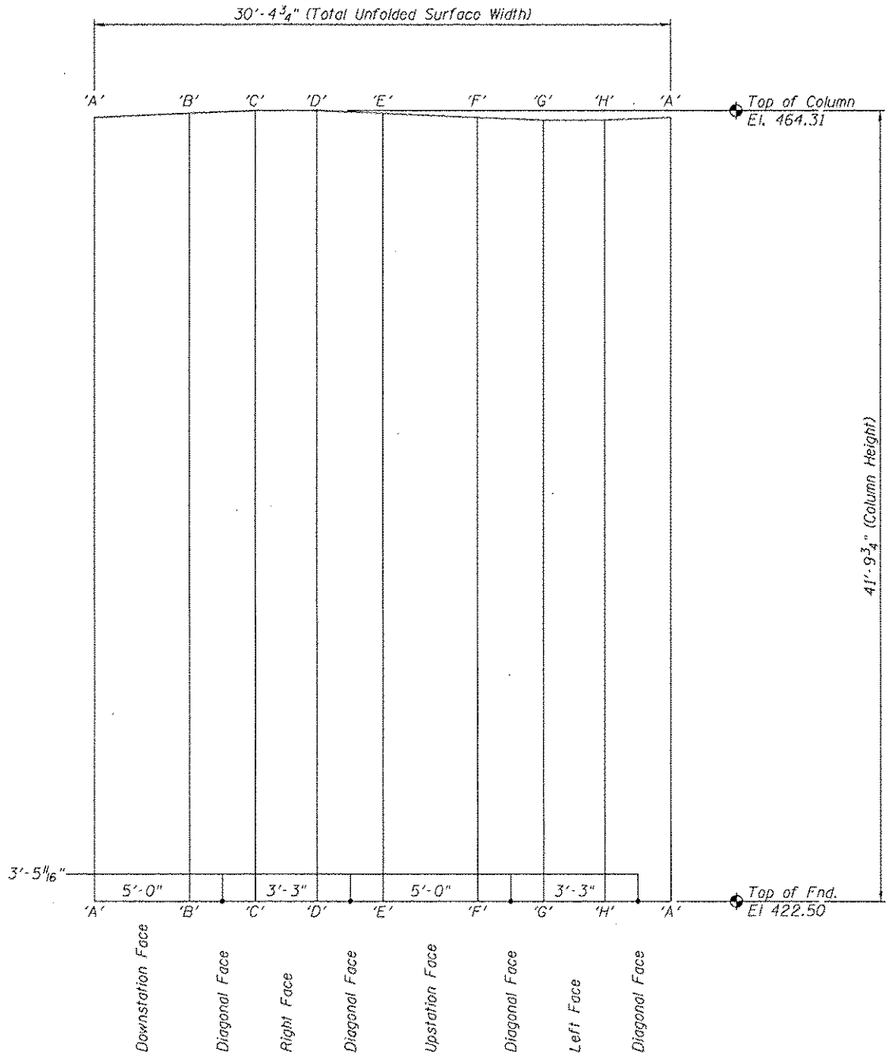
PIER NO. 14 - ELEVATION - LEFT COLUMN

I.D.	Description	Pay Item	Units	Quantity
112	Map Cracking	Concrete Sealer	SQ. FT.	249.9
-	-	-	-	-
-	-	-	-	-
-	-	-	-	-
-	-	-	-	-
-	-	-	-	-
-	-	-	-	-

CONCRETE SEALER
