ASBESTOS SURVEY REPORT

PTB 196-032
Asbestos Survey for Building Demolition (I-80)
256 Lucas Street, Joliet, Illinois
Region One/District One

October 9, 2025

Asbestos Survey Report
PTB 198-003
FAI-80 (I-80) over Des Plaines River Bridge
Job N. D-91-204-19
256 Lucas Street, Joliet, IL
Parcel No. 1P10124

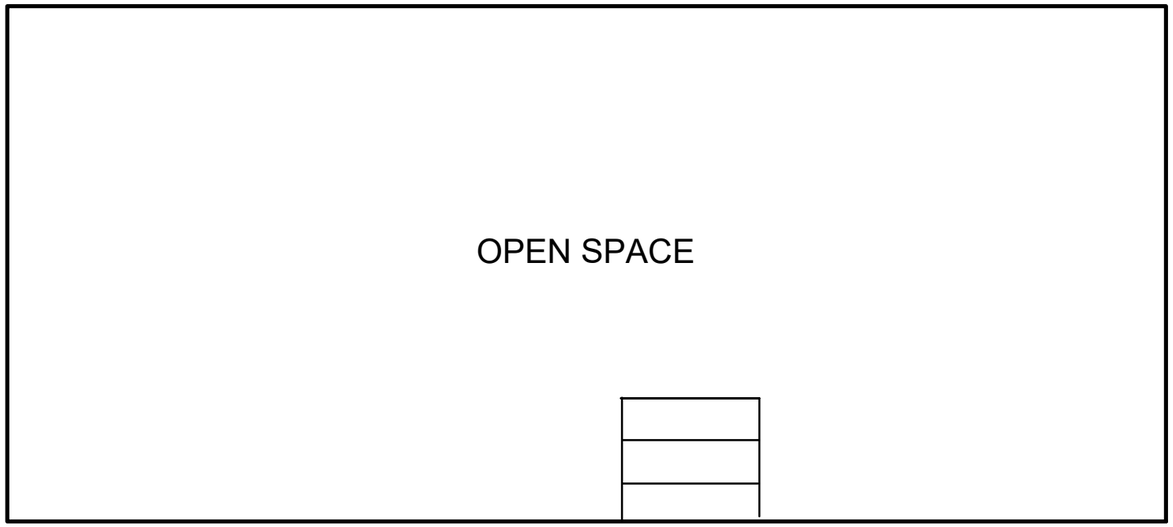
SL-1

*NO SUSPECT ACM WAS SAMPLED IN THE BASEMENT
