Pier 6 East Face

Pier 6 West Face

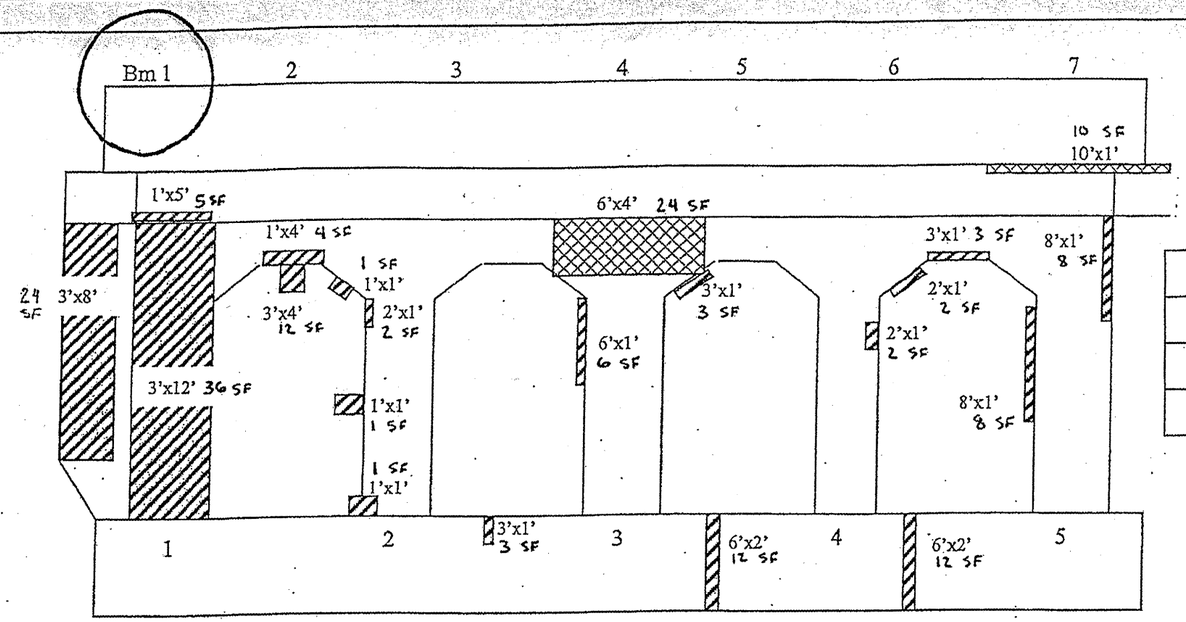
PIER 6 BILL OF MATERIAL	UNIT	QTY.
STRUCTURAL REPAIR OF CONCRETE ≤ 5"	SQ. FT.	244
STRUCTURAL REPAIR OF CONCRETE > 5"	SQ. FT.	41
TEMPORARY SHORING AND CRIBBING	EACH	2

While developing shoring details at this location the contractor must consider the Railroad's limitations for clearances.
