REPAIRS TO – PIER NUMBER 3 – COLUMNS
STRUCTURE NO. 060-0255
SHEET NO. 22 OF 48 SHEETS

F.A.P. RTE.	SECTION	COUNTY	TOTAL SHEETS	SHEET NO.
304	100B-10S-1	MADISON	58	32
		CONTRACT NO. 76E73		
		ILLINOIS FED. AID PROJECT

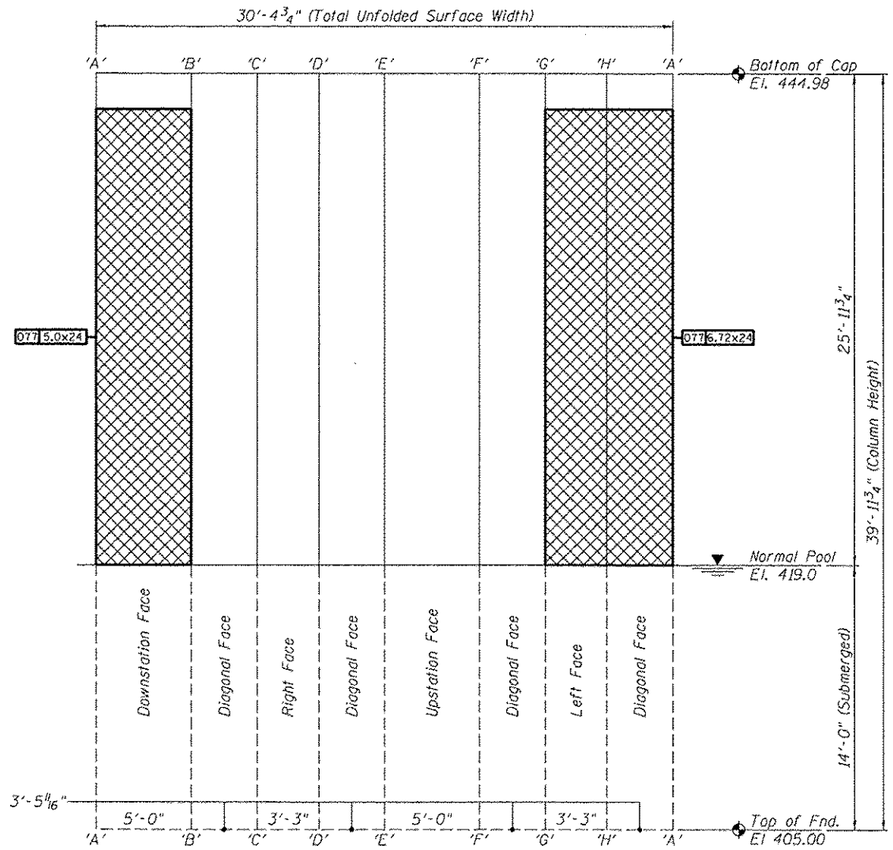
PIER NO. 3 - ELEVATION - LEFT COLUMN

I.D.	Description	Pay Item	Units	Quantity
077	Map Cracking	Concrete Sealer	SQ. FT.	120.0
077	Map Cracking	Concrete Sealer	SQ. FT.	161.3
-	-	-	-	-
-	-	-	-	-
-	-	-	-	-
-	-	-	-	-
-	-	-	-	-
-	-	-	-	-
-	-	-	-	-

CONCRETE SEALER
