MISSOURI APPROACH - SPANS 1 and 2

REPAIRS TO - DECK SLAB and PARAPETS - SPANS 1 and 2
STRUCTURE NO. 060-0255
SHEET NO. 04 OF 48 SHEETS

F.A.P. RTE.	SECTION	COUNTY	TOTAL SHEETS	SHEET NO.
304	100B-1DS-1	MADISON	58	14
		CONTRACT NO. 76E73		
		ILLINOIS FED. AID PROJECT

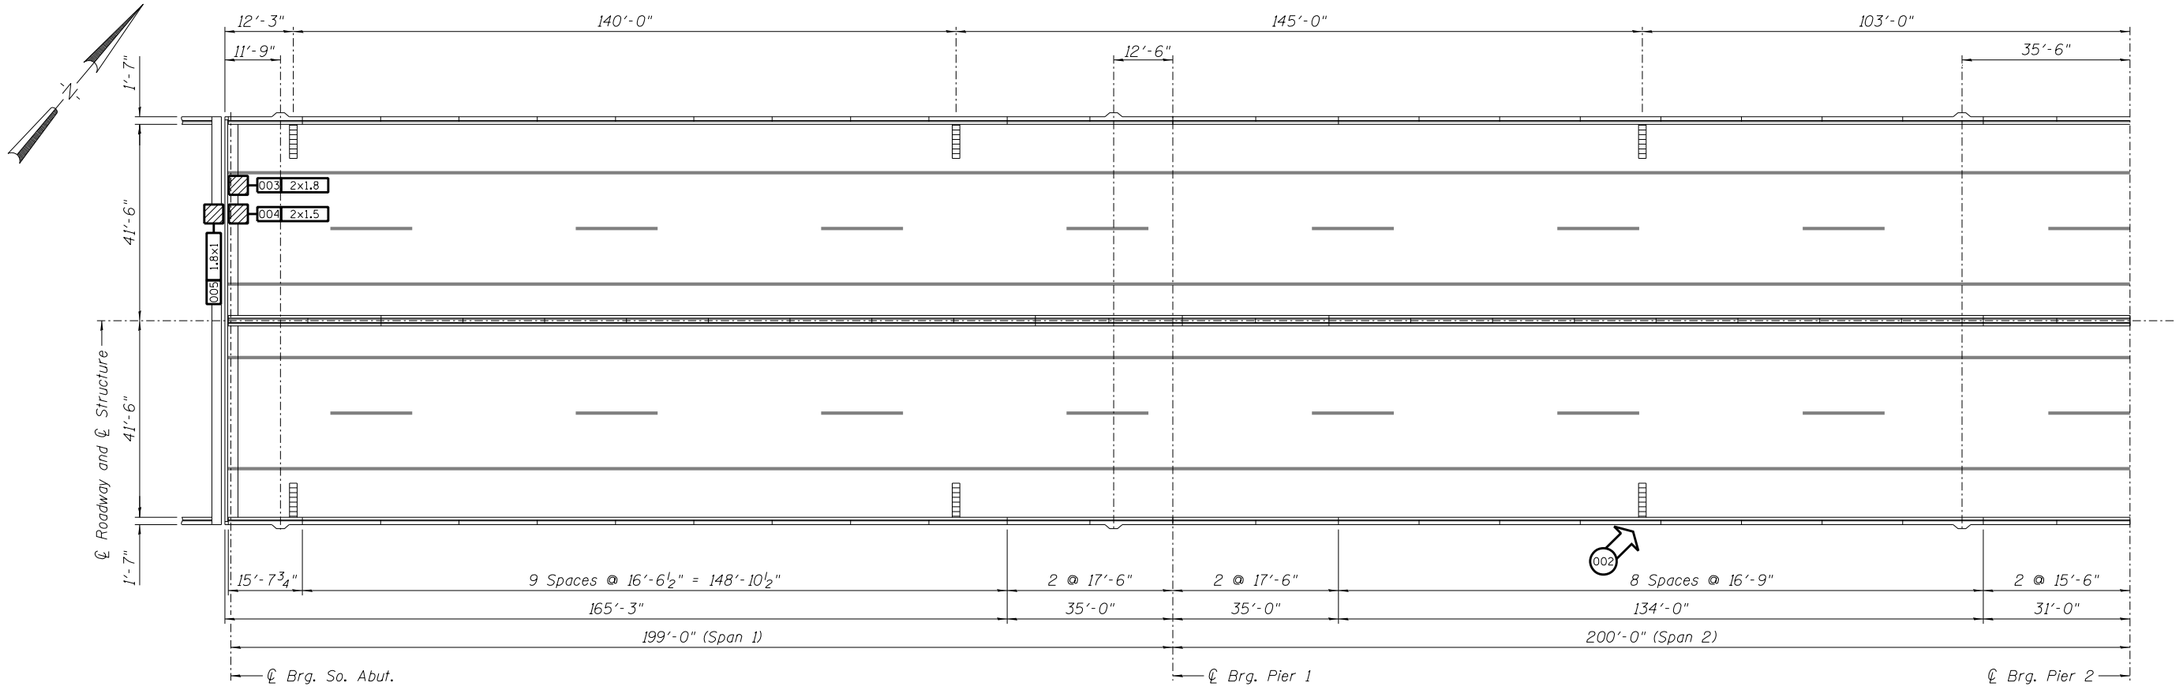
I.D.	Description	Pay Item	Units	Quantity
* 002	Missing Bracket Fastener	-	-	-
003	Concrete Spall	Deck Slab Repair (Partial)	SQ. YD.	0.40
004	Concrete Spall	Deck Slab Repair (Partial)	SQ. YD.	0.33
005	Concrete Spall	Deck Slab Repair (Partial)	SQ. YD.	0.20
-	-	-	-	-
-	-	-	-	-
-	-	-	-	-
-	-	-	-	-
-	-	-	-	-
-	-	-	-	-
-	-	-	-	-
-	-	-	-	-
-	-	-	-	-
-	-	-	-	-
-	-	-	-	-
-	-	-	-	-
-	-	-	-	-
-	-	-	-	-
-	-	-	-	-
-	-	-	-	-
-	-	-	-	-
-	-	-	-	-

EXISTING DRAIN BRACKET

Note:
* Cost of repairing existing drain bracket shall be included in the Cost of Cleaning Bridge Scuppers and Downspouts.
