CSS - ILLINOIS TAIL SPAN - SPAN 11

REPAIRS LIST - SPAN 11

STATE OF ILLINOIS
DEPARTMENT OF TRANSPORTATION

REPAIRS TO - CSS - DECK SLAB and PARAPETS - SPAN 11
STRUCTURE NO. 060-0255

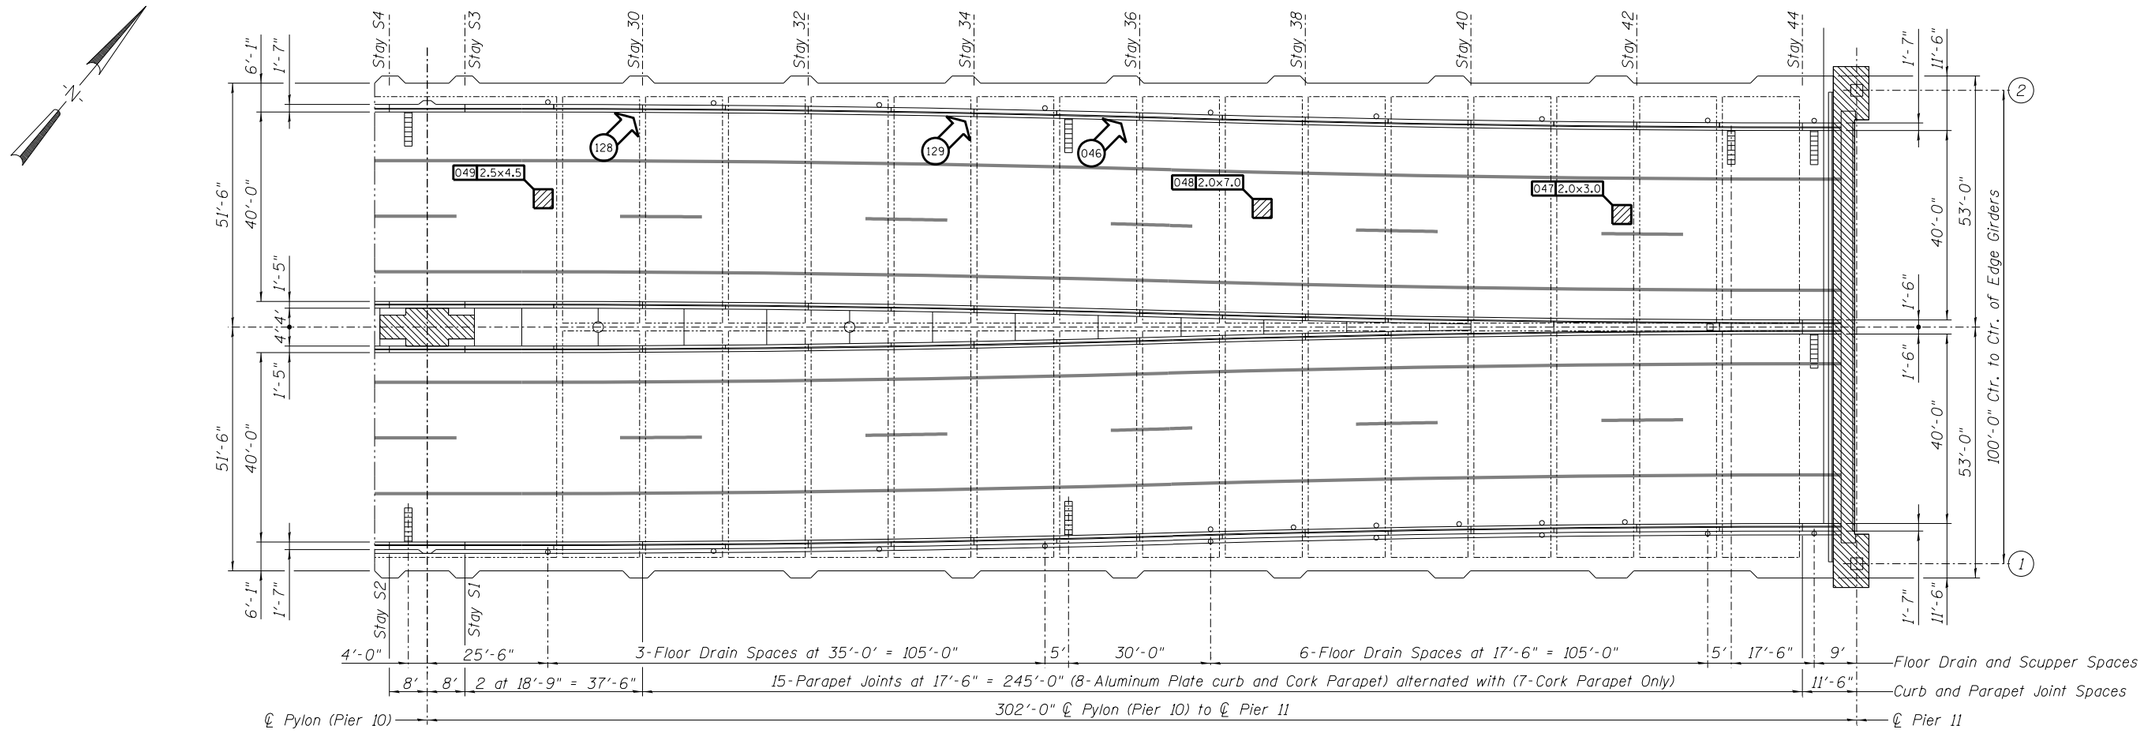
I.D.	Description	Pay Item	Units	Quantity
*	046	Missing Fasteners Bridge Rail Splice	-	-	-
	047	Concrete Spall	Deck Slab Repair (Partial)	SQ. YD.	0.67
	048	Concrete Spall	Deck Slab Repair (Partial)	SQ. YD.	1.56
	049	Concrete Spall	Deck Slab Repair (Partial)	SQ. YD.	1.25
*	128	Missing Fasteners Bridge Rail Splice	-	-	-
*	129	Missing Fasteners Bridge Rail Splice	-	-	-
	-	-	-	-	-
	-	-	-	-	-
	-	-	-	-	-
	-	-	-	-	-
	-	-	-	-	-
	-	-	-	-	-
	-	-	-	-	-
	-	-	-	-	-
	-	-	-	-	-
	-	-	-	-	-
	-	-	-	-	-
	-	-	-	-	-
	-	-	-	-	-
	-	-	-	-	-
	-	-	-	-	-
	-	-	-	-	-
