STATE OF ILLINOIS
DEPARTMENT OF TRANSPORTATION

ABUTMENT REPAIRS
U.S. 45 / 52 OVER SOUTH BRANCH FORKED CREEK
S.N. 099-0121

SCALE: | SHEET NO. S6 OF S6 SHEETS | STA. | TO STA.

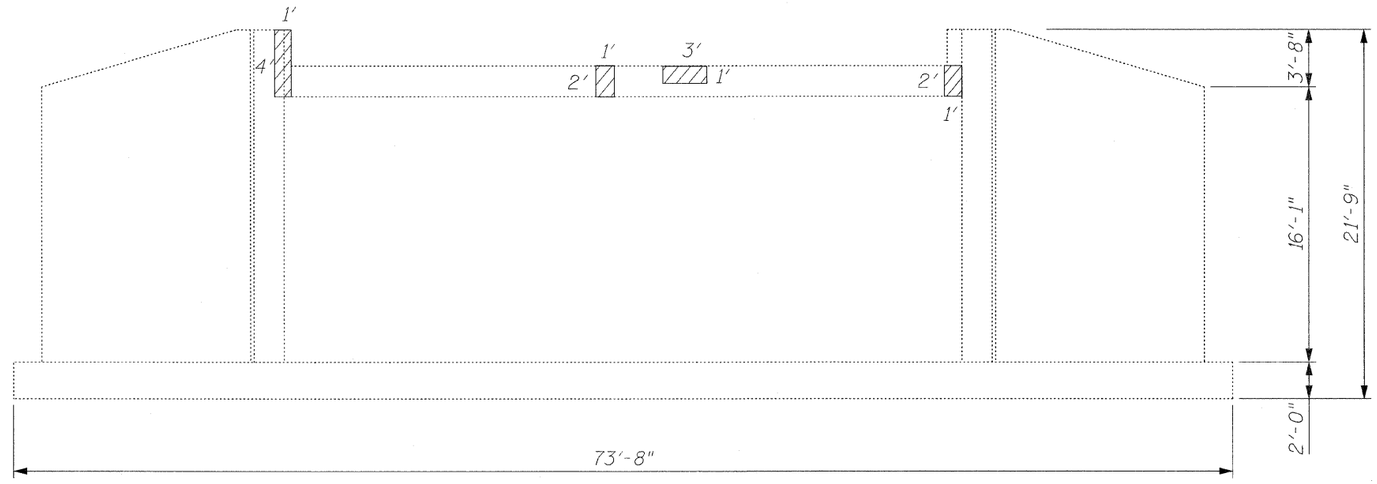
SOUTH ABUTMENT
(Looking South)

Structural Repair of Concrete
(Depth Equal to or Less Than 5 in.)
North Abut. = 37.0 S.F.
South Abut. = 11.0 S.F.
