FLOORBEAM WEB REPAIRS

STATE OF ILLINOIS
DEPARTMENT OF TRANSPORTATION

MAIN SPANS FLOORBEAM WEB REPAIRS – 3
S.N. 082-6001 MLK BRIDGE OVER MISSISSIPPI RIVER
SHEET NO. S67 OF S138 SHEETS

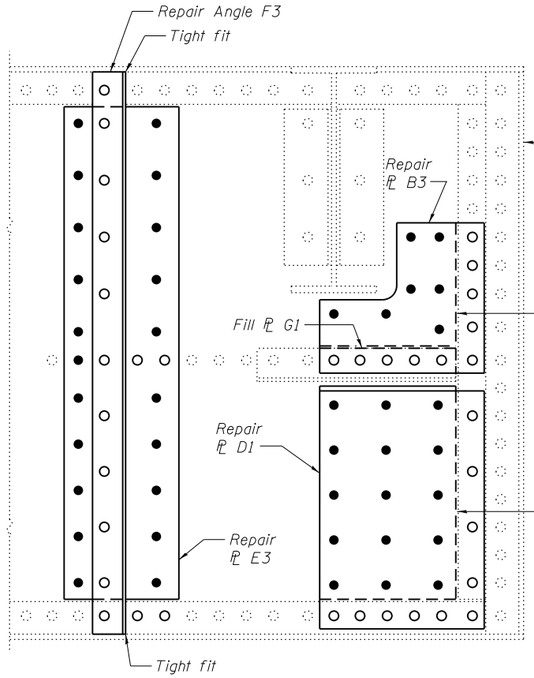
SOUTH END AT PANEL POINT L9
WEST FACE
Span 9

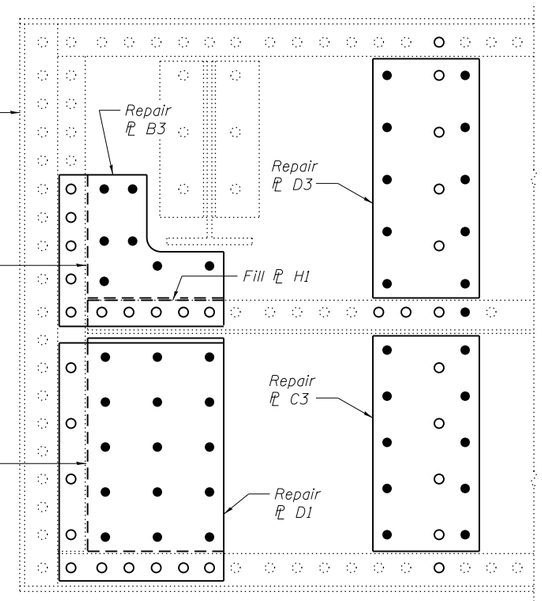
SOUTH END AT PANEL POINT L9
EAST FACE
Span 9
