STATE OF ILLINOIS
DEPARTMENT OF TRANSPORTATION

SOUTH FACE OF PIER NO. 3 STRUCTURE REPAIR

F.A.P RTE.	SECTION	COUNTY	TOTAL SHEETS	SHEET NO.
344	543 R-MB-BR	DUPAGE	19	12
		CONTRACT NO. 60L52		
		ILLINOIS FED. AID PROJECT

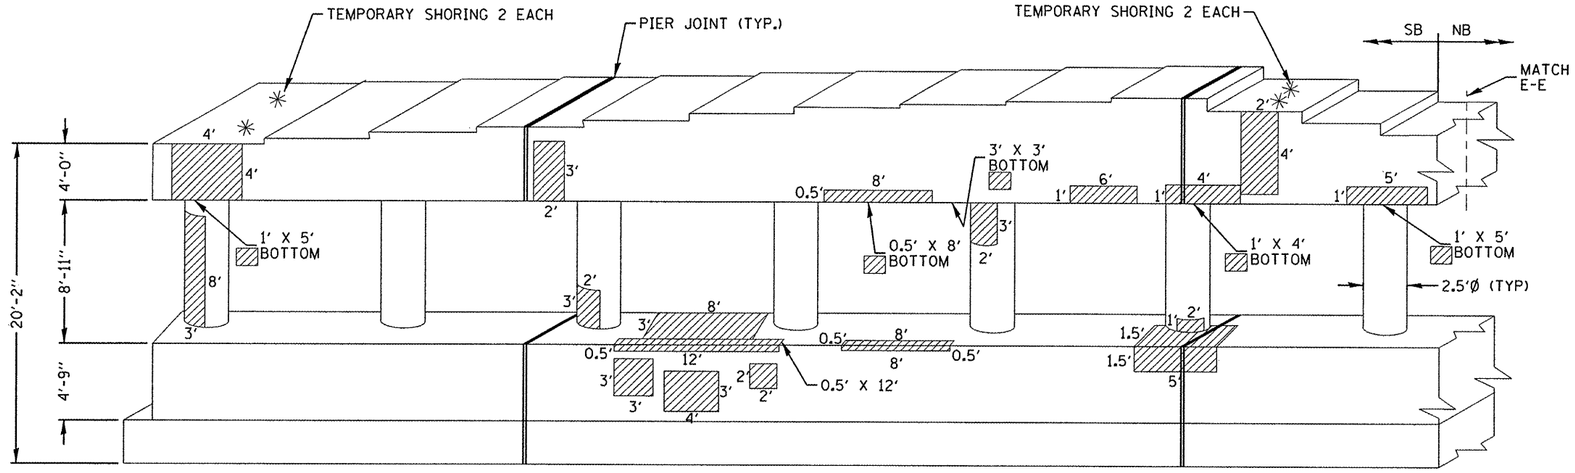
ELEVATION VIEW
LOOKING NORTH
IL 83 SB

STRUCTURAL REPAIR OF CONCRETE ≤ 5"

PIER 3 BILL OF MATERIAL	UNIT	TOTAL QTY	N FACE	S FACE
STRUCTURAL REPAIR OF CONCRETE ≤ 5"	SQFT	337	111	226
TEMPORARY SHORING AND CRIBBING	EACH	4	0	4
