STATE OF ILLINOIS
DEPARTMENT OF TRANSPORTATION
I-70 CONNECTION
CAHOKIA CANAL BOX CULVERT REPAIR PLANS

TOP SLAB REPAIR PLAN
SHEET 1 OF 2

SCALE: | SHEET NO. S-4 OF S-18 | STA. 150+80.33 TO STA.

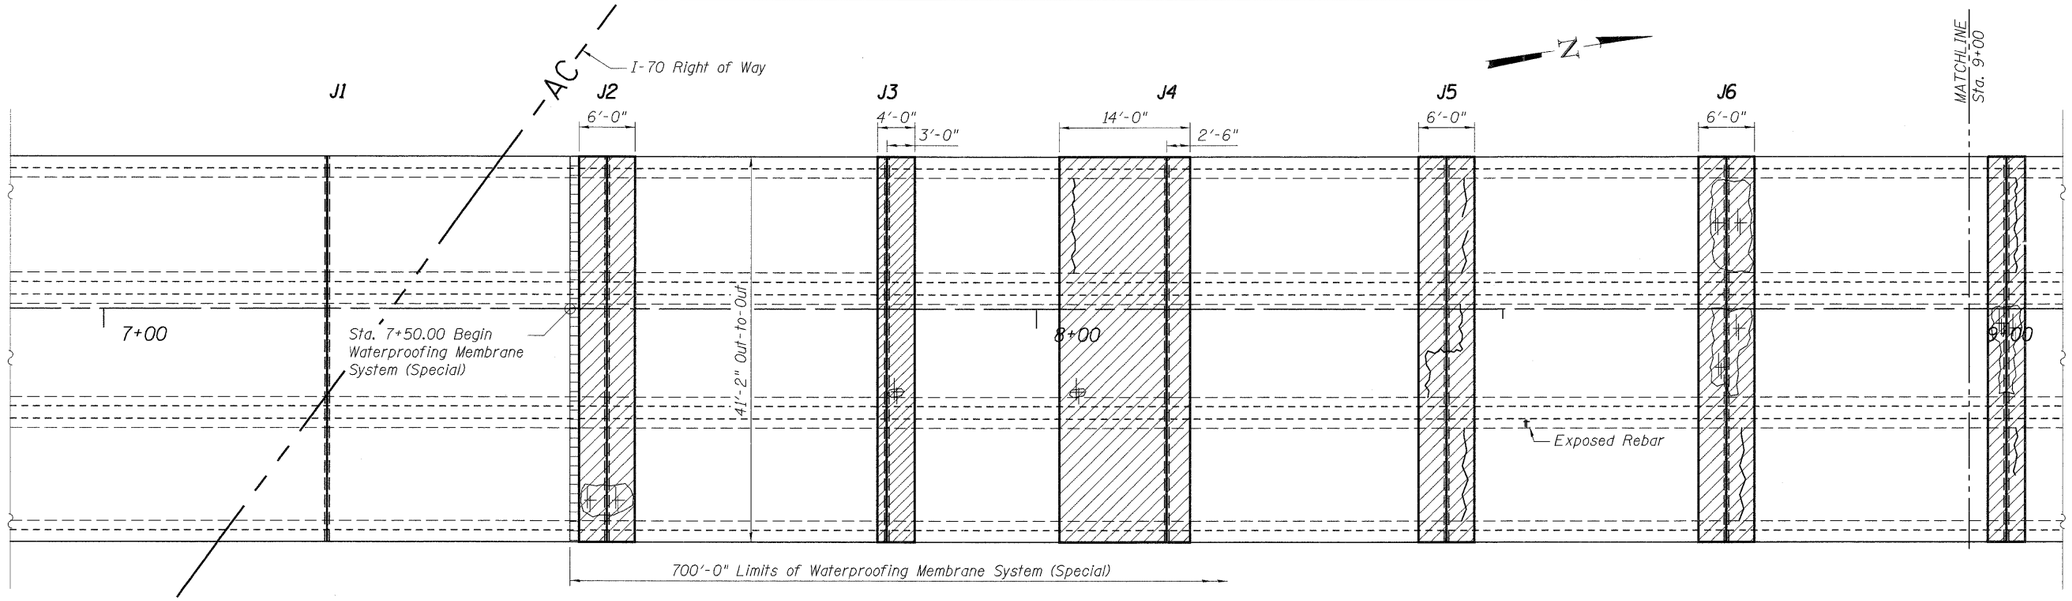
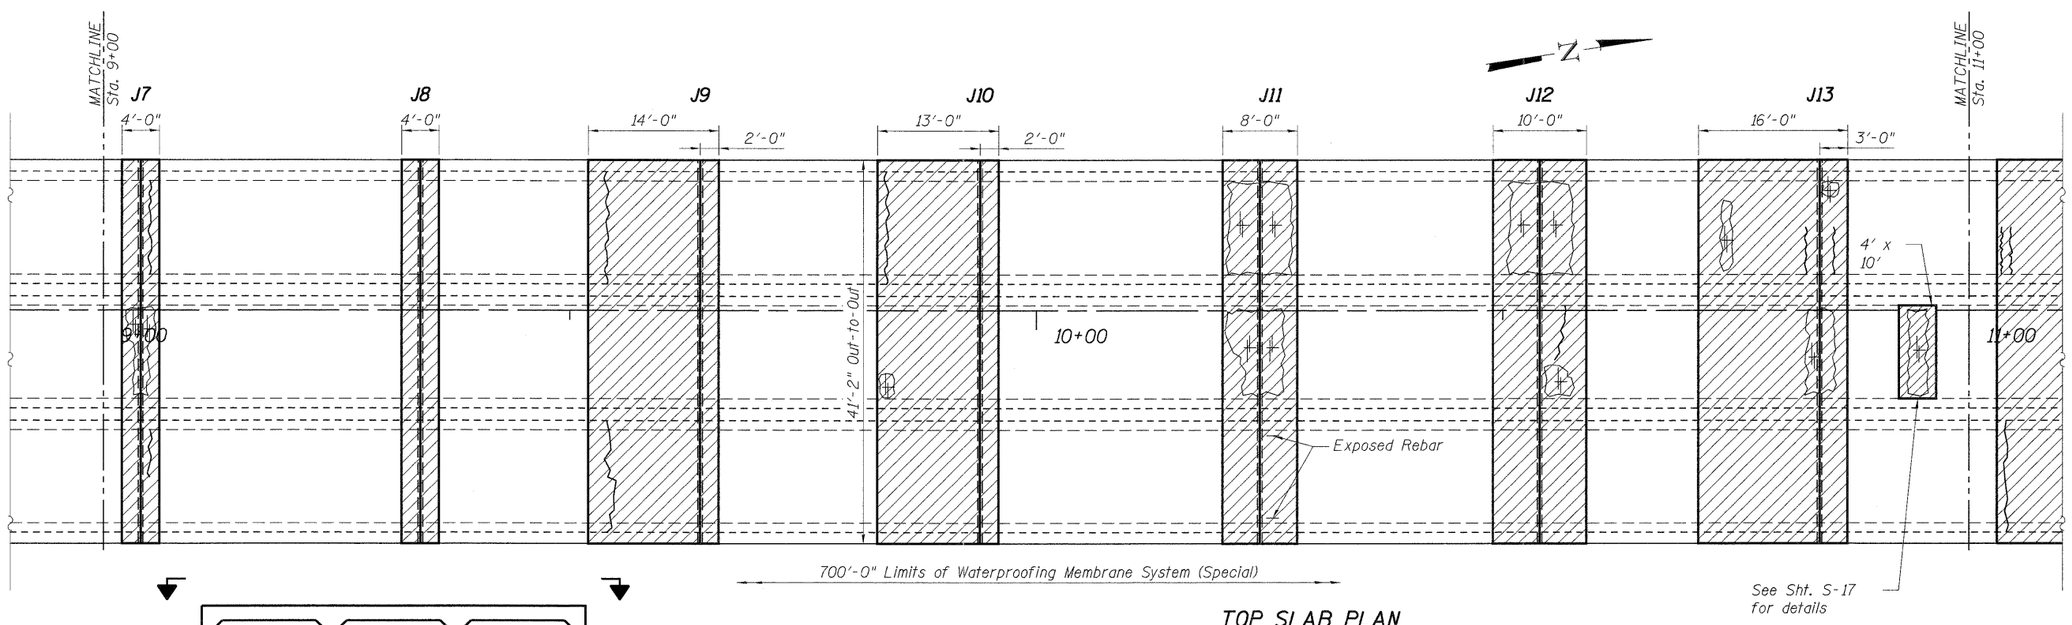
TOP SLAB PLAN

All cracks, spalls, and exposed rebar indicated are on the underside of slab.
