DESIGNED - DAB	EXAMINED - Timothy A. Daulton ACTING ENGINEER OF STRUCTURAL SERVICES	DATE - NOVEMBER 15, 2013	STATE OF ILLINOIS DEPARTMENT OF TRANSPORTATION		STRAIGHTENING DETAILS FOR GIRDERS 2 & 3 SN 016-2050		F.A. RTE.	SECTION	COUNTY	TOTAL SHEETS	SHEET NO.
CHECKED - SMR	PASSED - [Signature]						VAR	2013-044BR	COOK	35	19
DRAWN - Kyle M. Steffan	ACTING ENGINEER OF BRIDGES AND STRUCTURES						CONTRACT NO. 60W94				
CHECKED - DAB SMR					SHEET NO. 2 OF 4 SHEETS		ILLINOIS FED. AID PROJECT

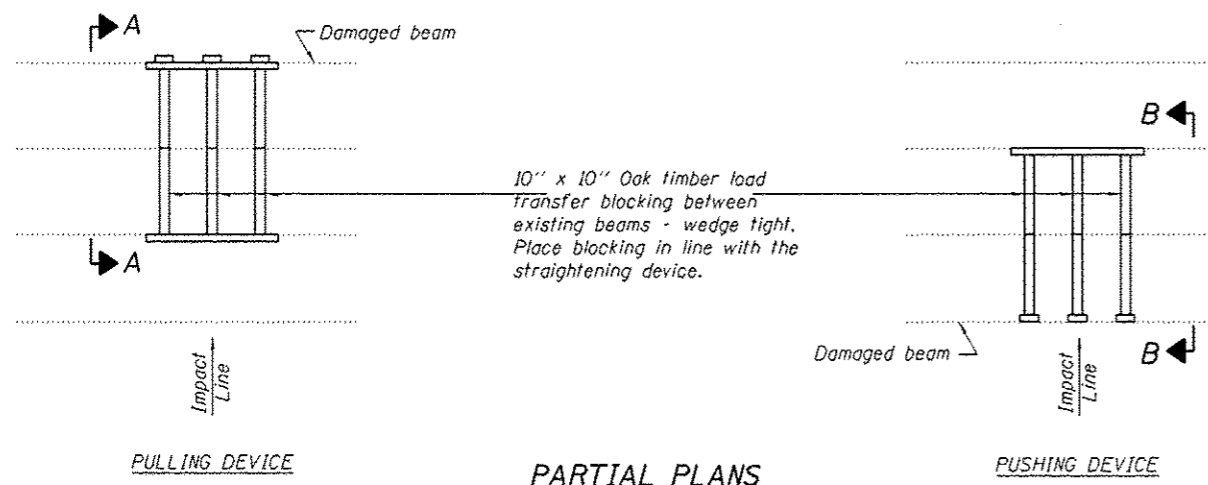
**PARTIAL PLANS**  
**SUGGESTED BEAM STRAIGHTENING METHODS**  
 Straightening force shall be maintained on all load transfer blocking during beam straightening.

Note:  
 Braces and jack assembly shall be placed on same side of web.  
 Bent bottom flange shall be straightened before starting any horizontal straightening operations.
