East River Road
Stephenson County, IL
Sampling Report

East River Road; Stephenson Co, IL - Sampling Report Summary

- Per request of Stephenson County, East River Road was sampled on November 7th, 2023, from Rock City Road to IL-75. The roadway was sampled to explore existing material, as well as evaluate the roadway's candidacy for a Cold In-Place Recycling (CIR) treatment utilizing engineered emulsion.
- The total project length is approximately 5.1 miles, averaging 20.9 feet wide, with a total existing pavement area of approximately 62,500 square yards.
- A total of 12 locations were sampled throughout the roadway to measure material thickness and examine material type.

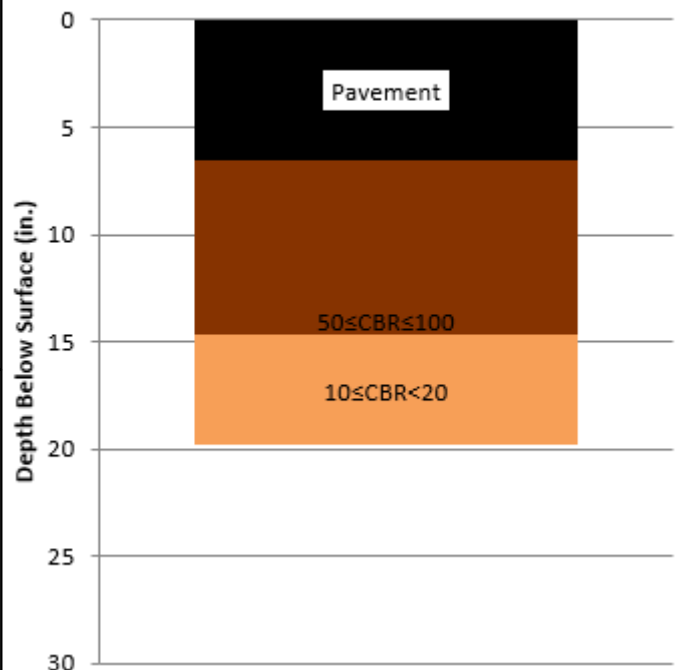
CBR vs. Depth Below Surface (in.) Location #1 - East River Road

- Longitudinal and transverse cracking was observed
- An average of 6.0 inches of bituminous material was observed at this location
- Top-down cracking was observed to a depth of 5.3 inches in core #3
- Full depth sample was not pictured of core #3
- A crushed aggregate base was observed directly below the bituminous material past a depth of 6.5 inches

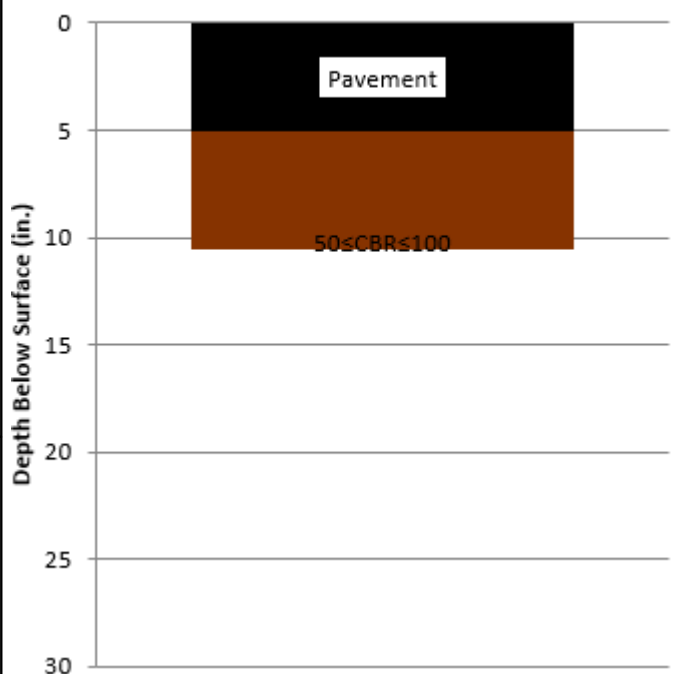
CBR vs. Depth Below Surface (in.) Location #2 - East River Road

- Longitudinal and transverse cracking was observed
- A total of 5.0 inches of bituminous material was observed at this location
- Top-down cracking was observed to 2.5 inches in core #3
- A crushed aggregate base was observed directly below the bituminous material

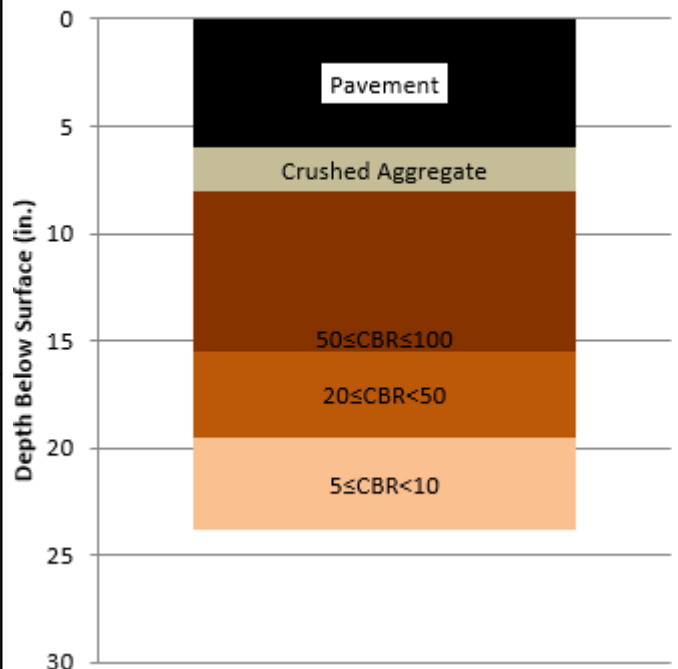
Location #3 - East River Road

- Loss of surface material was observed
- Loss of edge material was observed
- An average of 6.7 inches of bituminous material was observed at this location
- Full depth samples not pictured of cores #2 and 3
- A crushed aggregate base was observed directly below the bituminous material past a depth of 8.0 inches

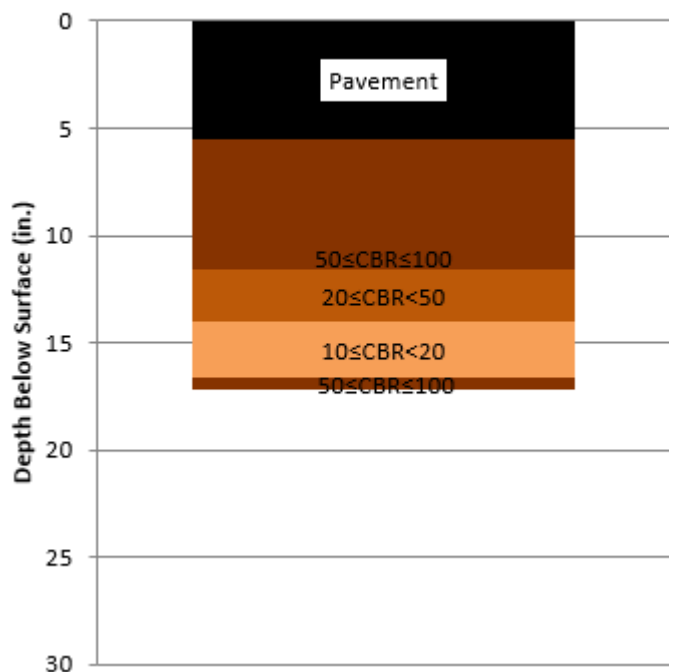
CBR vs. Depth Below Surface (in.) Location #4 - East River Road

- Longitudinal and transverse cracking was observed
- An average of 6.0 inches of bituminous material was observed at this location
- Full depth samples unable to be extracted intact due to stripping was observed between 5.5 and 6.5 inches
- A crushed aggregate base was observed below the bituminous material

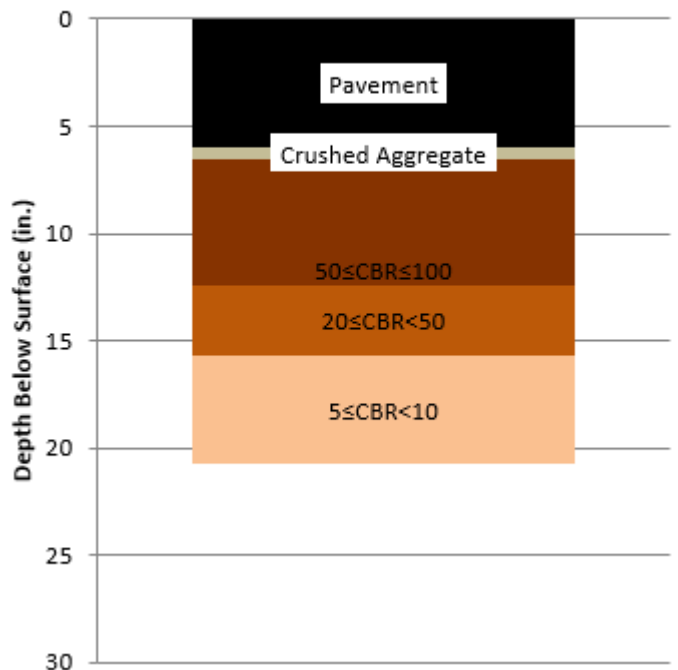
CBR vs. Depth Below Surface (in.) Location #5 - East River Road

- Alligator cracking was observed
- Surface patching was observed in the eastbound lane
- A total of 6.0 inches of bituminous material was observed at this location
- Stripping was observed past a depth of 3.0 inches in core #1
- A crushed aggregate base was observed below the bituminous material

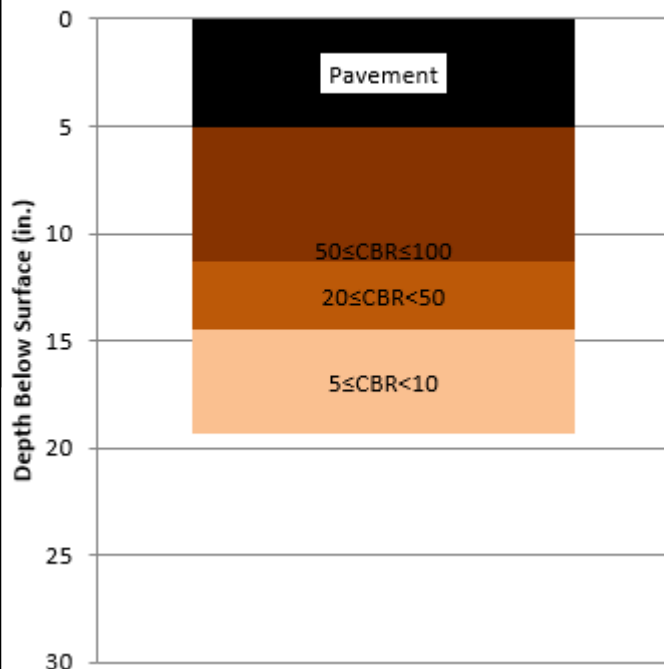
Location #6 - East River Road

- Alligator cracking was observed
- Loss of surface material was observed
- A total of 5.0 inches bituminous material was observed at this location
- A crushed aggregate base was observed directly below the bituminous material

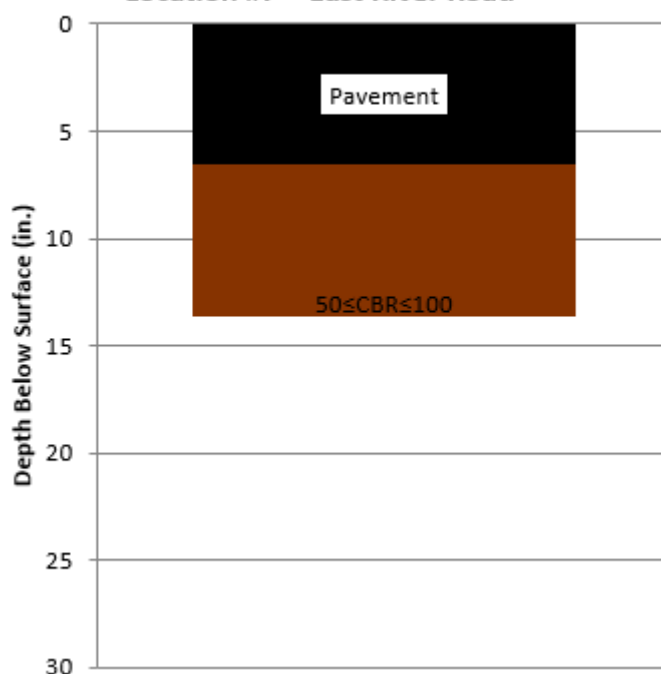
CBR vs. Depth Below Surface (in.) Location #7 - East River Road

- Longitudinal and transverse cracking was observed
- Loss of surface material was observed
- A total of 6.5 inches of bituminous material was observed at this location
- A crushed aggregate base was observed below the bituminous material

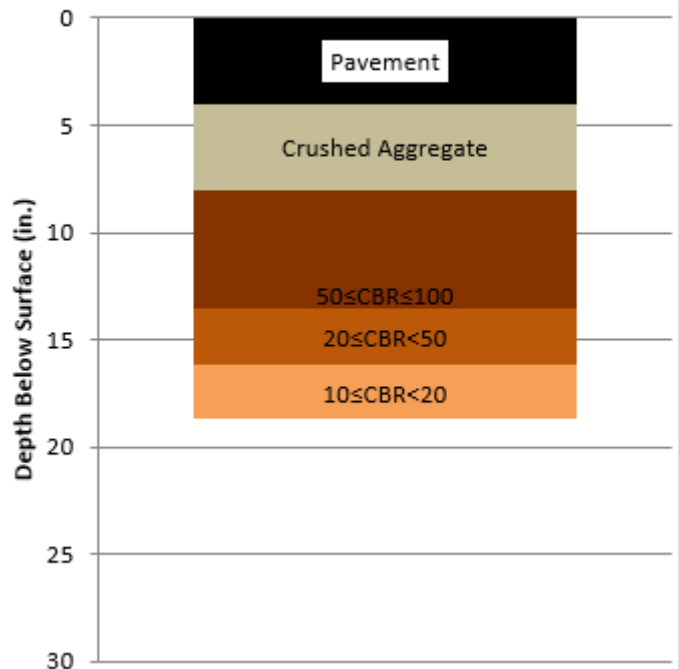
CBR vs. Depth Below Surface (in.) Location #8 - East River Road

- Transverse cracking was observed
- Alligator cracking was observed in the shoulders
- A total of 4.0 inches of bituminous material was observed at this location
- Full depth cracking was observed in core #2 and 3
- A crushed aggregate base was observed directly below the bituminous material past a depth of 8.0 inches

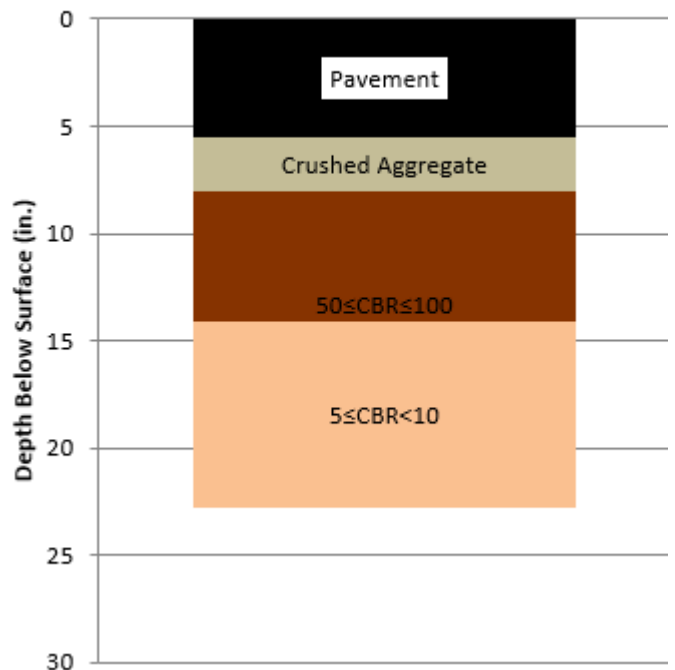
CBR vs. Depth Below Surface (in.) Location #9 - East River Road

- Longitudinal and transverse cracking was observed
- Transverse cracking was observed to be 4.0 inches in depth
- An average of 5.7 inches of bituminous material was observed at this location
- A crushed aggregate base was observed directly below the bituminous material past a depth of 8.0 inches

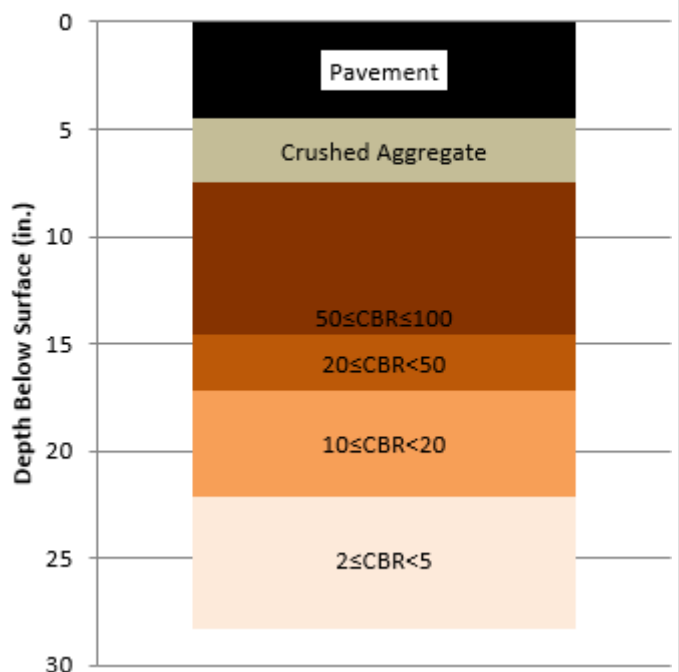
CBR vs. Depth Below Surface (in.) Location #10 - East River Road

- Longitudinal and transverse cracking was observed
- Alligator cracking was observed
- An average of 4.7 inches of HMA was observed at this location
- A crushed aggregate base was observed below the bituminous material past a depth of 7.5 inches

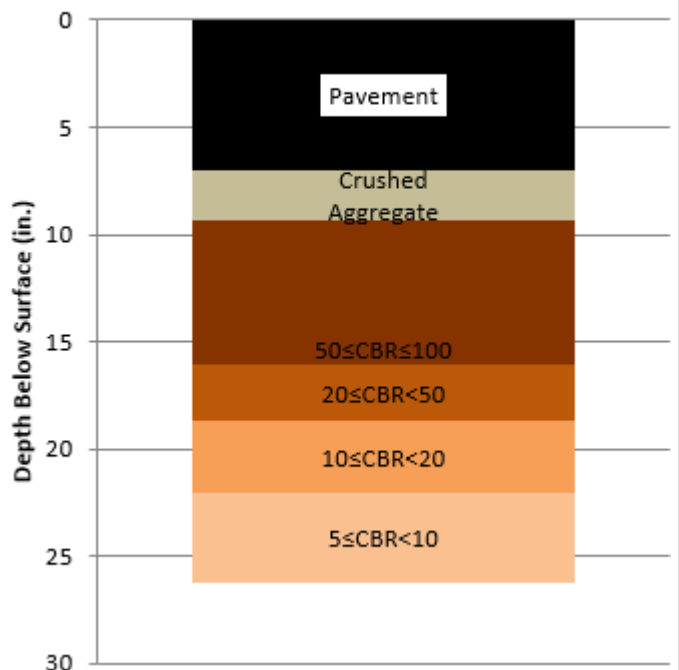
CBR vs. Depth Below Surface (in.) Location #11 - East River Road

- Longitudinal and transverse cracking was observed
- Loss of edge material was observed in the westbound lane
- A total of 6.8 inches of bituminous material was observed at this location
- A crushed aggregate base was observed directly below the bituminous material past a depth of 9.3 inches

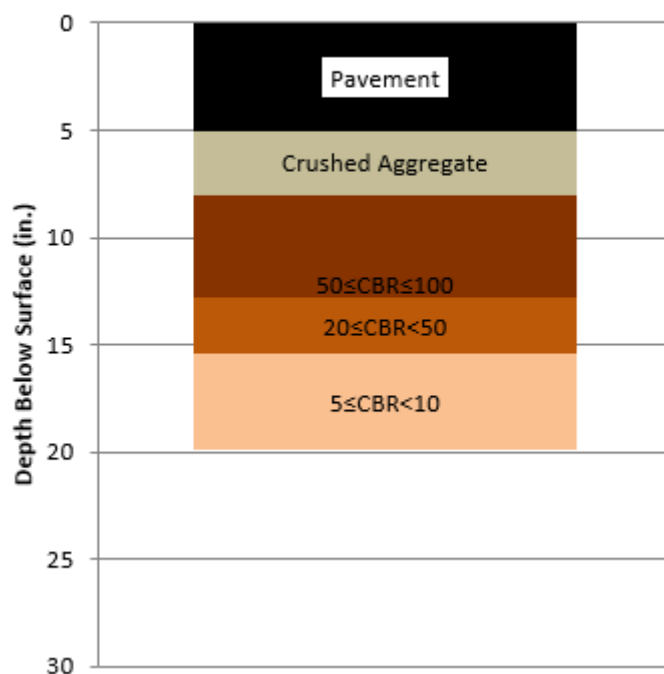
CBR vs. Depth Below Surface (in.) Location #12 - East River Road

- Longitudinal and transverse cracking was observed
- An average of 4.8 inches of bituminous material was observed at this location
- A crushed aggregate was observed directly below the bituminous material past a depth of 8.0 inches
