ROUTE NO.	SECTION	COUNTY	TOTAL SHEETS	SHEET NO.
FAP 315		McLEAN	44	23
STA.	TO STA.			
FED. ROAD DIST. NO.	ILLINOIS	FED. AID PROJECT-		
*102X-BR-2		DWG. NO.	11	OF 17
CONTRACT NO. 66584

**EAST ABUTMENT**  
**US 136 OVER BRANCH OF SALT CREEK**  
**FAP ROUTE 315 - SECTION 102X-BR-2**  
**McLEAN COUNTY**  
**STATION 616+99.00**  
**STRUCTURE NO. 057-0185**

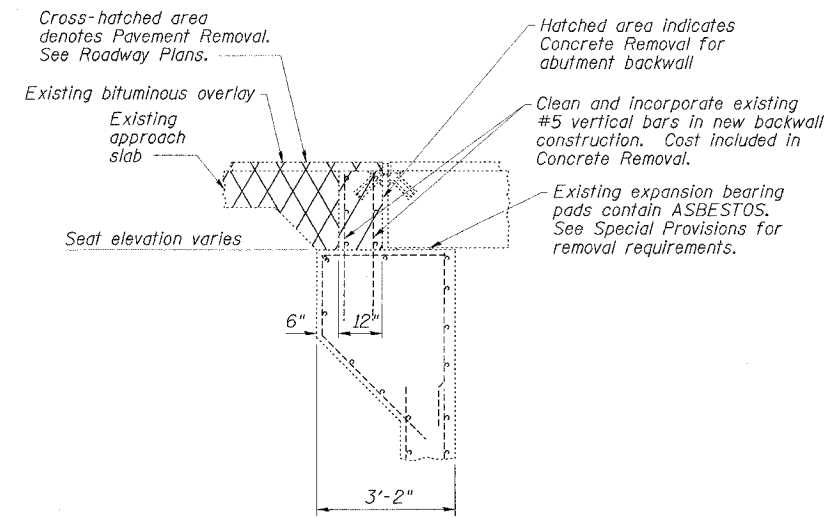
**SECTION B-B**  
EXISTING

**ELEVATION**  
Backwall Repairs

\*Epoxy grout bars in 8" min. depth drilled holes according to section 584 of the Standard Specifications.
