ILLINOIS DEPARTMENT OF TRANSPORTATION

I-64 OVER
WABASH RIVER
STRUCTURE NUMBER: 097-0003
EASTBOUND PIER 3

Drawn By: PRH/DR		Date: JULY, 2005
Checked By: JEO		Scale: 1"=20'
Code: 419503-04		Figure No.: 14

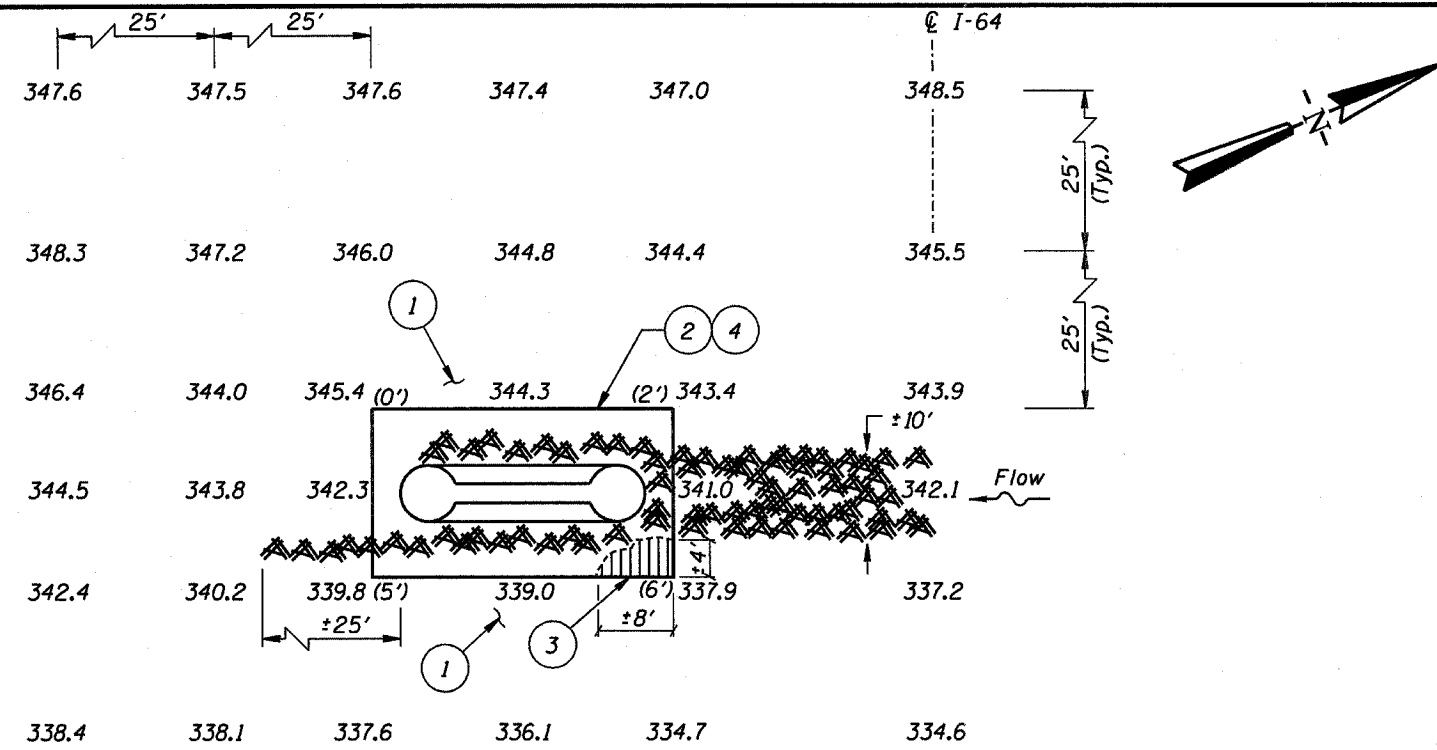
- ① The channel bottom material typically consisted of sandstone, which was fragmented along the upstream nose of the pier.
- ② Footing exposure, with vertical limits as shown.
- ③ Footing undermined, creating a 1-foot vertical cavity with up to 4 feet of penetration.
- ④ Timber formwork covered approximately 90 percent of the vertical concrete footing surface.
- ⑤ Minor area of concrete section loss located 6 feet above the waterline. The area measured 16 inches wide and 4 inches high, with up to 4 inches of penetration.
- ⑥ Heavy accumulation of timber debris, consisting of trees measuring up to 3 feet in diameter with associated branches.
- ⑦ Heavy accumulation of timber debris, consisting of trees measuring up to 1.5 feet in diameter with associated branches.
- ⑧ No damage below waterline.
