F.A.I. RTE.	SECTION	COUNTY	TOTAL SHEETS	SHEET NO.
64	97-3B-1-2	WHITE	15	8
STA.		TO STA.		
FED. ROAD DIST. NO.	ILLINOIS	FED. AID PROJECT

I-64 OVER
WABASH RIVER
STRUCTURE NUMBER: 097-0004
WESTBOUND PIER 3

Drawn By: PRH/DR	COLLINS ENGINEERS <small>123 North Wacker Drive Suite 300 Chicago, IL 60606 (312) 704-9300 www.collinsengr.com</small>	Date: JULY, 2005
Checked By: JEO		Scale: 1"=20'
Code: 419503-04		Figure No.: 15

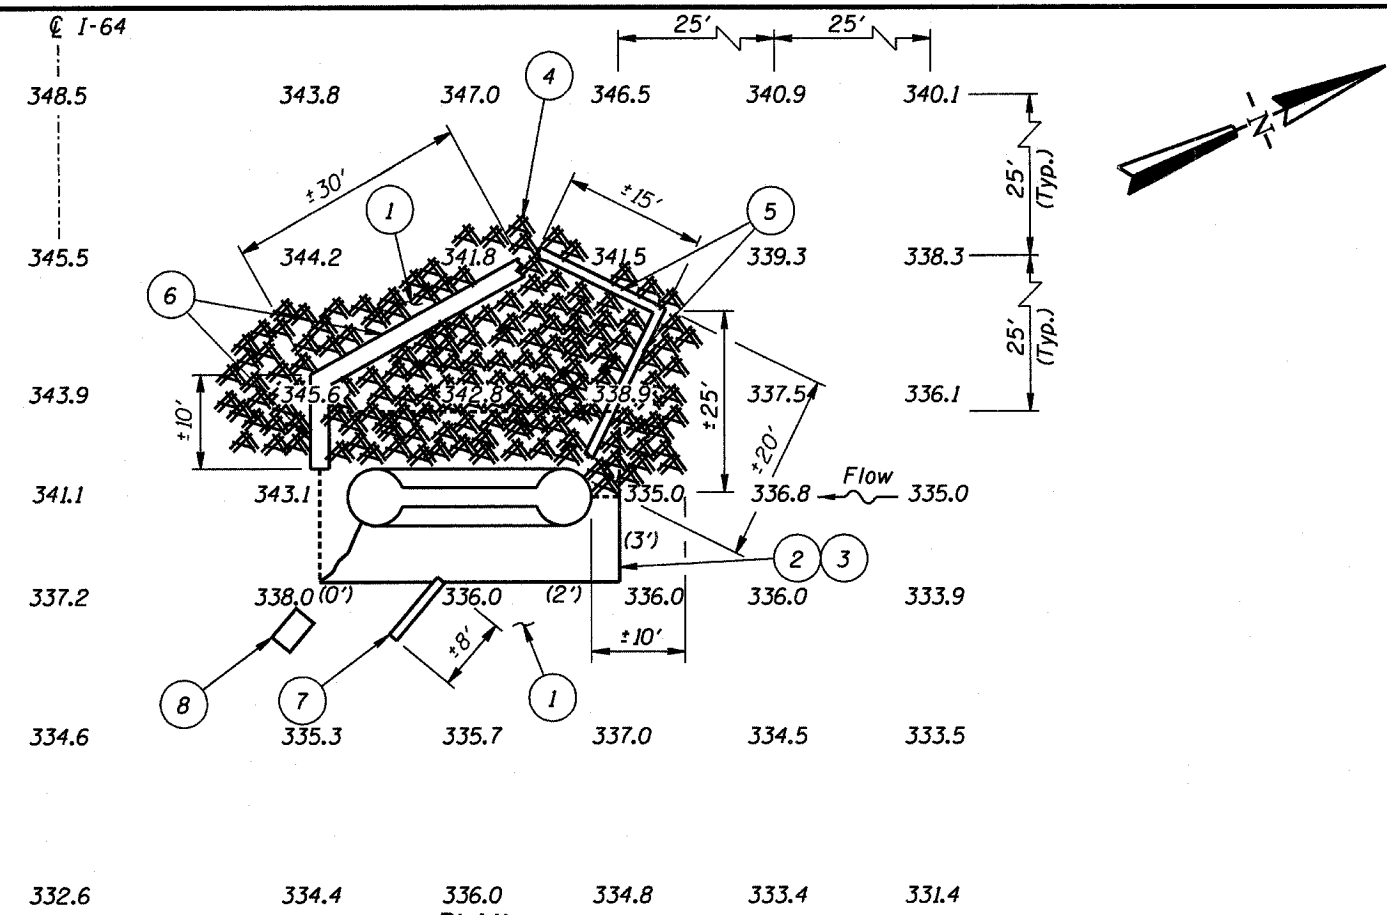
- Inspection Notes:**
- 1 The channel bottom material typically consisted of fragmented sandstone.
 - 2 Footing exposure, with vertical limits as shown. Due to heavy timber and steel debris accumulations, the footing could not be detected along the west fascia or western half of the upstream nose. In the area where the footing was exposed, no undermining was detected.

- 3 Timber formwork covered approximately 90 percent of the vertical concrete footing surface.
 - 4 Heavy accumulation of timber debris, consisting of trees measuring up to 3 feet in diameter and random railroad ties.

- 5 Steel debris, consisting of two steel beams connected by a gusset plate. The beams measured 15 feet and 20 feet in length, and were approximately 1 foot deep. Small circular ribs were noted along the steel beams, indicating riveted fasteners consistent with railroad truss construction. Due to the heavy accumulations of timber debris covering portions of these beams, exact measurements could not be obtained. While the locations of the observed beams were noted, additional steel debris may intermixed below the large drift accumulation.

- 6 Steel debris, consisting of two steel beams connected by a gusset plate. The beams measured 10 feet and 30 feet in length, and were approximately 2 feet deep. Small circular ribs were noted along the steel beams, indicating riveted fasteners consistent with railroad truss construction. Due to the heavy accumulations of timber debris covering portions of these beams, exact measurements could not be obtained. While the locations of the observed beams were noted, additional steel debris may intermixed below the large drift accumulation.

- 7 Steel debris, consisting of an 8-foot long steel beam measuring approximately 1 foot in depth.
 - 8 Steel debris, consisting of a 55-gallon drum located along the channel bottom.

- 9 No change in exposure condition from June 2005 inspection.
 - 10 No damage below waterline.
