**ILLINOIS  
DEPARTMENT OF TRANSPORTATION**

I-64 OVER  
WABASH RIVER  
STRUCTURE NUMBER: 097-0003  
**EASTBOUND PIER 4**

Drawn By: PRH/DR	<b>COLLINS ENGINEERS</b> <small>123 North Wacker Drive Suite 300 Chicago, IL 60606 (312) 704-9300 www.collinseng.com</small>	Date: JULY, 2005
Checked By: JEO		Scale: 1"=20'
Code: 419503-04		Figure No.: 16

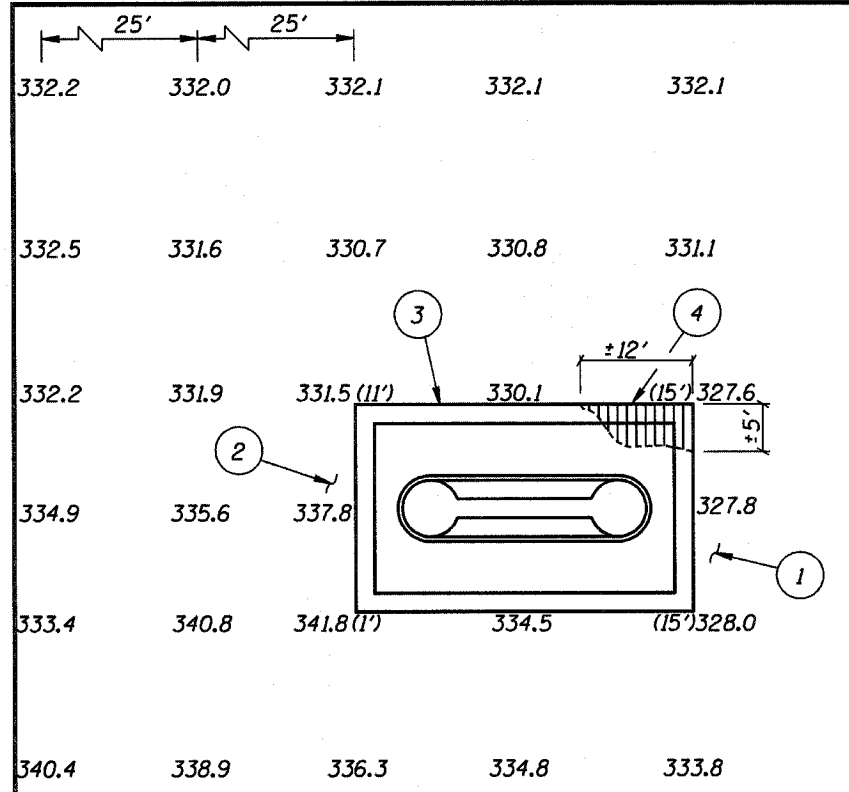
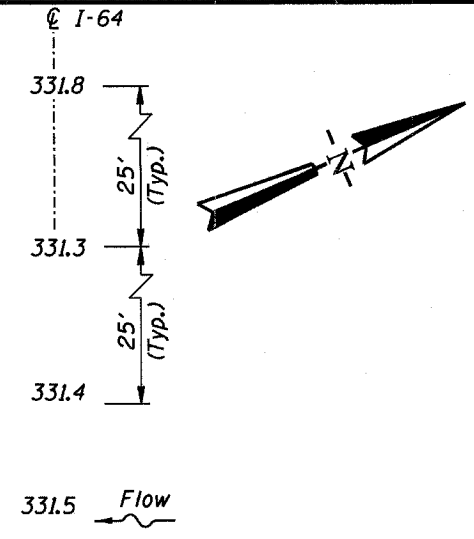
- 1 The channel bottom material typically consisted of fragmented sandstone.
- 2 The channel bottom material typically consisted of loose sand, with up to 1.5 feet of probe rod penetration.
- 3 Seal exposure, with vertical limits as shown.
- 4 Seal undermined, creating a 1-foot vertical cavity with up to 4 feet of penetration. The bottom concrete surface of the undermined seal was typically rough and loose.
- 5 No damage below waterline.

1. At the time of the inspection, the waterline was located approximately 14.4 feet below the bottom of the pier beam at Eastbound Pier 3. This corresponds to a waterline elevation of 358.1 feet, based on the 1966 design plans.
2. Soundings indicate the channel bottom elevation at the time of inspection and are measured in feet.
