F.A.I. RTE.	SECTION	COUNTY	TOTAL SHEETS	SHEET NO.
64	97-3B-I-2	WHITE	15	10
STA.		TO STA.		
FED. ROAD DIST. NO.		ILLINOIS	FED. AID PROJECT

<b>ILLINOIS DEPARTMENT OF TRANSPORTATION</b>		
I-64 OVER WABASH RIVER STRUCTURE NUMBER: 097-0004 <b>WESTBOUND PIER 4</b>		
Drawn By: PRH/DR	<b>COLLINS ENGINEERS</b> <small>123 North Wacker Drive Suite 300 Chicago, IL 60606 (312) 704-9300 www.collinsengr.com</small>	Date: JULY, 2005
Checked By: JEO		Scale: 1"=20'
Code: 419503-04		Figure No.: 17

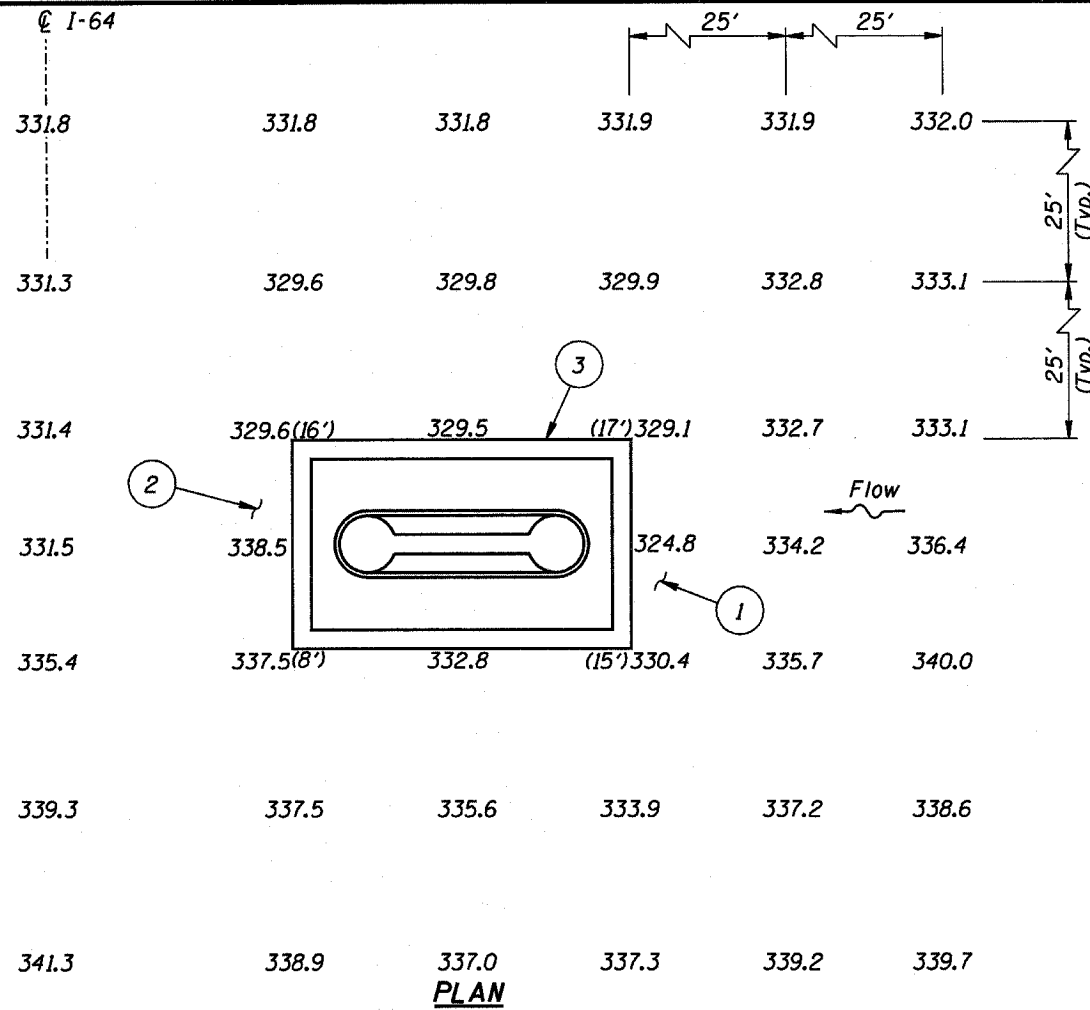
- ① The channel bottom material typically consisted of loose sand and gravel, with up to 2 feet of probe rod penetration.
- ② The channel bottom material typically consisted of loose gravel, with up to 1 foot of probe rod penetration.
- ③ Seal exposure, with vertical limits as shown. No seal undermining detected.
- ④ Band of heavy concrete scale around pier perimeter, measuring 8 inches wide, located 4 feet below the top of the seal. The scale had a typical penetration of 6 inches and a maximum penetration of 1 foot.
- ⑤ No damage below waterline.

1. At the time of the inspection, the waterline was located approximately 14.4 feet below the bottom of the pier beam at Eastbound Pier 3. This corresponds to a waterline elevation of 358.1 feet, based on the 1966 design plans.
2. Soundings indicate the channel bottom elevation at the time of inspection and are measured in feet.
