June 9 Inspection Notes:

ILLINOIS DEPARTMENT OF TRANSPORTATION		
I-64 OVER WABASH RIVER STRUCTURE NUMBER: 097-0004 WESTBOUND PIER 6		
Drawn By: PRH/DR	COLLINS ENGINEERS <small>123 North Wacker Drive Suite 300 Chicago, IL 60606 (312) 704-9300 www.collinsengr.com ILLINOIS PROFESSIONAL DESIGN FIRM LICENSE NO. 184-000993</small>	Date: JULY, 2005
Checked By: JEO		Scale: 1"=20'
Code: 419503-04		Figure No.: 21

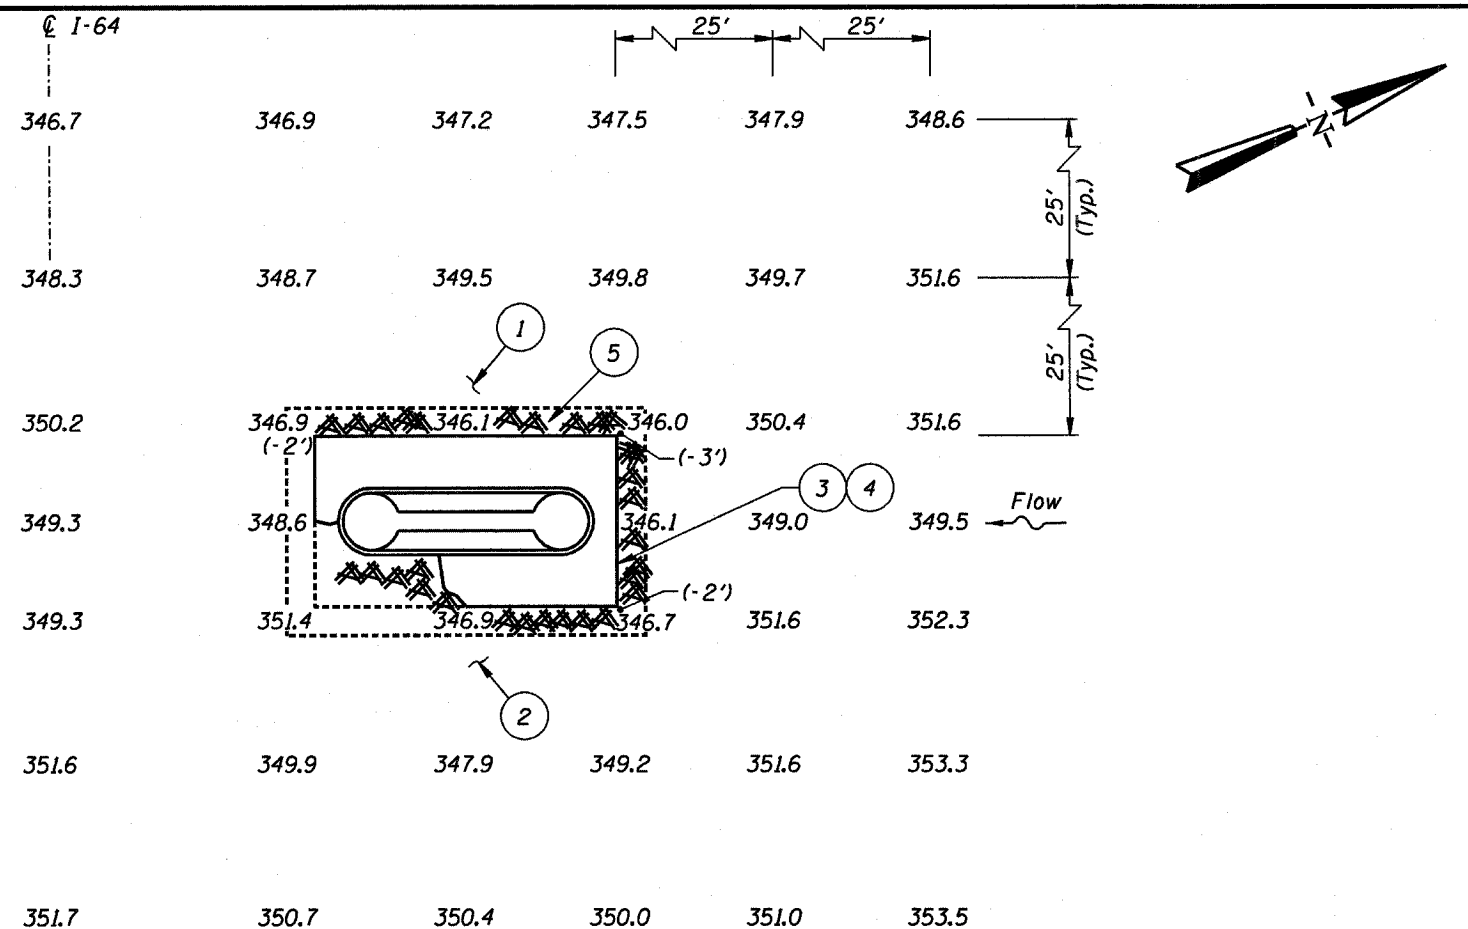
- ① The channel bottom material typically consisted of loose sandy silt, with up to 1.5 feet of probe rod penetration.
- ② The channel bottom material typically consisted of soft silt, with up to 3 feet of probe rod penetration.
- ③ Footing exposure, with vertical limits as shown. In the area where the footing was exposed, no undermining was detected.
- ④ Timber formwork covered approximately 90 percent of the vertical concrete footing surface.
- ⑤ Heavy accumulation of timber debris, consisting of trees measuring up to 2 feet in diameter with associated branches.
- ⑥ No damage below waterline.
