STATE OF ILLINOIS
DEPARTMENT OF TRANSPORTATION

REPAIR DETAILS
SN 016-0545

SHEET NO. 2 OF 2 SHEETS

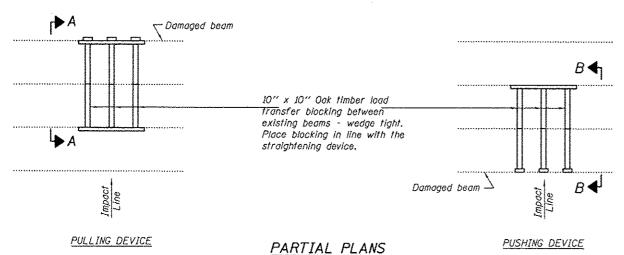
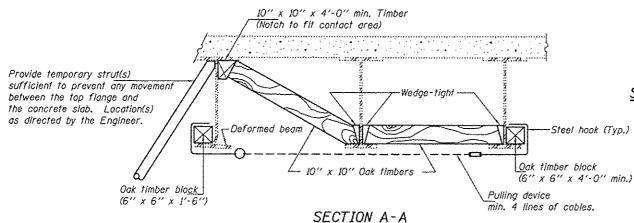
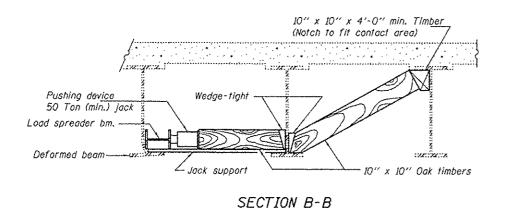
SUGGESTED BEAM STRAIGHTENING METHODS

EXISTING DEFORMATION TO BE STRAIGHTENED

(Looking East)
(Approximate max. deflections)
Deflected length of beam to be
straightened is approximately 4'-0''.

Straightening force shall be maintained on all lood transfer blocking during beam straightening.

Grind existing nicks, gouges and shallow cracks in the damaged beams as detailed. Ground surfaces shall be inspected for cracks using magnetic particle testing prior to initiating any beam straightening operations. Any cracks that cannot be removed by grinding approximately $\frac{1}{4}$ " deep shall be identified and reported to the Bureau of Bridges and Structures for further disposition. Ground surfaces shall be spot cleaned and painted with an aluminum epoxy mastic primer followed by a finish coat to match the color of the existing beam. Cost of grinding, testing and spot painting included with Beam Straightening,

Braces and jack assembly shall be placed on same side of web. Bent bottom flange shall be straightened before starting any horizontal straightening operations.
