**STATE OF ILLINOIS
DEPARTMENT OF TRANSPORTATION**

**SINKHOLE LOCATION NOS. 2 & 3
NEAR STATION 262+20**

SHEET NO. 2 OF 4 SHEETS

F.A.I. RTE. 55	SECTION 2010-079-RS	COUNTY COOK/DUPAGE	TOTAL SHEETS 26	SHEET NO. 208
ILLINOIS FED. AID PROJECT			CONTRACT NO. 60L67

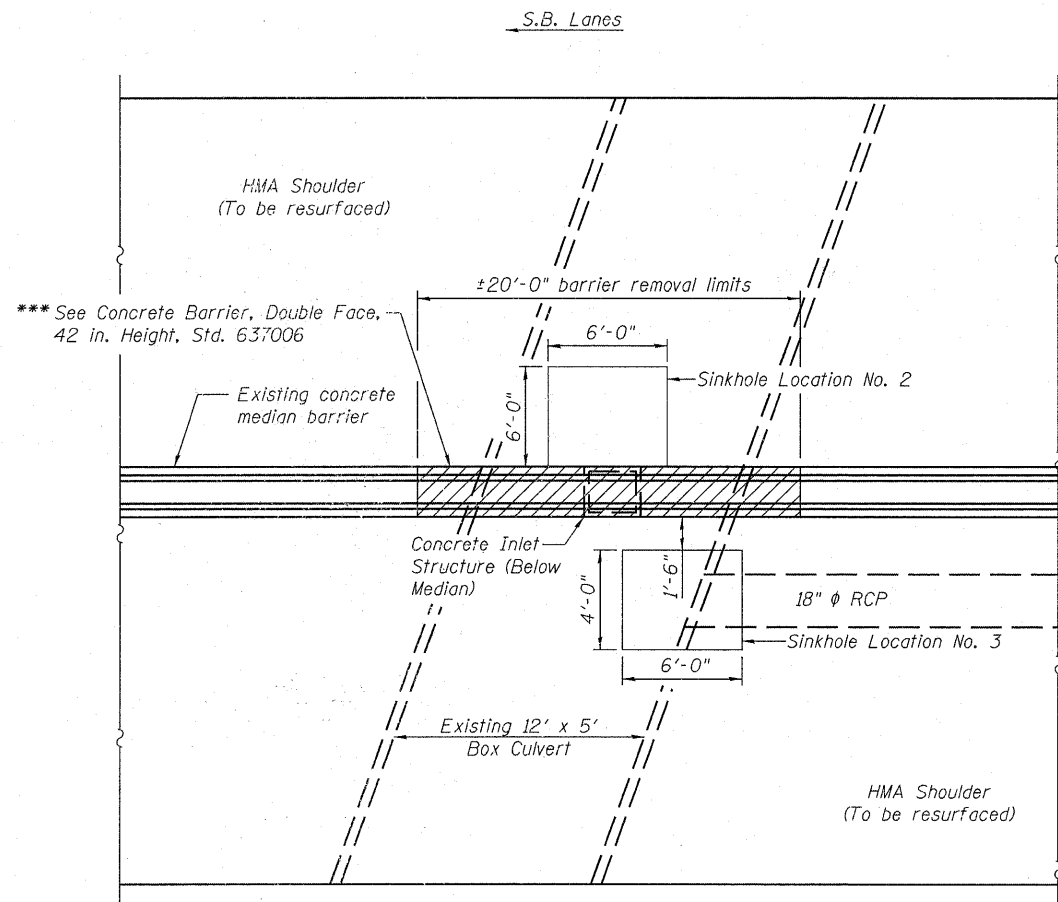
BARRIER REPAIR DETAIL

*** Match existing dimensions. Protective Coat shall be applied on top and side faces of new barrier.

**Drill and epoxy grout according to Article 584 of the Standard Specifications, included in the cost of Concrete Barrier Removal and Replacement Double Face.
