ROADWAY GEOTECHNICAL REPORT\_REVISION 2  
IL 127 near Amphitheater  
Campground, Slope Stability  
PTB 199-039 – WO 2 and 3, Loc. 1  
JACKSON COUNTY, ILLINOIS

Subject: ROADWAY GEOTECHNICAL REPORT\_REVISION 2, IL 127 NEAR  
AMPHITHEATER CAMPGROUND, SLOPE STABILITY  
PTB 199-039 – WO 2 AND 3, LOC. 1, JACKSON COUNTY, ILLINOIS

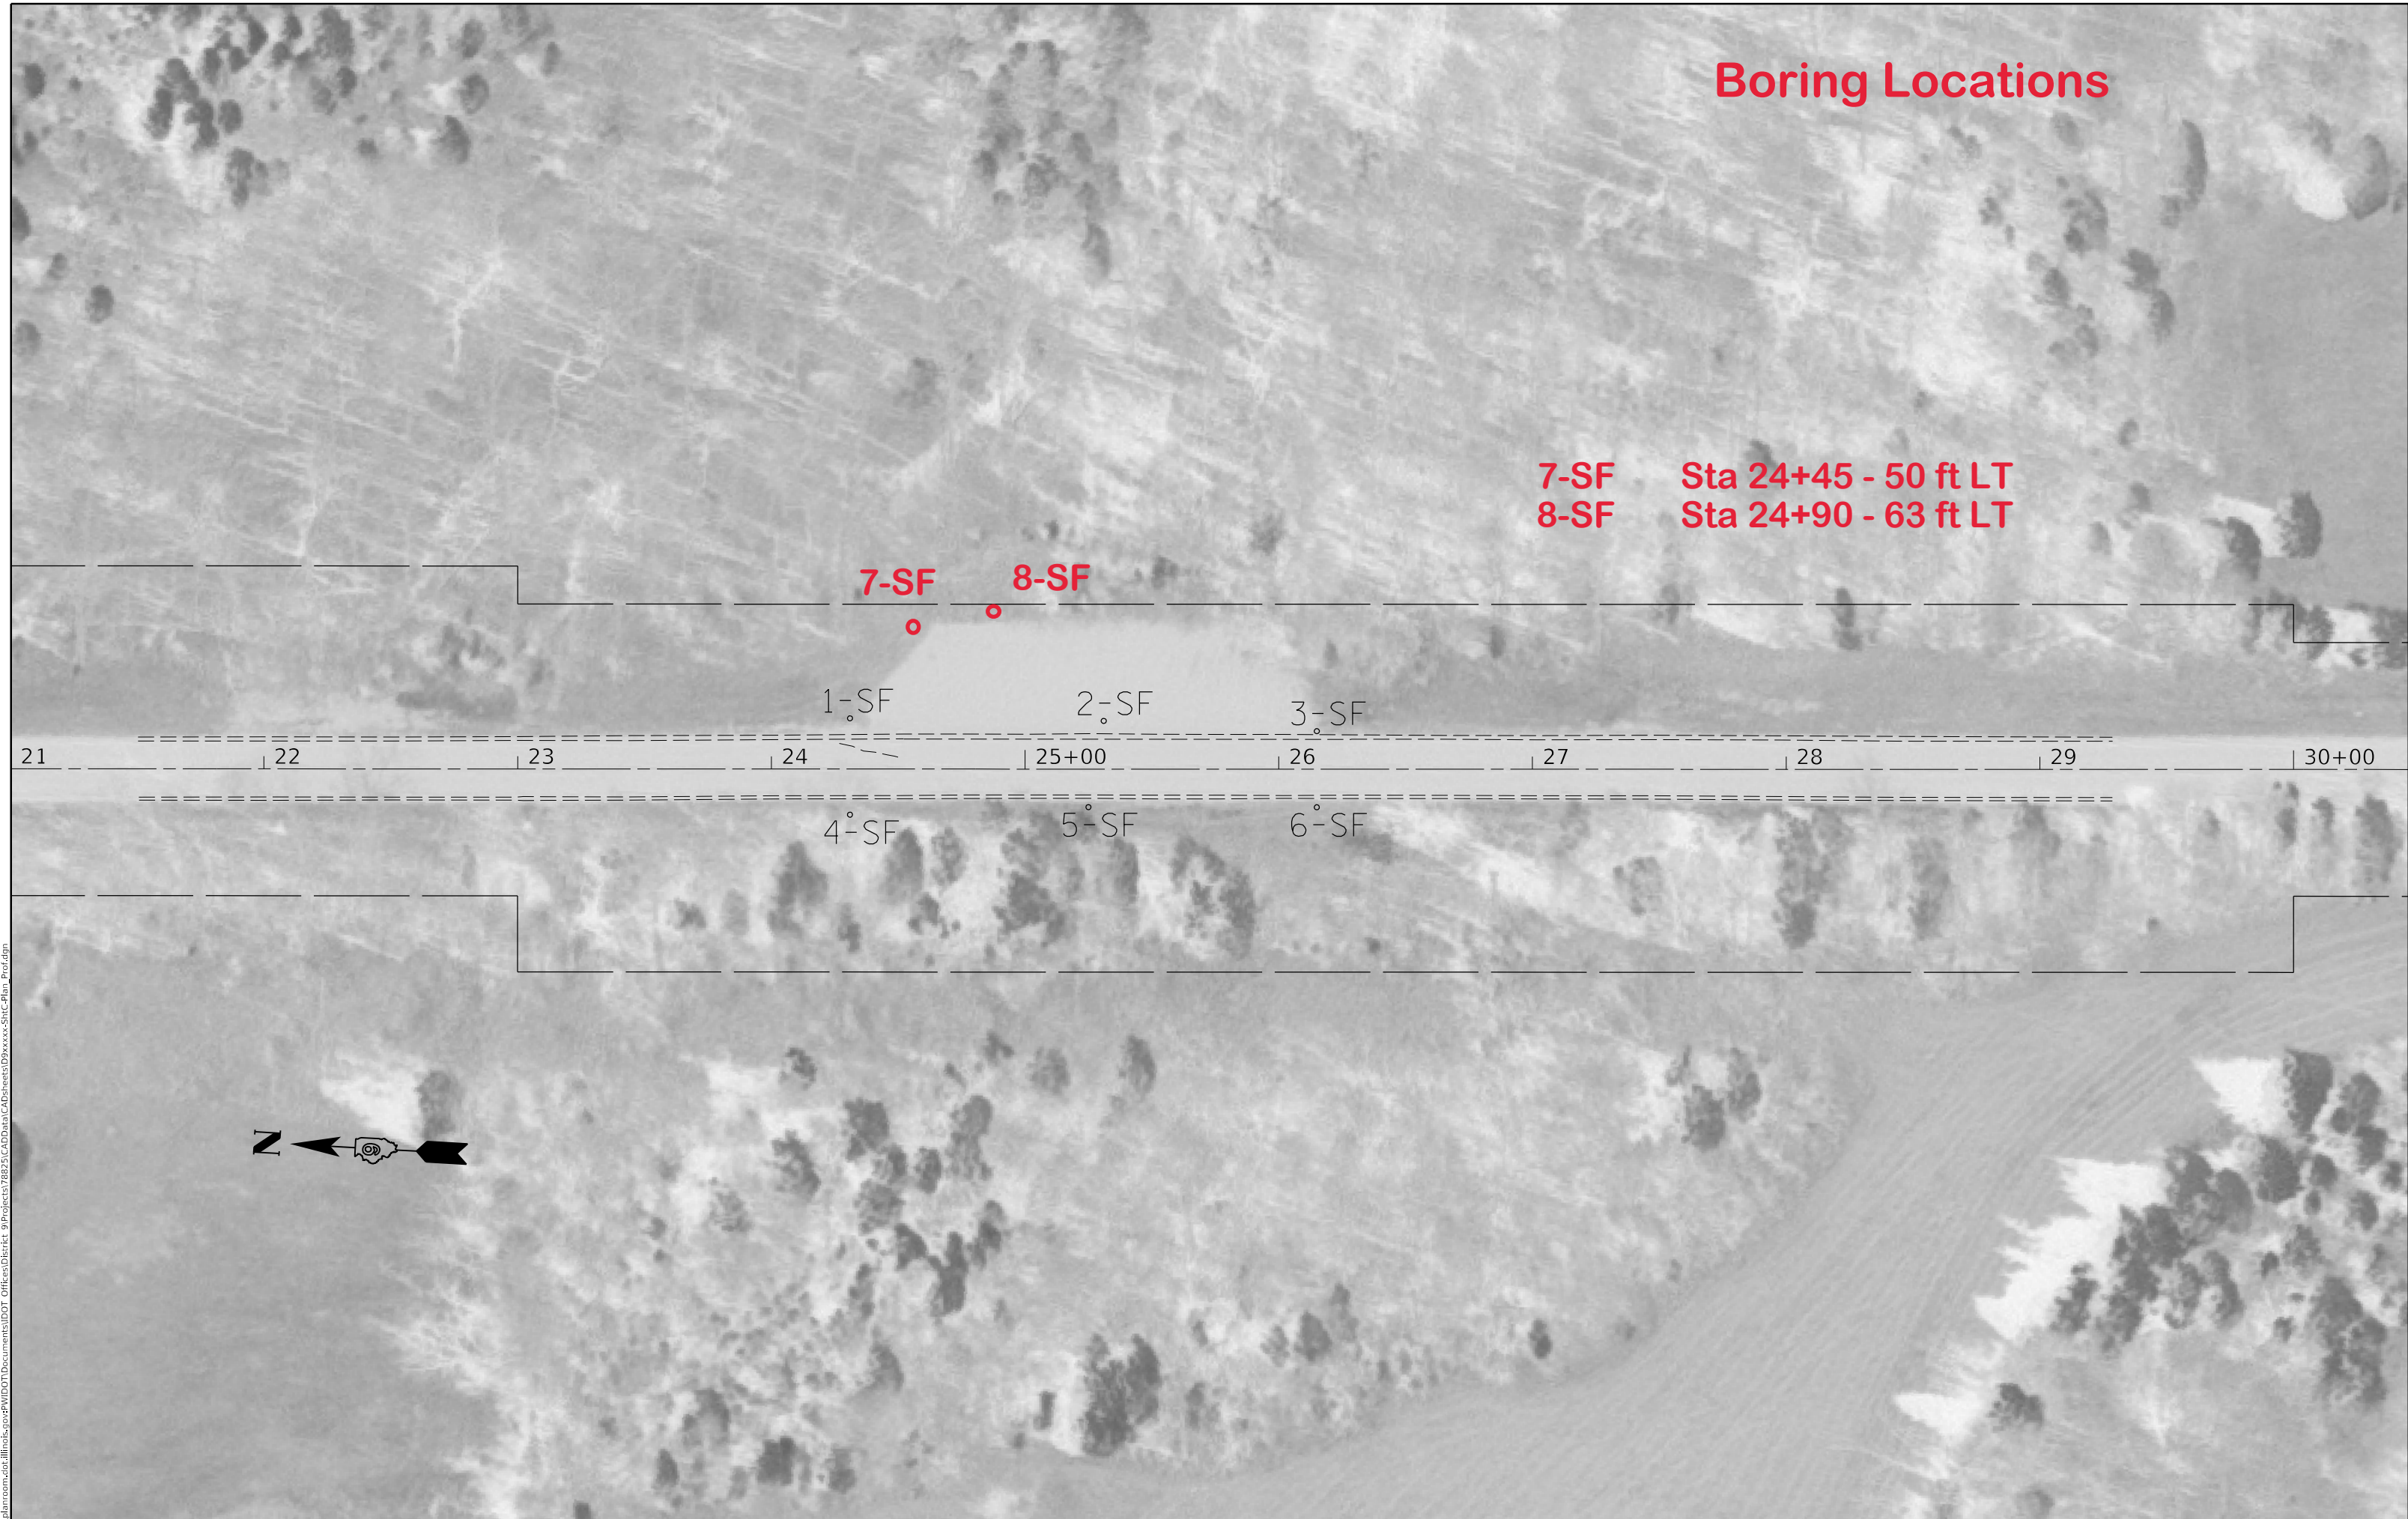
# Boring Locations

7-SF Sta 24+45 - 50 ft LT  
 8-SF Sta 24+90 - 63 ft LT

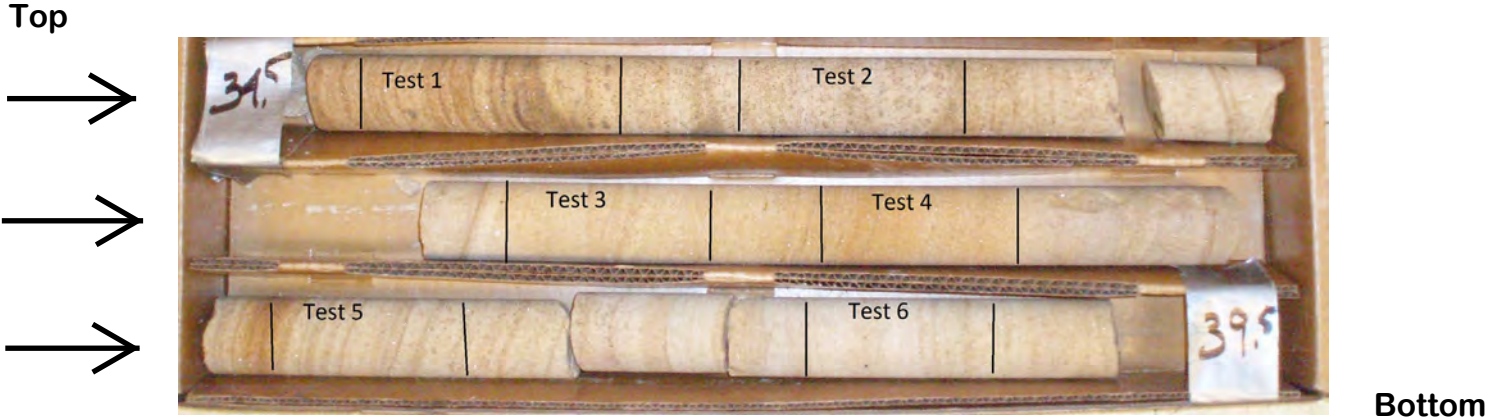
IL 127 Slope Failure  
 Jackson Co.  
 Boring 2-SF

Boring #	Specimen#	Depth	Unconfined Compression
2-SF	1	34' 10"	3,585 psi
2-SF	2	35'6"	5,227 psi
2-SF	3	37'	6,838 psi
2-SF	4	37'7"	3,812 psi
2-SF	5	38'5"	2,720 psi
2-SF	6	39'5"	3,408 psi

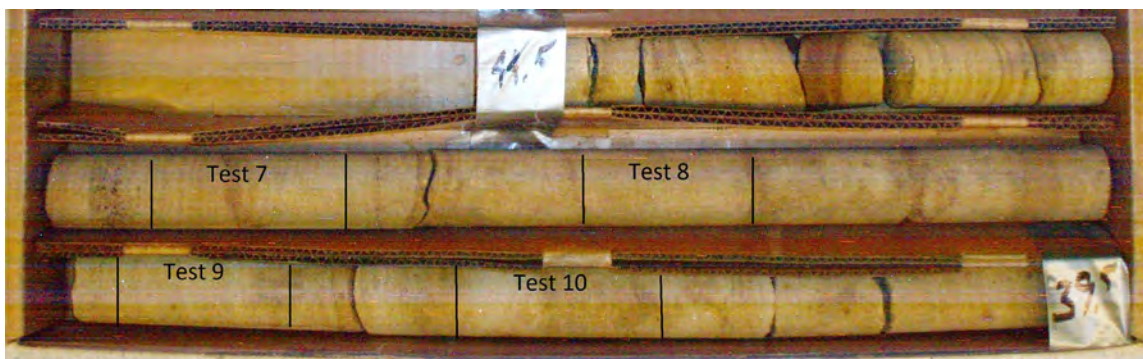
IL 127 Slope Failure  
 Jackson Co.  
 Boring 2-SF

Boring #	Specimen#	Depth	Unconfined Compression
2-SF	10	40'5"	5,131 psi
2-SF	9	41'5"	4,017 psi
2-SF	8	42'5"	4,952 psi
2-SF	7	43'1"	2,897 psi

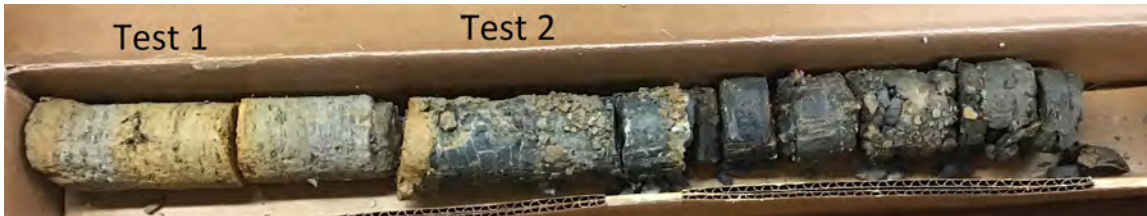
**IL 127**  
**Jackson Co. Slope Failure N. of Pomona Rd.**  
**Boring 4-SF**  
**6-7-21 Lab #22**

Boring #	Specimen#	Thickness	L/D ratio	Depth	Unconfined Compression Reading (lbs) (psi)	
4-SF	1	3.0"	*1.7:1	16.0	75	30 psi
4-SF	2	2.9"	*1.6:1	17.75'	35	14 psi

\*Desirable specimen length to diameter ratios are between 2.0:1 and 2.5:1. The results may differ from results obtained from a test specimen that meets the requirements.

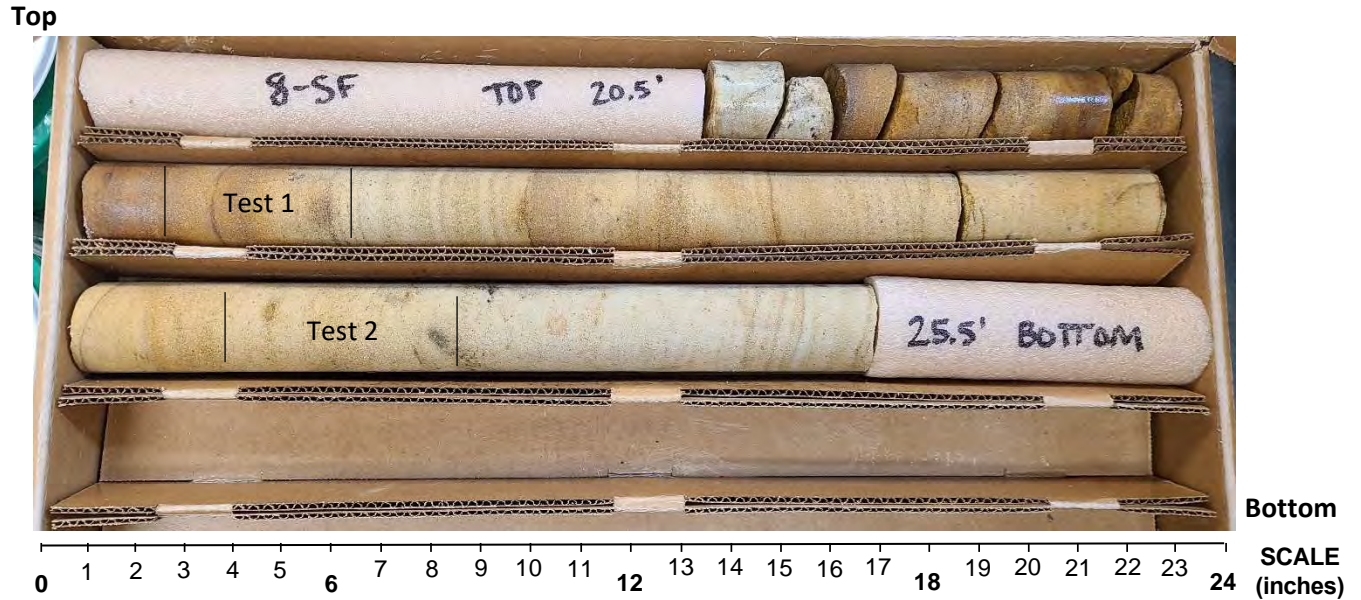
IL 127 Slope Failure  
 Jackson Co.  
 Boring 8-SF

Boring#	Specimen#	Depth	Unconfined Compression
8-SF	1	21.5'	15,122 psi
8-SF	2	24.5'	10,215 psi

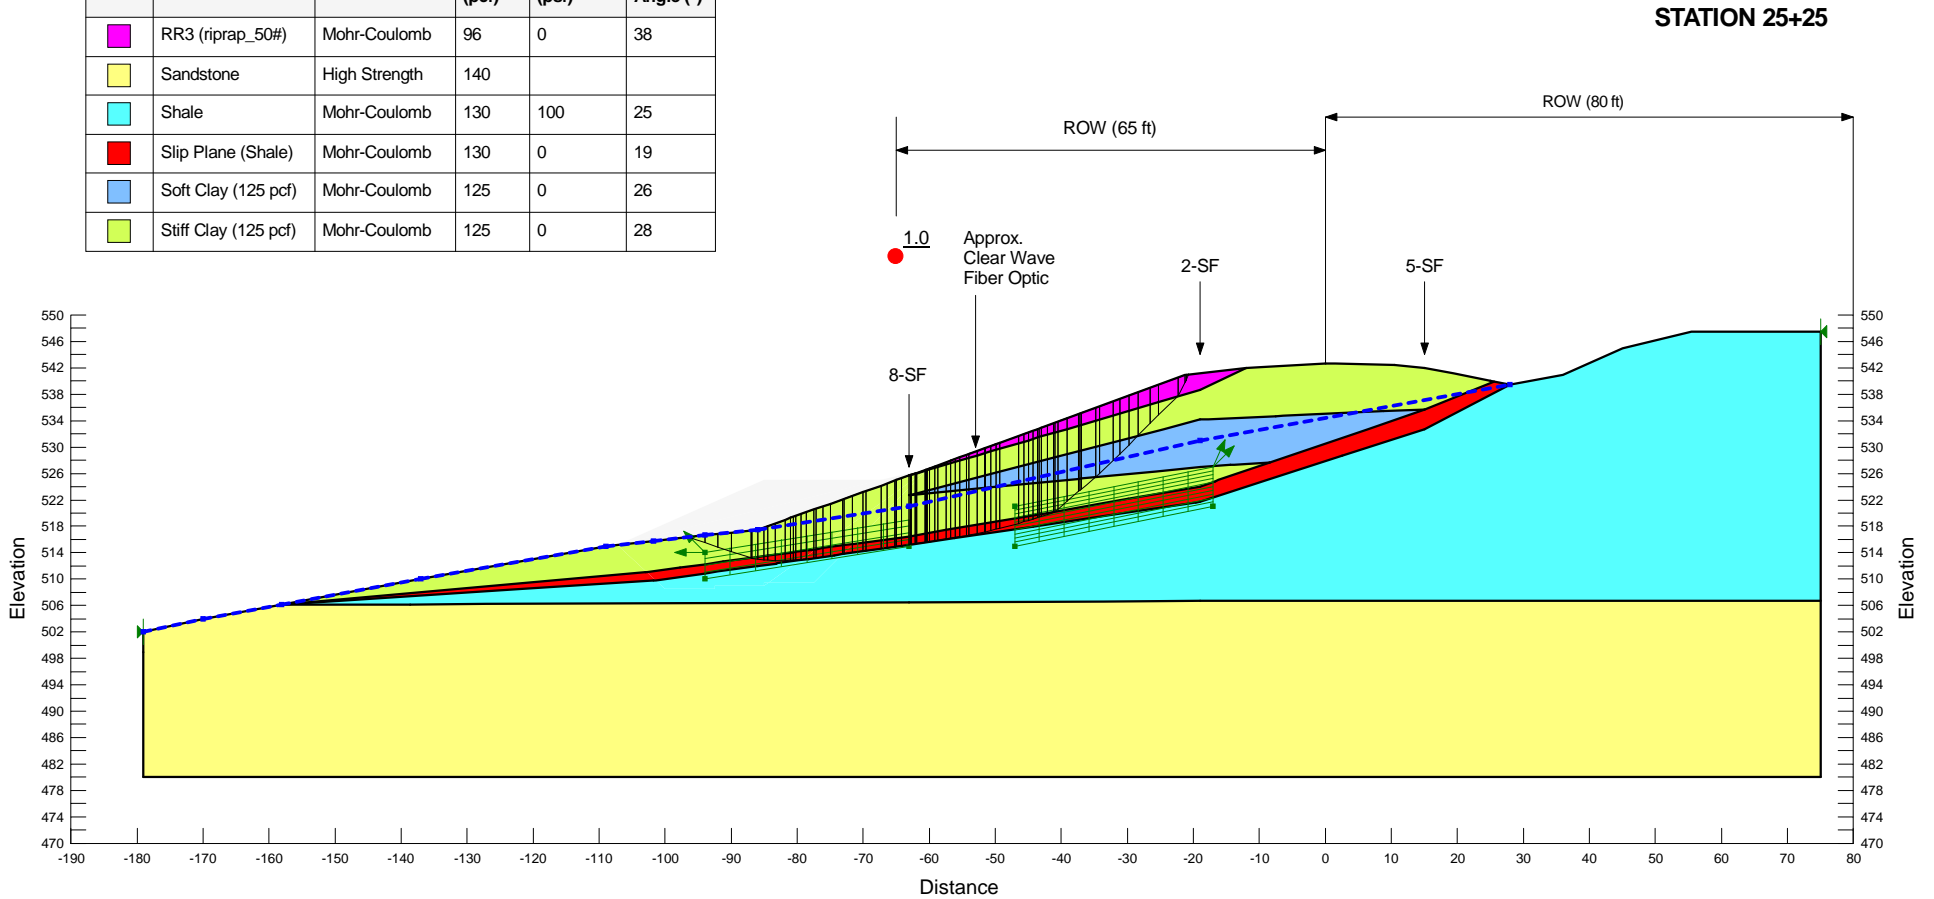
Shannon & Wilson No. 106747-003

Color	Name	Slope Stability Material Model	Unit Weight (pcf)	Effective Cohesion (psf)	Effective Friction Angle (°)
■	RR3 (riprap_50#)	Mohr-Coulomb	96	0	38
■	Sandstone	High Strength	140		
■	Shale	Mohr-Coulomb	130	100	25
■	Slip Plane (Shale)	Mohr-Coulomb	130	0	19
■	Soft Clay (125 pcf)	Mohr-Coulomb	125	0	26
■	Stiff Clay (125 pcf)	Mohr-Coulomb	125	0	28

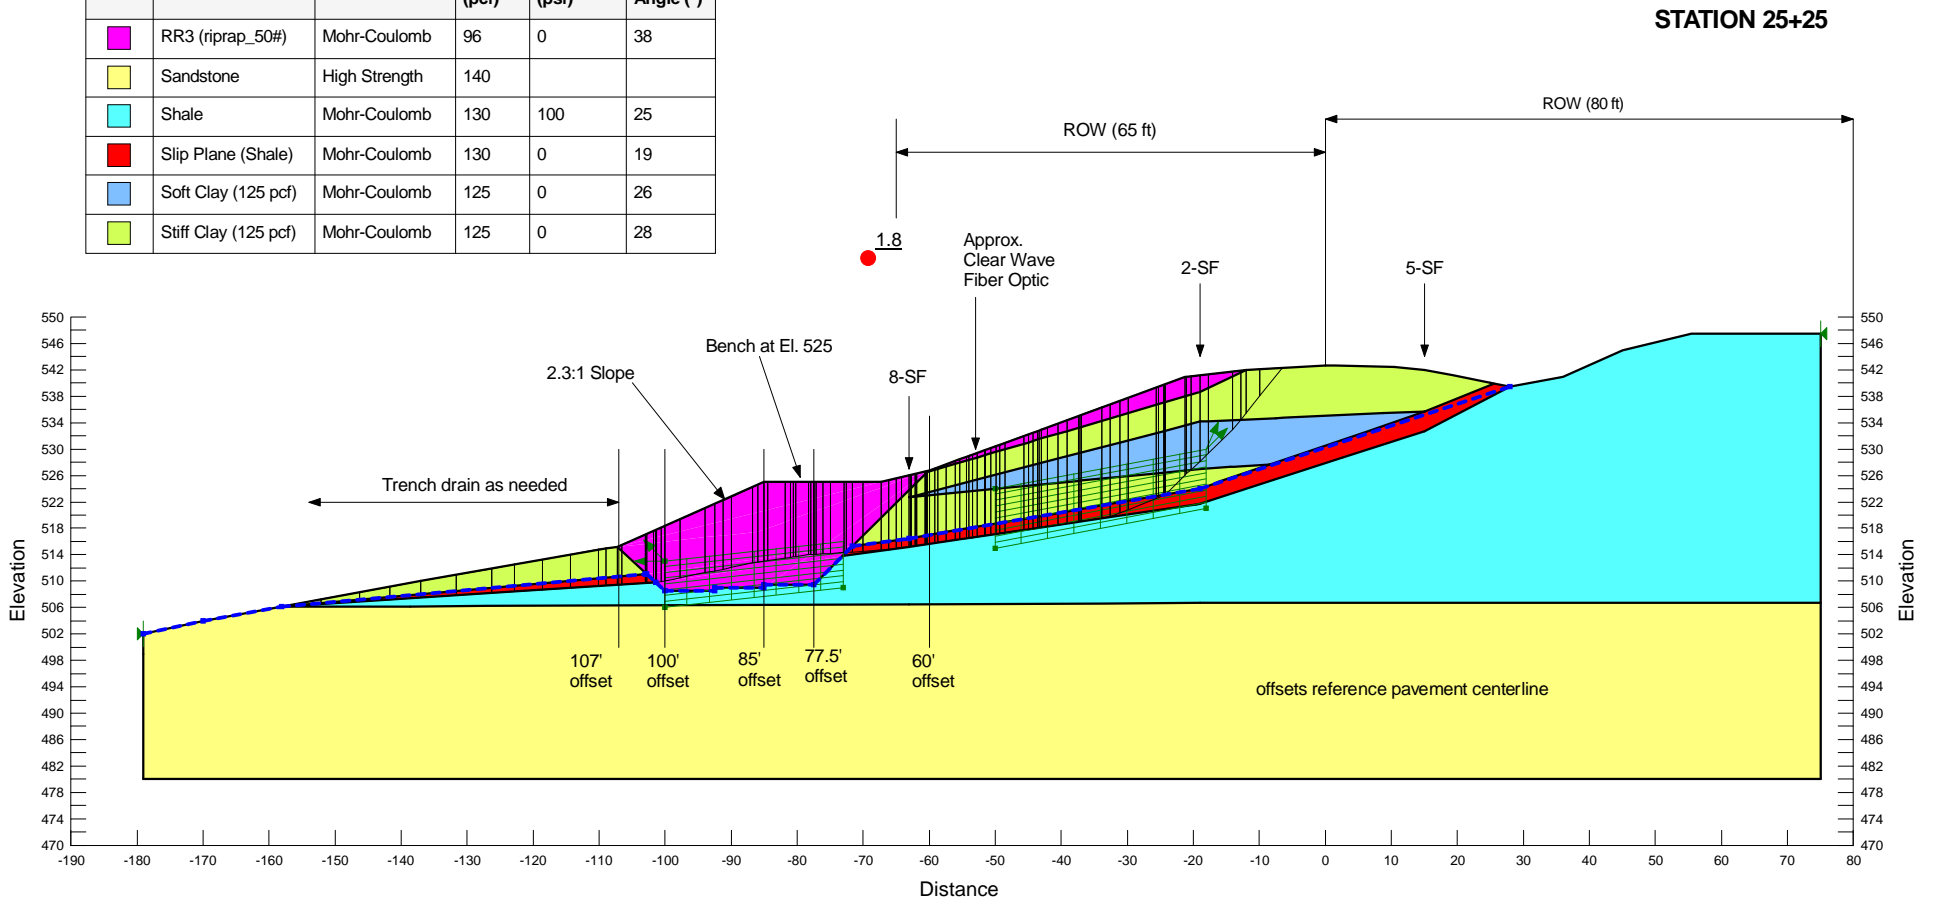
Shannon & Wilson No. 106747-003

Color	Name	Slope Stability Material Model	Unit Weight (pcf)	Effective Cohesion (psf)	Effective Friction Angle (°)
■	RR3 (riprap_50#)	Mohr-Coulomb	96	0	38
■	Sandstone	High Strength	140		
■	Shale	Mohr-Coulomb	130	100	25
■	Slip Plane (Shale)	Mohr-Coulomb	130	0	19
■	Soft Clay (125 pcf)	Mohr-Coulomb	125	0	26
■	Stiff Clay (125 pcf)	Mohr-Coulomb	125	0	28

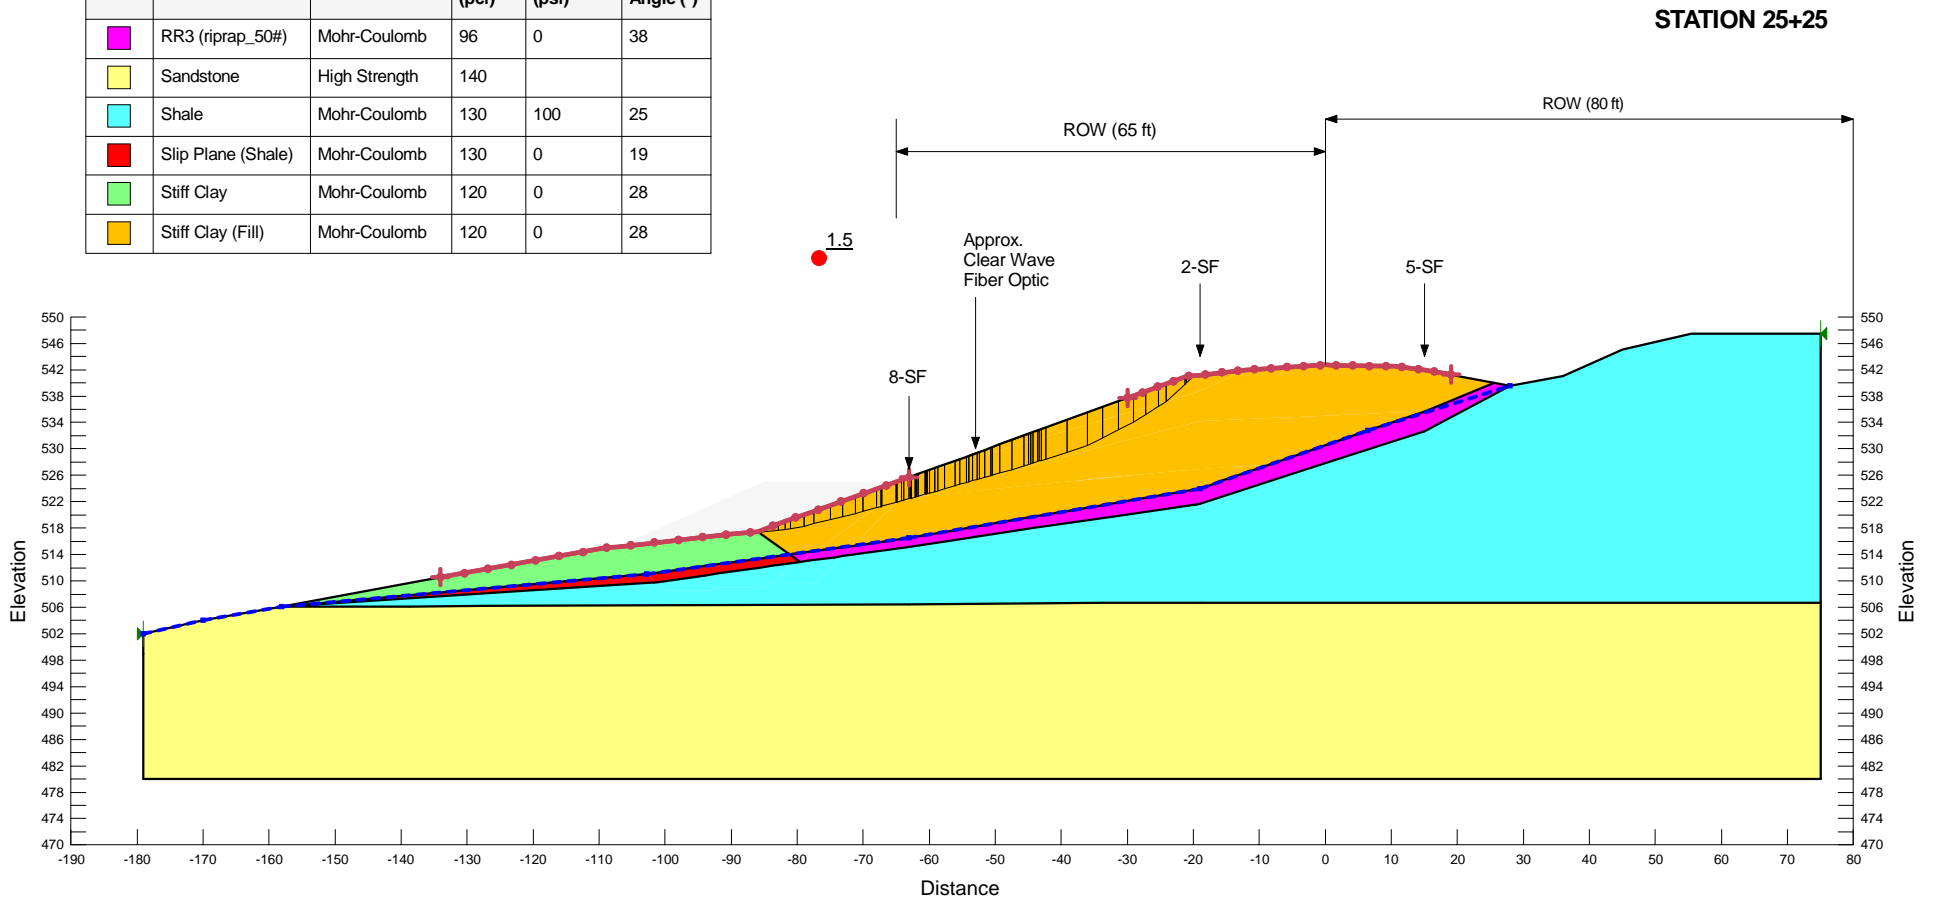
Shannon & Wilson No. 106747-003

Color	Name	Slope Stability Material Model	Unit Weight (pcf)	Effective Cohesion (psf)	Effective Friction Angle (°)
■	RR3 (riprap_50#)	Mohr-Coulomb	96	0	38
■	Sandstone	High Strength	140		
■	Shale	Mohr-Coulomb	130	100	25
■	Slip Plane (Shale)	Mohr-Coulomb	130	0	19
■	Stiff Clay	Mohr-Coulomb	120	0	28
■	Stiff Clay (Fill)	Mohr-Coulomb </td <td>120</td> <td>0</td> <td>28</td>	120	0	28

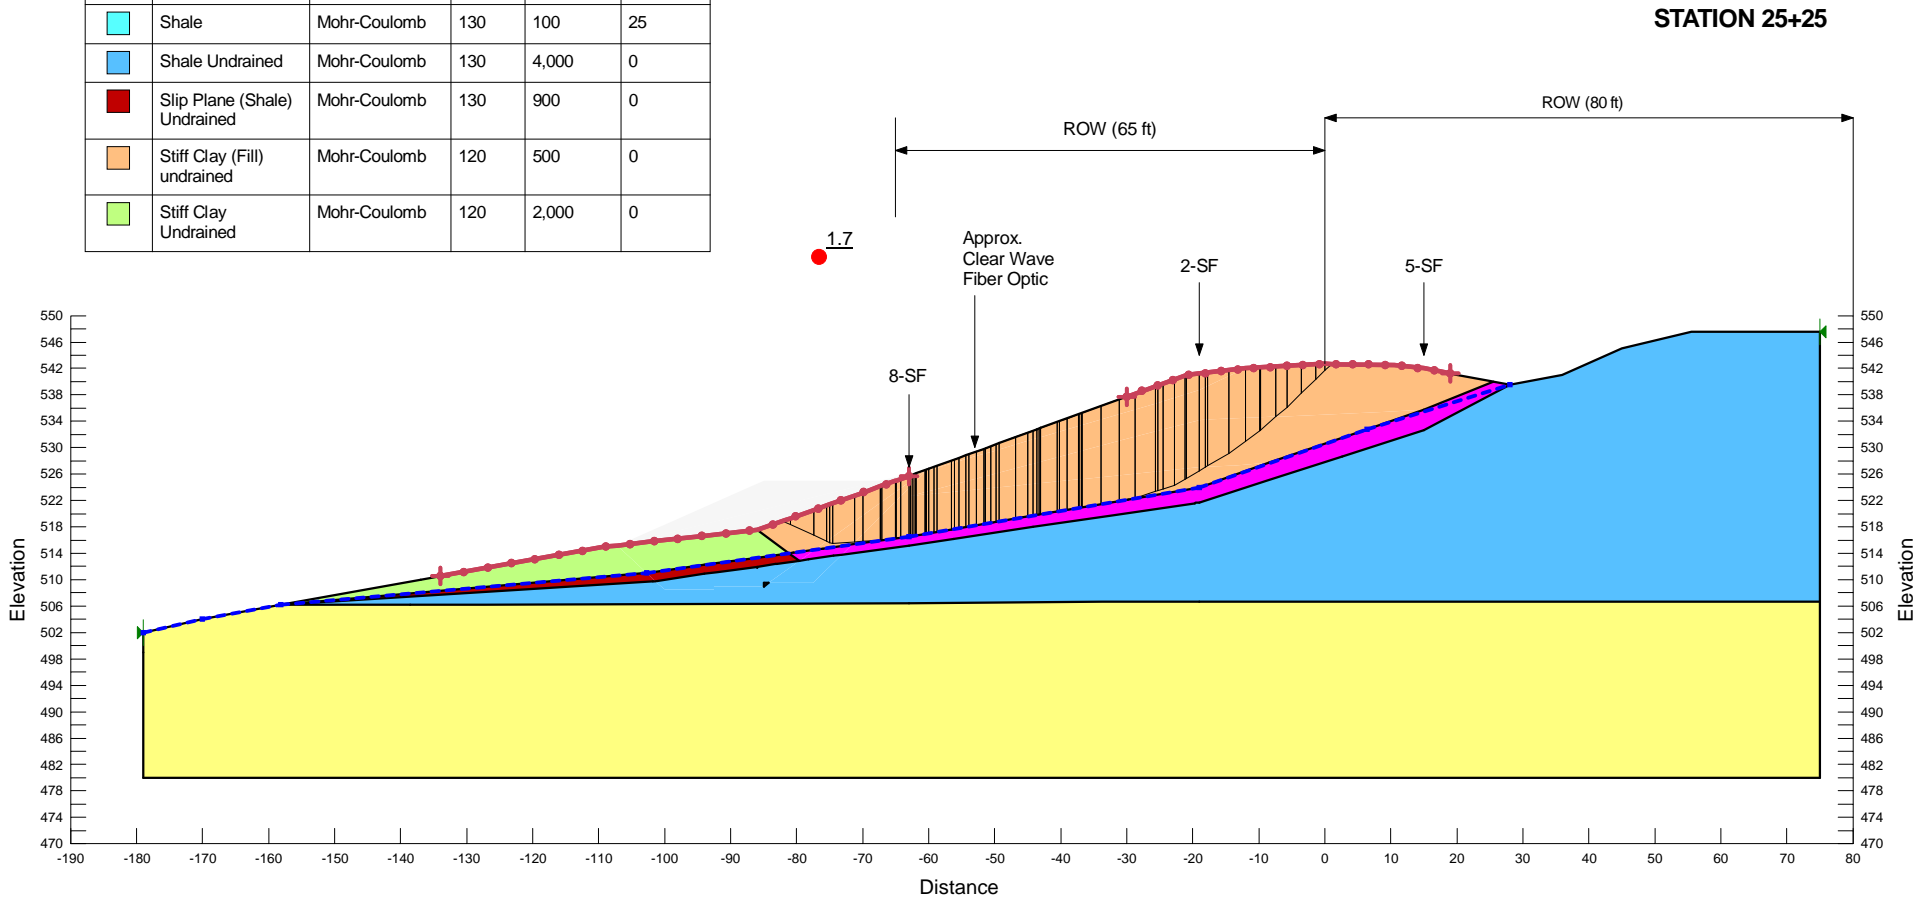
Shannon & Wilson No. 106747-003

Color	Name	Slope Stability Material Model	Unit Weight (pcf)	Effective Cohesion (psf)	Effective Friction Angle (°)
■	RR3 (riprap_50#)	Mohr-Coulomb	96	0	38
■	Sandstone	High Strength	140		
■	Shale	Mohr-Coulomb	130	100	25
■	Shale Undrained	Mohr-Coulomb	130	4,000	0
■	Slip Plane (Shale) Undrained	Mohr-Coulomb	130	900	0
■	Stiff Clay (Fill) undrained	Mohr-Coulomb	120	500	0
■	Stiff Clay Undrained	Mohr-Coulomb	120	2,000	0
