STATE OF ILLINOIS  
DEPARTMENT OF TRANSPORTATION

REPAIR DETAILS  
FAU-2744 SHERIDAN RD. OVER BUCKLEY RD.  
SEC. 71 HB-I-1  
LAKE COUNTY  
STATION 120+00.00  
STRUCTURE NO. 049-0161

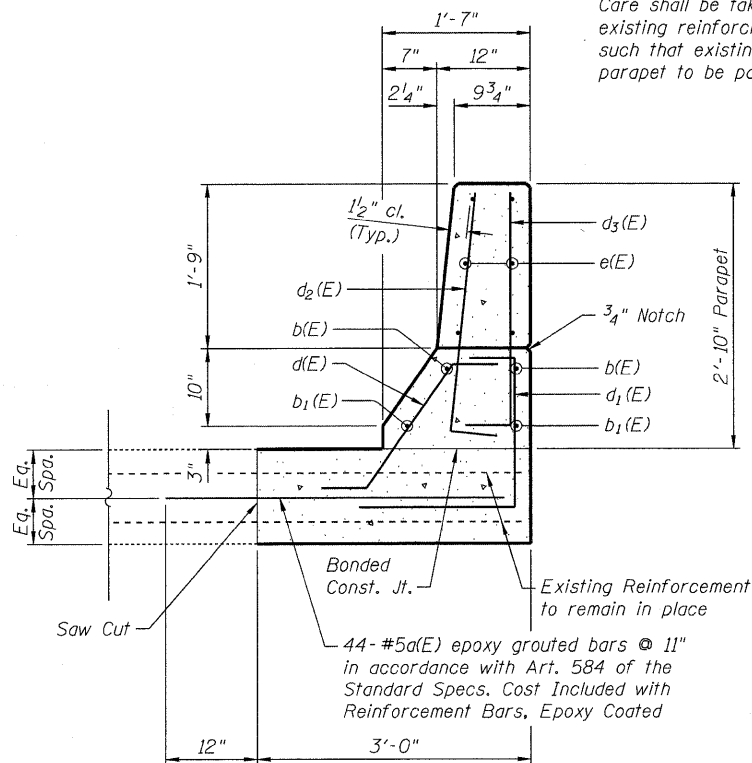
TYPICAL SECTION THRU PARAPET

The damaged parapet is composed of two (2) twenty (20) foot long sections on the northeast side. The actual location of the two sections will be field determined by the Engineer. The cost of backfill to correct settlement of the damaged barrier is included in the pay item "Concrete Superstructure". The bar lengths in the Reinforcement Bill of Material shall be cut and the epoxy coating repaired as required for the 2 - 20 foot sections.

Care shall be taken during concrete removal for parapet repairs, to preserve, clean and reuse existing reinforcing steel in bridge slab. Locate limits of repairs as directed by the Engineer such that existing adjacent joints are a minimum distance of 5'-0" away. Removal of existing parapet to be paid for as Concrete Removal.
