STATE OF ILLINOIS
DEPARTMENT OF TRANSPORTATION

DECK PLAN (SB)
STRUCTURE NO. 058-0101(NB) & 0102(SB)

SHEET 4 OF 26	F.A.P. RTE. 322	SECTION (58-20)RS	COUNTY MACON	TOTAL SHEETS 151	SHEET NO. 69
	STA. 133+62.02		CONTRACT NO. 74150		
FED. ROAD DIST. NO. ILLINOIS FED. AID PROJECT

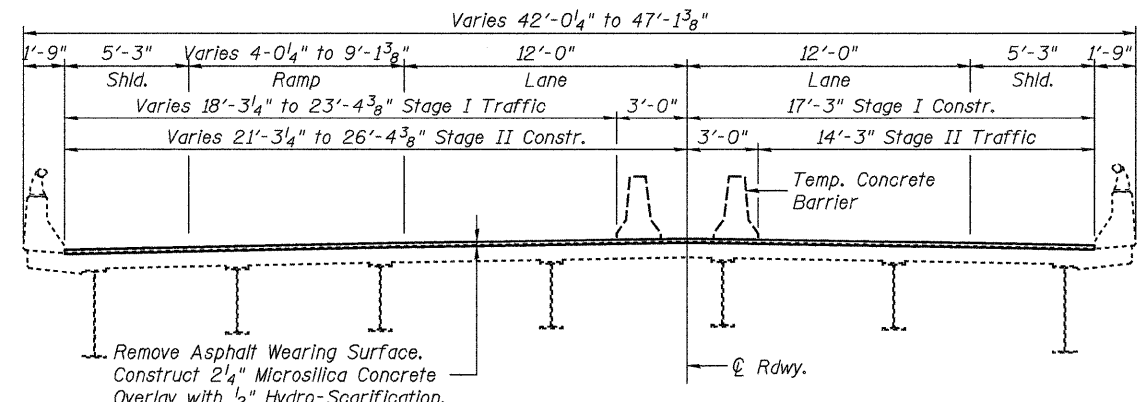
Notes:
Deck Condition Survey performed 9/16/2009.
Plan quantities assume that areas of "exposed reinforcing" greater than 5 sq. ft. will use Full-depth Type II repair.
Repair areas are estimated, the Engineer shall determine actual repair locations and record them on the As-Built plans.
Partial depth repairs are included with Bridge Deck Hydro-scarification, see Special Provision for Bridge Deck Microsilica Concrete Overlay.

Item	Unit	Total
Deck Slab Repair (Full Depth, Type II)	Sq. Yd.	15
