STATE OF ILLINOIS
DEPARTMENT OF TRANSPORTATION

DECK PLAN (SB)
STRUCTURE NO. 058-0108(SB) & 0109(NB)

| SHEET 4 OF 26 | F.A.P. RTE. 322 | SECTION (58-20)RS | COUNTY MACON | TOTAL SHEETS 151 | SHEET NO. 106 |

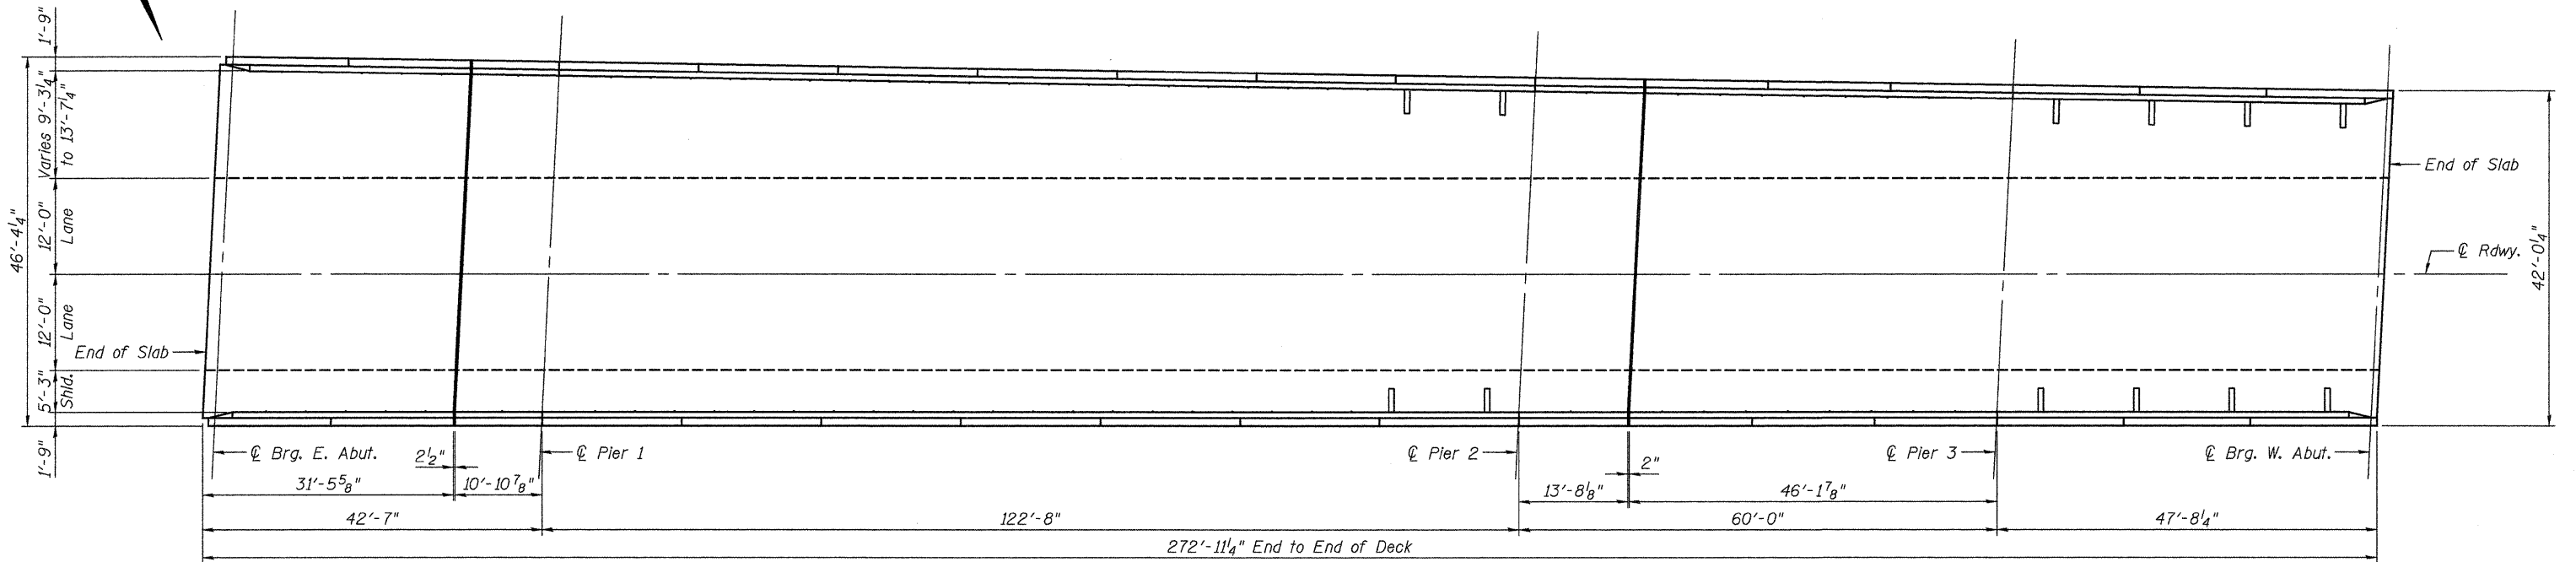
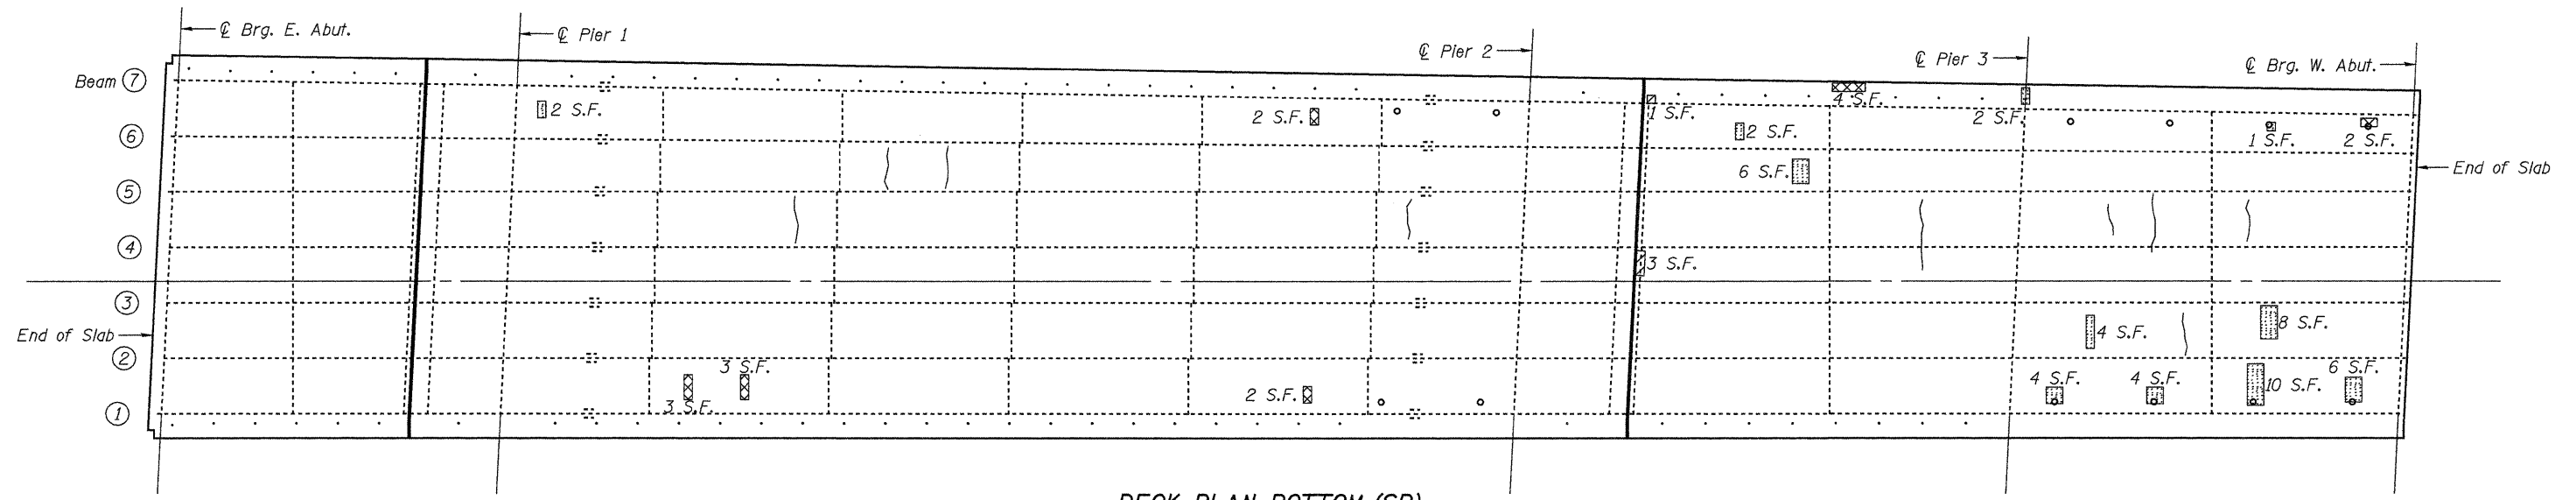
DECK PLAN-BOTTOM (SB)

Notes:
 Deck Condition Survey performed 9/17/2009.
 Plan quantities assume that areas of "exposed reinforcing" greater than 5 sq. ft. will use Full-depth Type II repair.
 Repair areas are estimated, the Engineer shall determine actual repair locations and record them on the As-Built plans.
 Partial depth repairs are included with Bridge Deck Hydro-scarification, see Special Provision for Bridge Deck Microsilica Concrete Overlay.
