DECK REPAIRS (NB)
STRUCTURE NO. 060-0196(SB) & 0197(NB)

F.A.I. RTE.	SECTION	COUNTY	TOTAL SHEETS	SHEET NO.
55	60-3RS-1, 60-(3HB,3HB-1)I	MADISON	123	105
STA. 318+48.55		CONTRACT NO. 76601		
FED. ROAD DIST. NO.		ILLINOIS FED. AID PROJECT

SHEET 2 OF 14

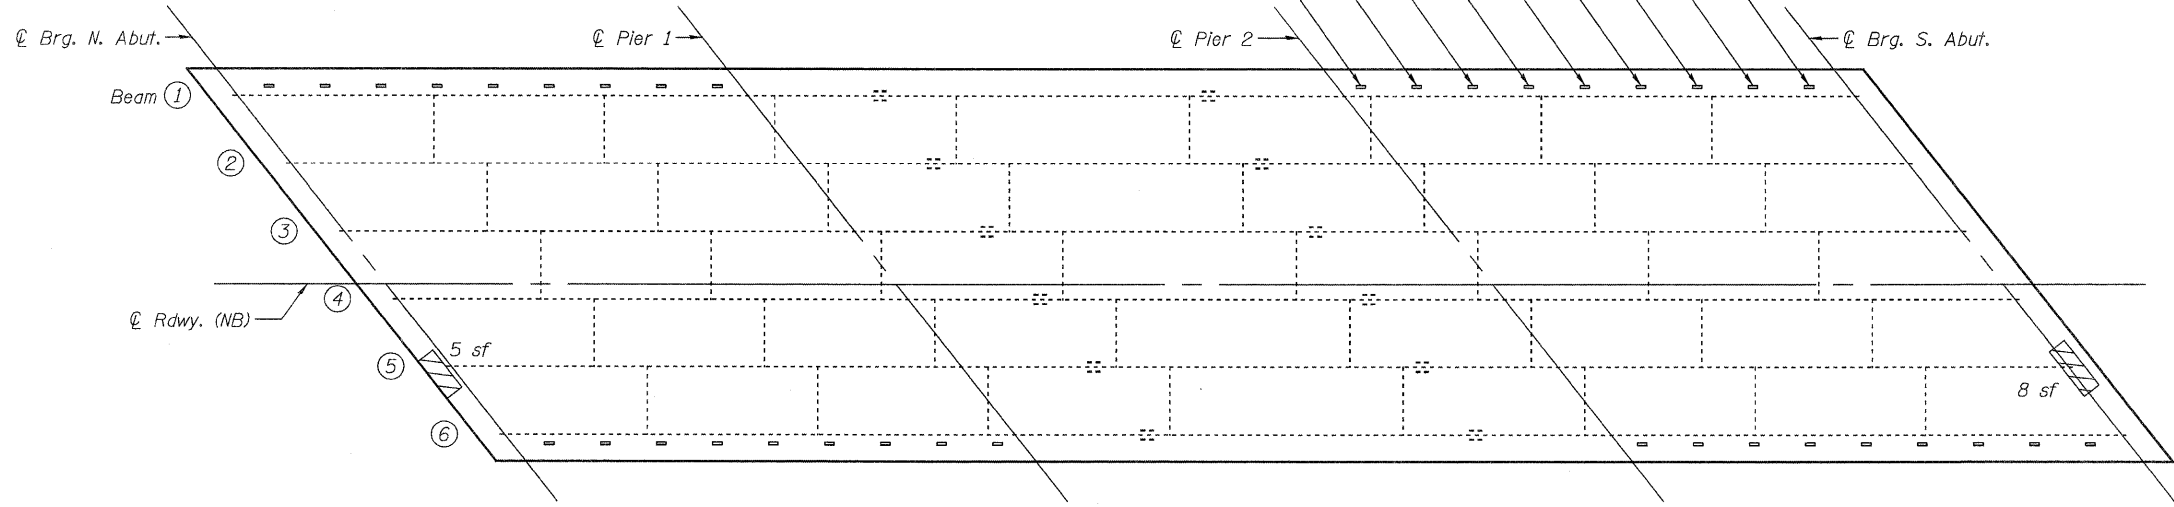
Notes:
Deck Condition Survey performed 4/15/2010.

No full-depth repair areas are anticipated.

Repair areas are estimated, the Engineer shall determine actual repair locations and record them on the As-Built plans.

Partial depth repairs shall be included with Bridge Deck Hydro-scarification, see Special Provision for Bridge Deck Microsilica Concrete Overlay.
