STATE OF ILLINOIS  
DEPARTMENT OF TRANSPORTATION

REPAIRS 8 & 9  
SN 062-0036

SHEET NO. 9 OF 10 SHEETS

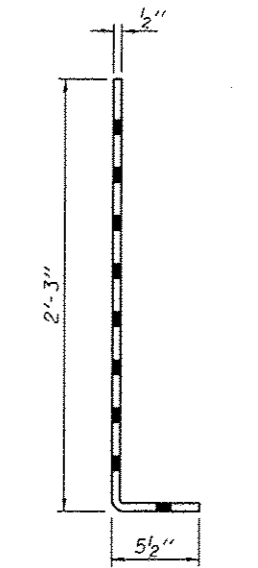
**REPAIR 8 DETAILS**

Span 8, Floor Beam 0, North Face, East End  
Span 8, Floor Beam 8, South Face, West End

**BENT PLATE**  
P 1/2" x 2'-8 1/2" x 5'-1 1/2"  
(2 Required)

**STEPS TO REPAIR THE FLOOR BEAMS**

1. Provide support to the exterior stringer at the floor beam that is to be repaired.
2. Remove the existing WT5x16.5 from the W30x116 floor beam.
3. Prepare all surfaces of the existing W30x116, from the end of the floor beam to 1 foot beyond the end of the new bent plate. The linear distance would be approximately 7 feet. Included in the surface preparation will be the angles that attach the exterior stringer to the floor beam and 2 linear feet of the exterior stringer. Refer to "Cleaning and Painting Contact Surface Areas of Existing Steel Structures"
4. Install the Bent Plate (1/2" x 2'-8 1/2" x 5'-1 1/2") on the W30x116 floor beam.
5. Install the WT5x16.5 on top of the bent plate. Reuse the existing holes in the web of the W30x116 to attach the WT and bent plate to the existing floor beam.
