STATE OF ILLINOIS
DEPARTMENT OF TRANSPORTATION

ROUTE NO.	SECTION	COUNTY	TOTAL SHEETS	SHEET NO.
FAP 315	*	McLEAN	44	26
STA.	TO STA.			
FED. ROAD DIST. NO.	ILLINOIS	FED. AID PROJECT-		
*102X-BR-2	DWG. NO. 14 OF 17			
CONTRACT NO. 66584

PIER 2
US 136 OVER BRANCH OF SALT CREEK
FAP ROUTE 315 - SECTION 102X-BR-2
McLEAN COUNTY
STATION 616+99.00
STRUCTURE NO. 057-0185

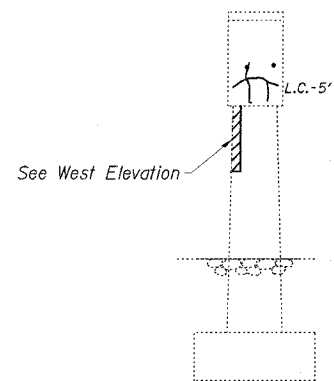
8.7 S.F. Formed Concrete Repair to be used to slope existing level portions of pier seat to provide uniform bearing area for proposed beams

Efflorescent stain (Typ.)

EXISTING BEARING SEAT TO BE INSPECTED BY THE ENGINEER AFTER DECK BEAM REMOVAL. DETERIORATED CONCRETE AREAS SHALL BE REPAIRED (ESTIMATED 15 S.F. ADDITIONAL FORMED CONCRETE REPAIR DEPTH < 5") AND CRACKS SHALL BE SEALED (ESTIMATED 20' ADDITIONAL EPOXY CRACK SEALING) IF FOUND.
