PIER END OF BEAM STRUCTURAL STEEL REPAIR DETAIL

**STRUCTURAL STEEL
STRUCTURE NO. 005-3006**

PROJECT NUMBER: 08.0204.130 DATE: 11/10/09

C.H.	SECTION	COUNTY	TOTAL SHEETS	SHEET NO.
3A	05-00065-00-BR	BROWN	24	18
FED. ROAD DIST. NO.			ILLINOIS FED. AID PROJECT ARA 1583(103)	
CONTRACT NO. 93509

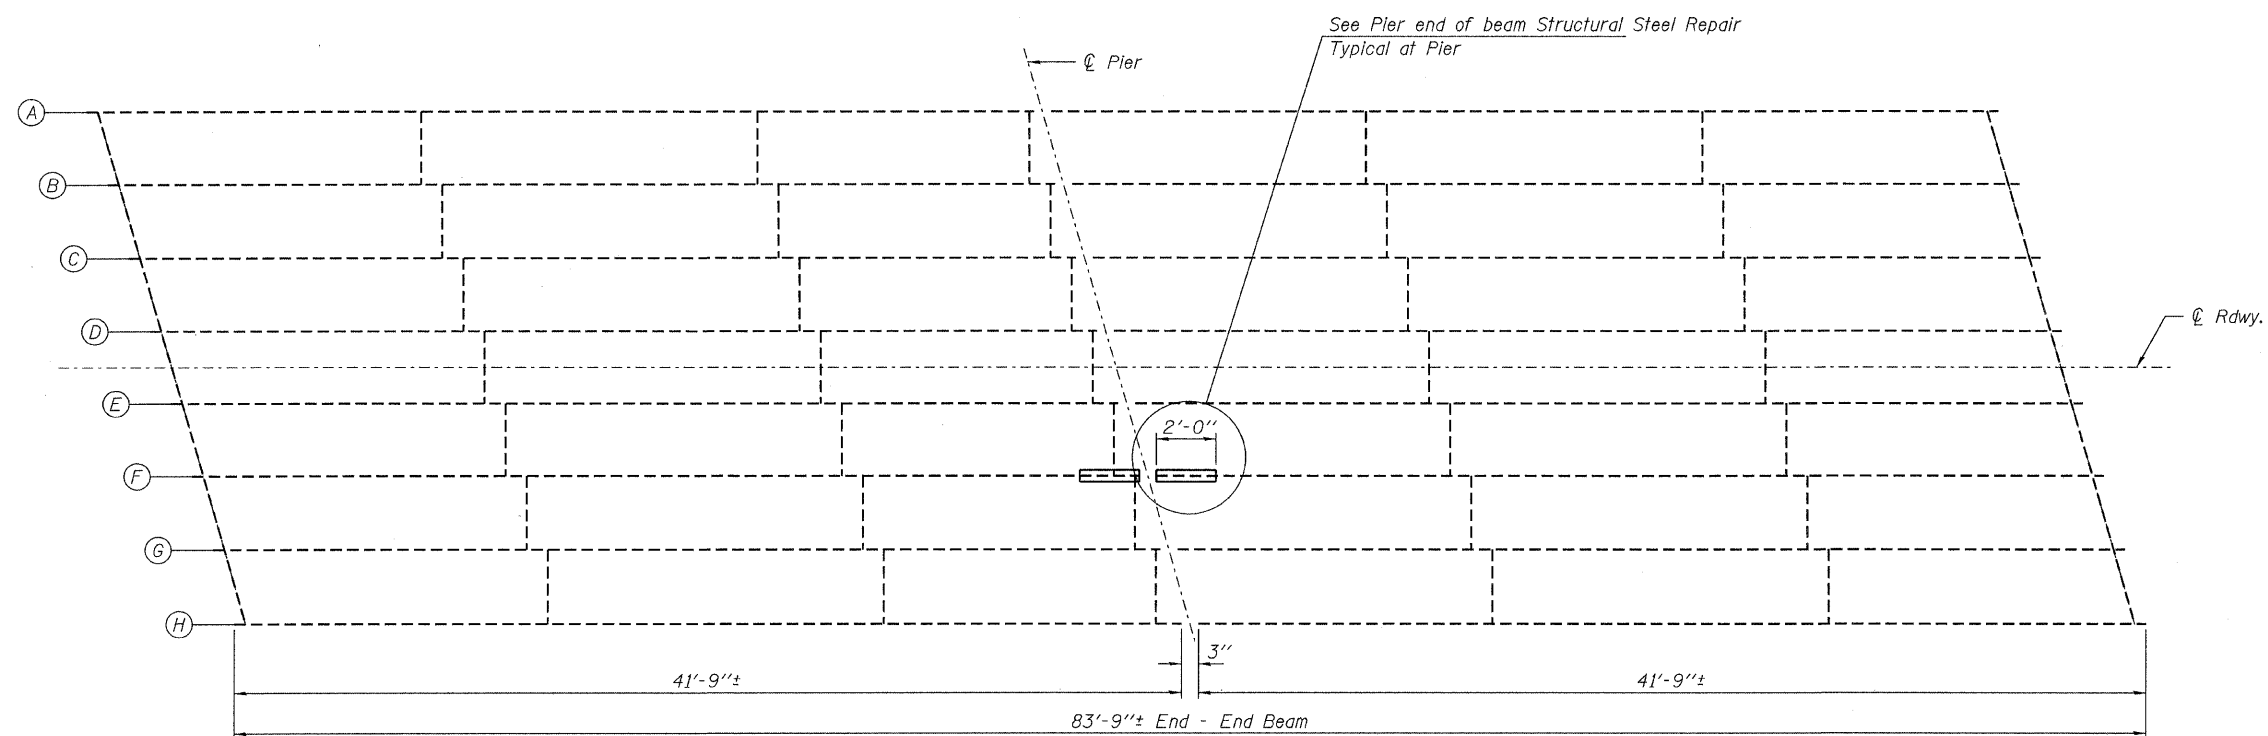
EXISTING FRAMING PLAN

* Top Flange to be removed and repaired if engineer determines the overall thickness of the flange is less than 1/2" for a length of 6" at the pier end.
