**TIMBER BEAM REPAIR DETAILS**

**PIER 3 DETAILS**

**GLEN CARBON HERITAGE BIKE TRAIL OVER JUDY BRANCH MADISON COUNTY STATION 108+17.70 STRUCTURE NO. 1**

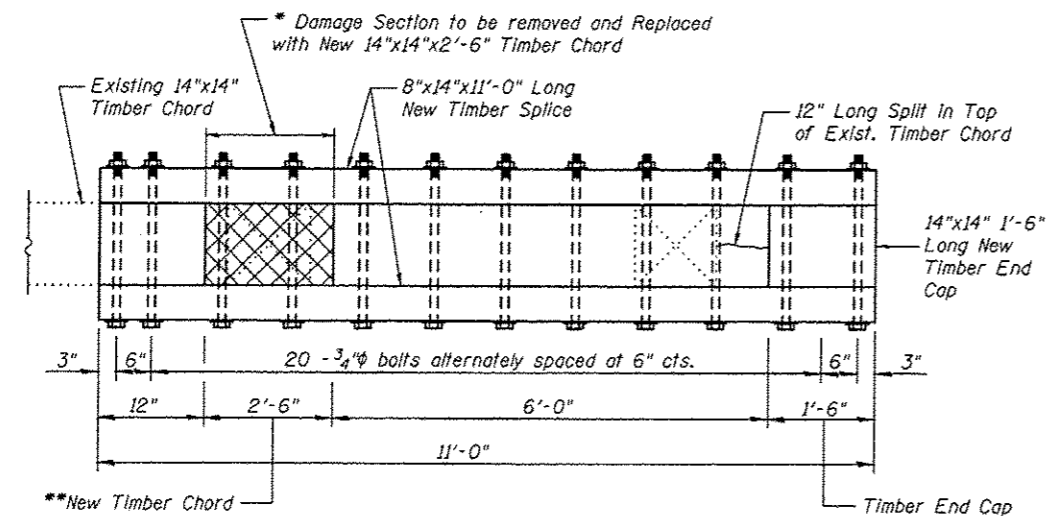
**ELEVATION OF TIMBER BEAM REPAIR**

**Note:**  
 All dimensions are approximate. Bolts, nuts and washers for the Timber Beam Repair shall be hot-dipped galvanized.  
 \* Cross Hatched area indicates removal of damaged 2'-6" length of Existing Timber Chord. Replace the removed section with new 14"x14"x2'-6" Timber Chord.  
 \*\* Replacement of removed section with new 14"x14"x2'-6" Timber Chord.  
 \*\*\* The 3"x10" Existing Diagonal Timber Bracing shall be removed and reinstalled to clear Timber Beam Repair. Existing bolts, nuts, and washers to be removed, cleaned and reinstalled. Cost of removing and relocating the existing timber bracing shall be included with Timber Beam Repair.
