**TABLE OF REPAIRS**

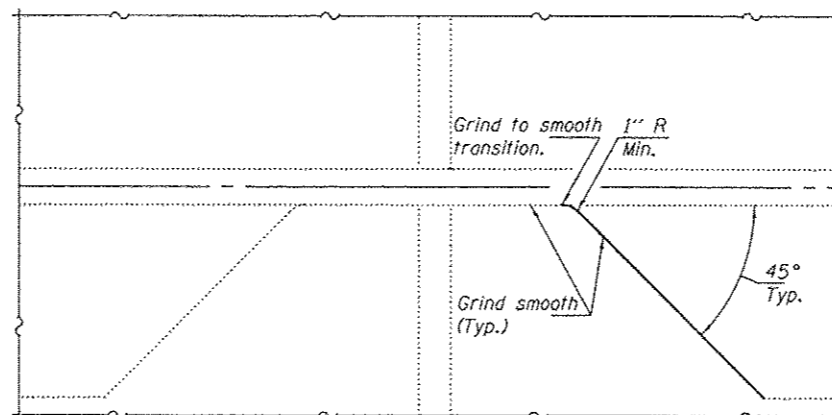
**ITEM 107 REPAIR DETAIL**

Hatched area indicates section removal.  
(Showing 1 location)

**Procedure for Stiffener Intersection Modification Repair Detail:**

- Cut areas of existing longitudinal stiffener and along web as shown, with a 1" R (Min) at Web. The minimum distance from cut to face of web shall be the larger of  $\frac{1}{4}''$  or web to plate weld size, with removal of remaining material by grinding as described below. The cut shall be made parallel to the web without angling the cut towards the web. Equipment and method of cutting shall be approved by the Engineer. Any method of removal to be used shall ensure that no damage is done to the existing web, vertical stiffener or welds connecting these elements. Cutting shall be done in a manner such that the paint on the opposite face of the web is not damaged. If damage occurs, the damaged area shall be repainted at the contractor's expense and procedures shall be modified to prevent damage at subsequent removal locations.

- The web and or flange surface at the modification shall be inspected using dye penetrant or magnetic particle (MT) methods. Any cracks found shall be identified and reported to the Bureau of Bridges and Structures for further disposition.
