STATE OF ILLINOIS
 DEPARTMENT OF TRANSPORTATION

REPAIR DETAILS
 SN 010-0146

F.A.I. RTE.	SECTION	COUNTY	TOTAL SHEETS	SHEET NO.
72	410-TIMBIBOR,BJR	CHAMPAIGN	14	8
CONTRACT NO. 70865			ILLINOIS FED. AID PROJECT

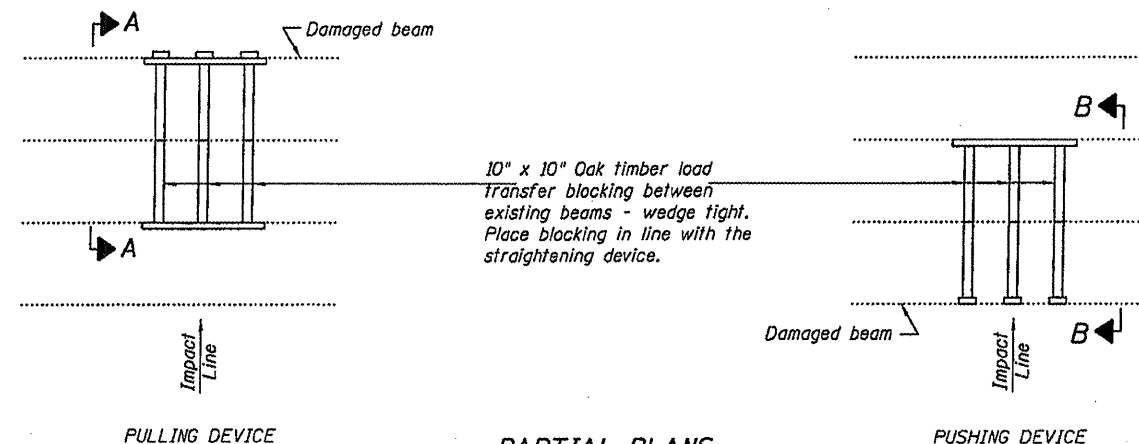
PARTIAL PLANS
SUGGESTED BEAM STRAIGHTENING METHODS
 Straightening force shall be maintained on all load transfer blocking during beam straightening.

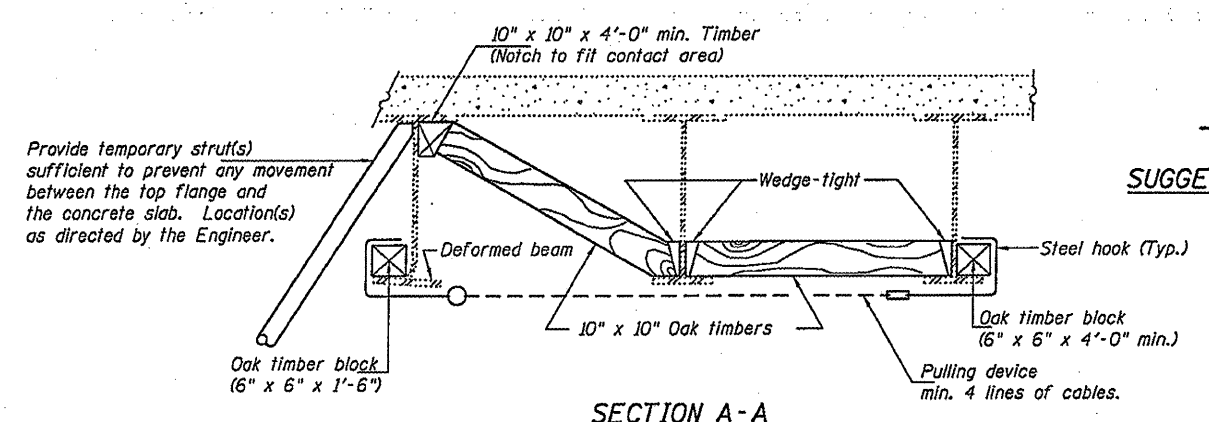
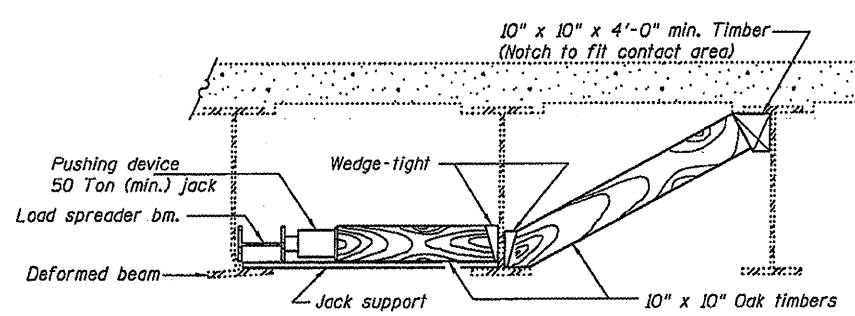
* Edge of plate shall line up with edge of deformation.
 Note:
 Braces and jack assembly shall be placed on same side of web.
 Bent bottom flange shall be straightened before starting any horizontal straightening operations.

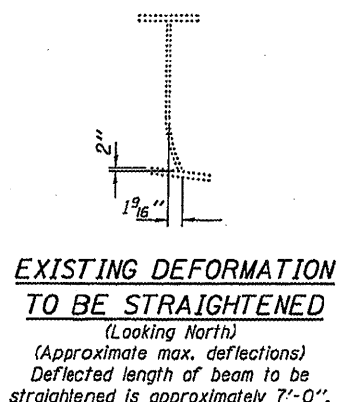
GRINDING DETAIL

Grind existing nicks, gouges and shallow cracks in the damaged beams as detailed. Ground surfaces shall be inspected for cracks using magnetic particle testing prior to initiating any beam straightening operations. Any cracks that cannot be removed by grinding approximately 1/4" deep shall be identified and reported to the Bureau of Bridges and Structures for further disposition. Ground surfaces shall be spot cleaned and painted with an aluminum epoxy-mastic primer followed by a finish coat to match the color of the existing beam. Cost of grinding, testing and spot painting included with Beam Straightening.
