**STATE OF ILLINOIS
 DEPARTMENT OF TRANSPORTATION**

**REPAIRS TO - PIER NUMBER 20 - COLUMNS
 STRUCTURE NO. 060-0255**

SHEET NO. 44 OF 48 SHEETS

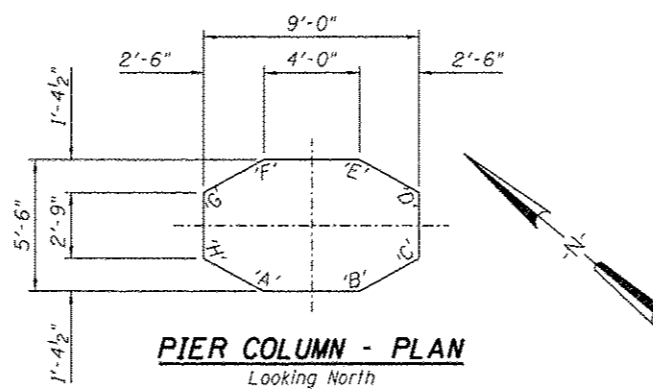
PIER COLUMN - PLAN
 Looking North

I.D.	Description	Pay Item	Units	Quantity
116	Erosion Under Drain Outlet	Slope Wall 6 Inch	SQ. YD.	1.78
117	Graffiti on Concrete	Graffiti Removal	SQ. YD.	19.37
-	-	-	-	-
-	-	-	-	-
-	-	-	-	-
-	-	-	-	-
-	-	-	-	-
