ROADWAY GEOTECHNICAL REPORT
SLOPE STABILITY INVESTIGATION AND STUDY
ILLINOIS 71 AT DIMMICK HILL

FAP 627 (IL 71)

Contract 66F07

April 21, 2016

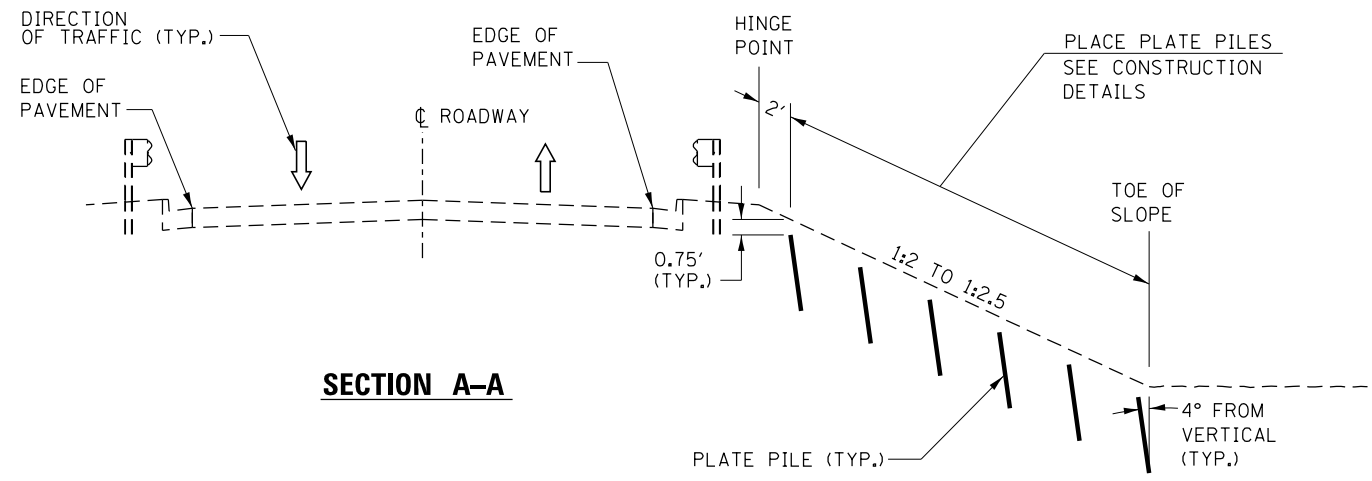
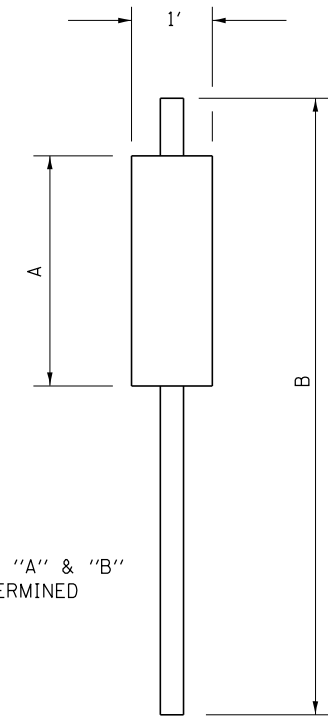
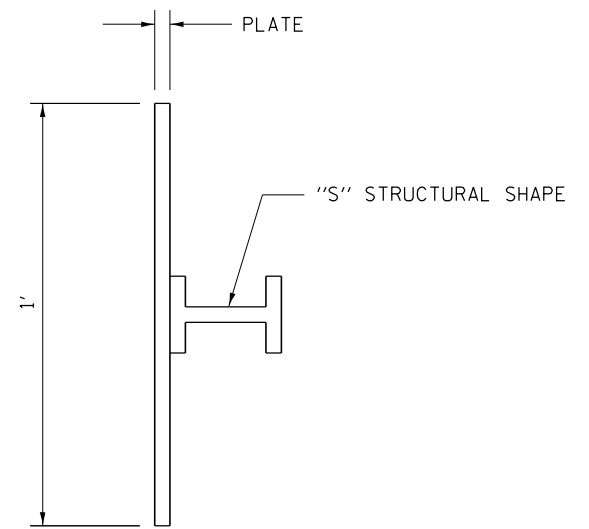
PLATE PILE DETAILS

DIMENSIONS "A" & "B"
TO BE DETERMINED
BY DESIGN

Plate piles consist of relatively small steel pile with a flat steel plate attached to one end of the pile. The piles are driven vertically into the ground so the steel plate is parallel to the slope failure and the top of the pile rests approximately 12 inches below the finished ground surface.

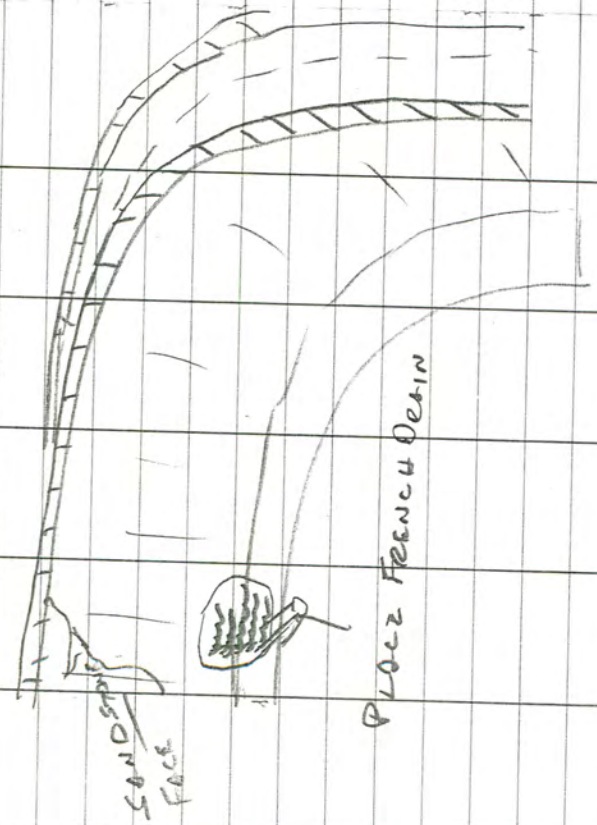
WATER COMING OUT OF HILL
NEAR SANDSTONE FACE.
THE CONTRACTOR HAS REMOVED THE
POOR SOIL MATERIAL. THE
NEW EMBRANKMENT WILL BE
SETTING ON A MED SAND OR SOME
BRICKING.

I RECOMMENDED A FRENCH DRAIN
FROM THE EXISTING FILL TO
BEYOND THE NEW FILL TO DRAIN
THE WATER COMING OUT OF THE HILL
SIDE.

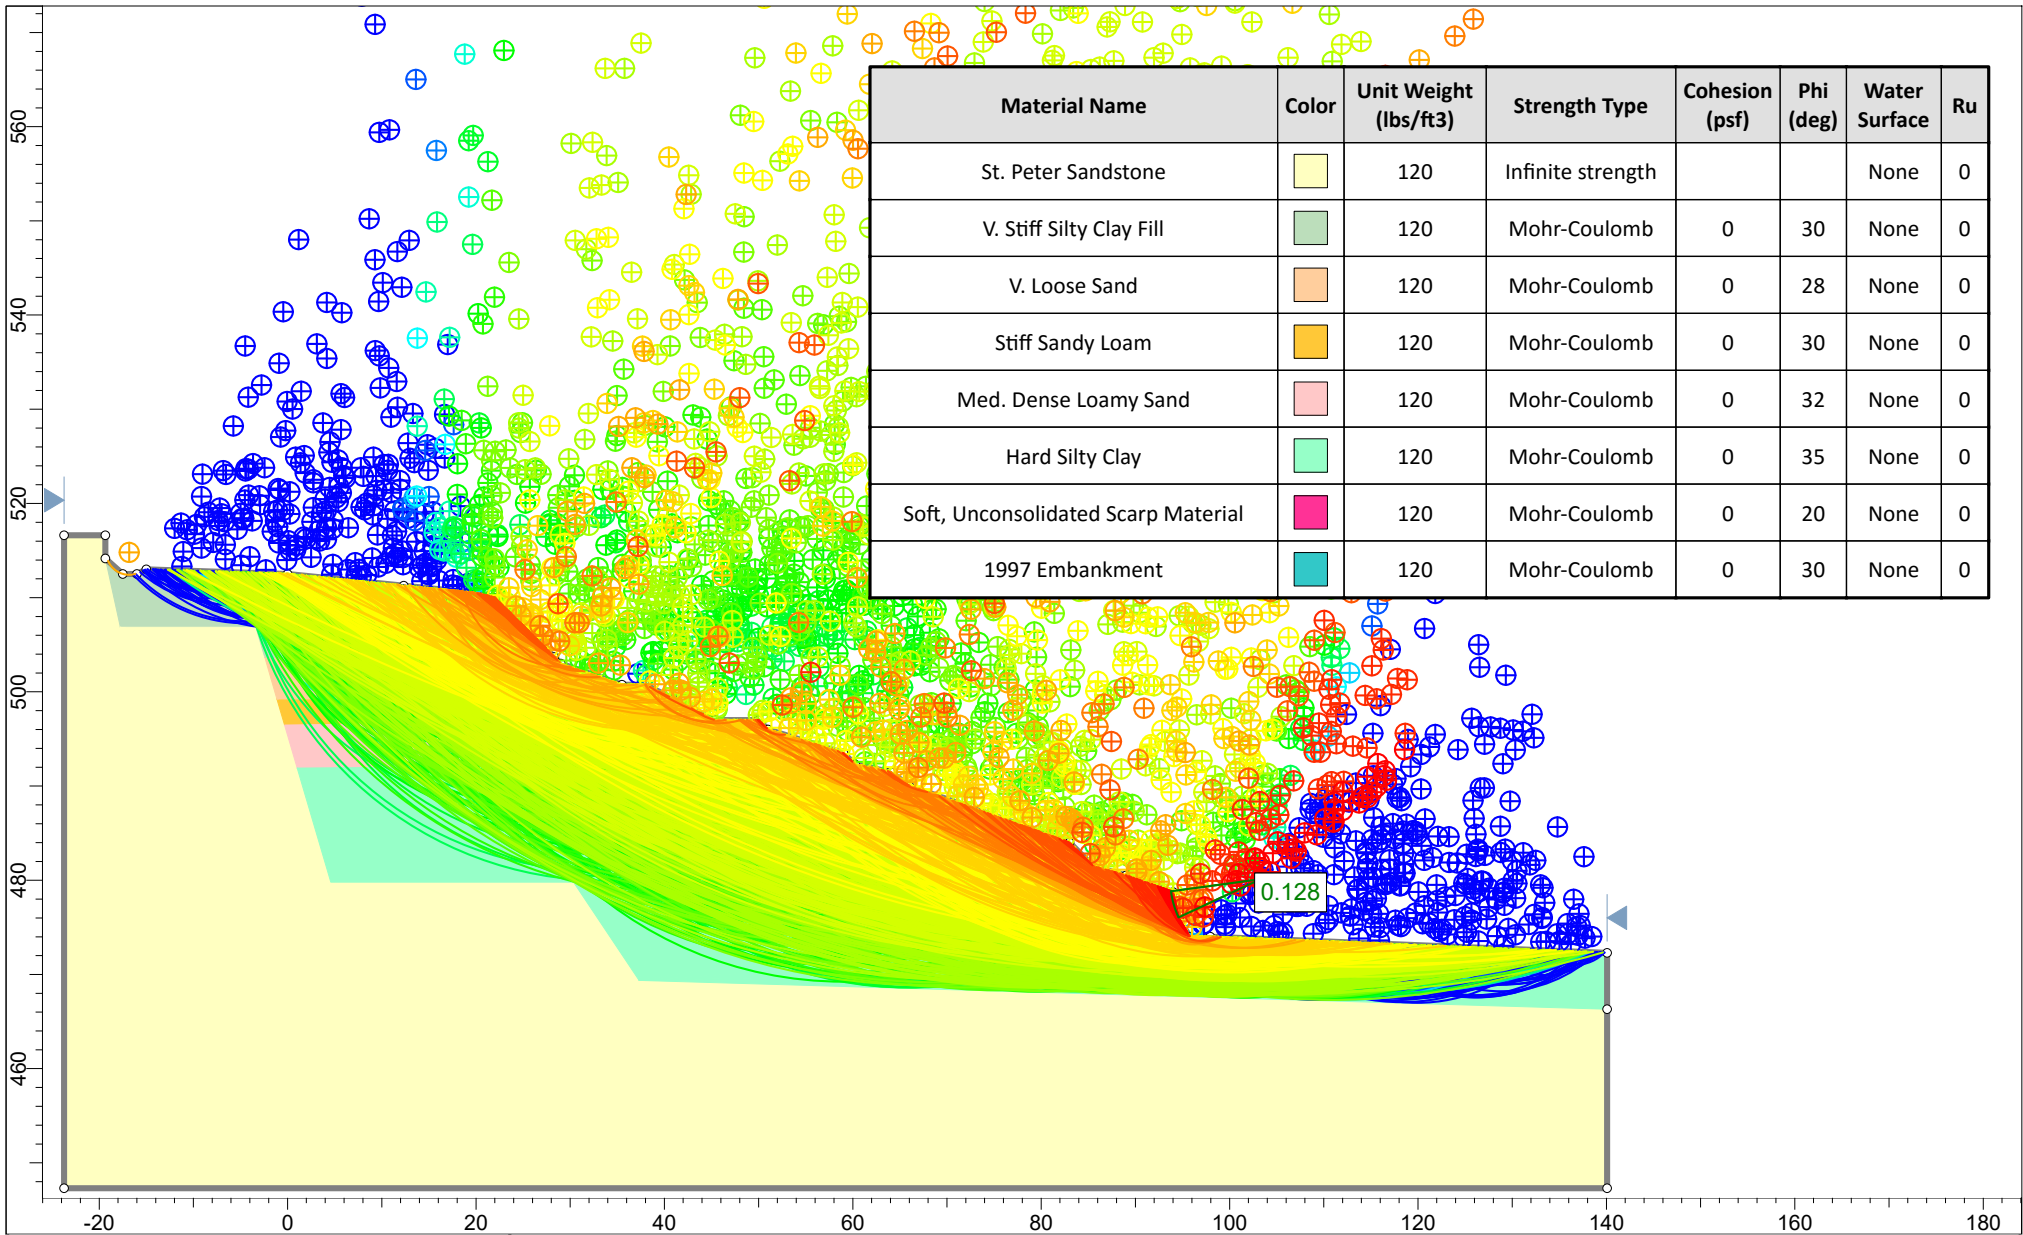
Bishop - Existing Slope with Drained Material Properties

The factor of safety (FS) of the existing slope modeled at station 9+90 is estimated to be 0.128. The location of this failure surface was at the near vertical portion of the slope at the bottom end of the mud wave. Many failure surfaces with similar factors of safety exist up and down the slope within the upper 5 ft. of the slope surface.

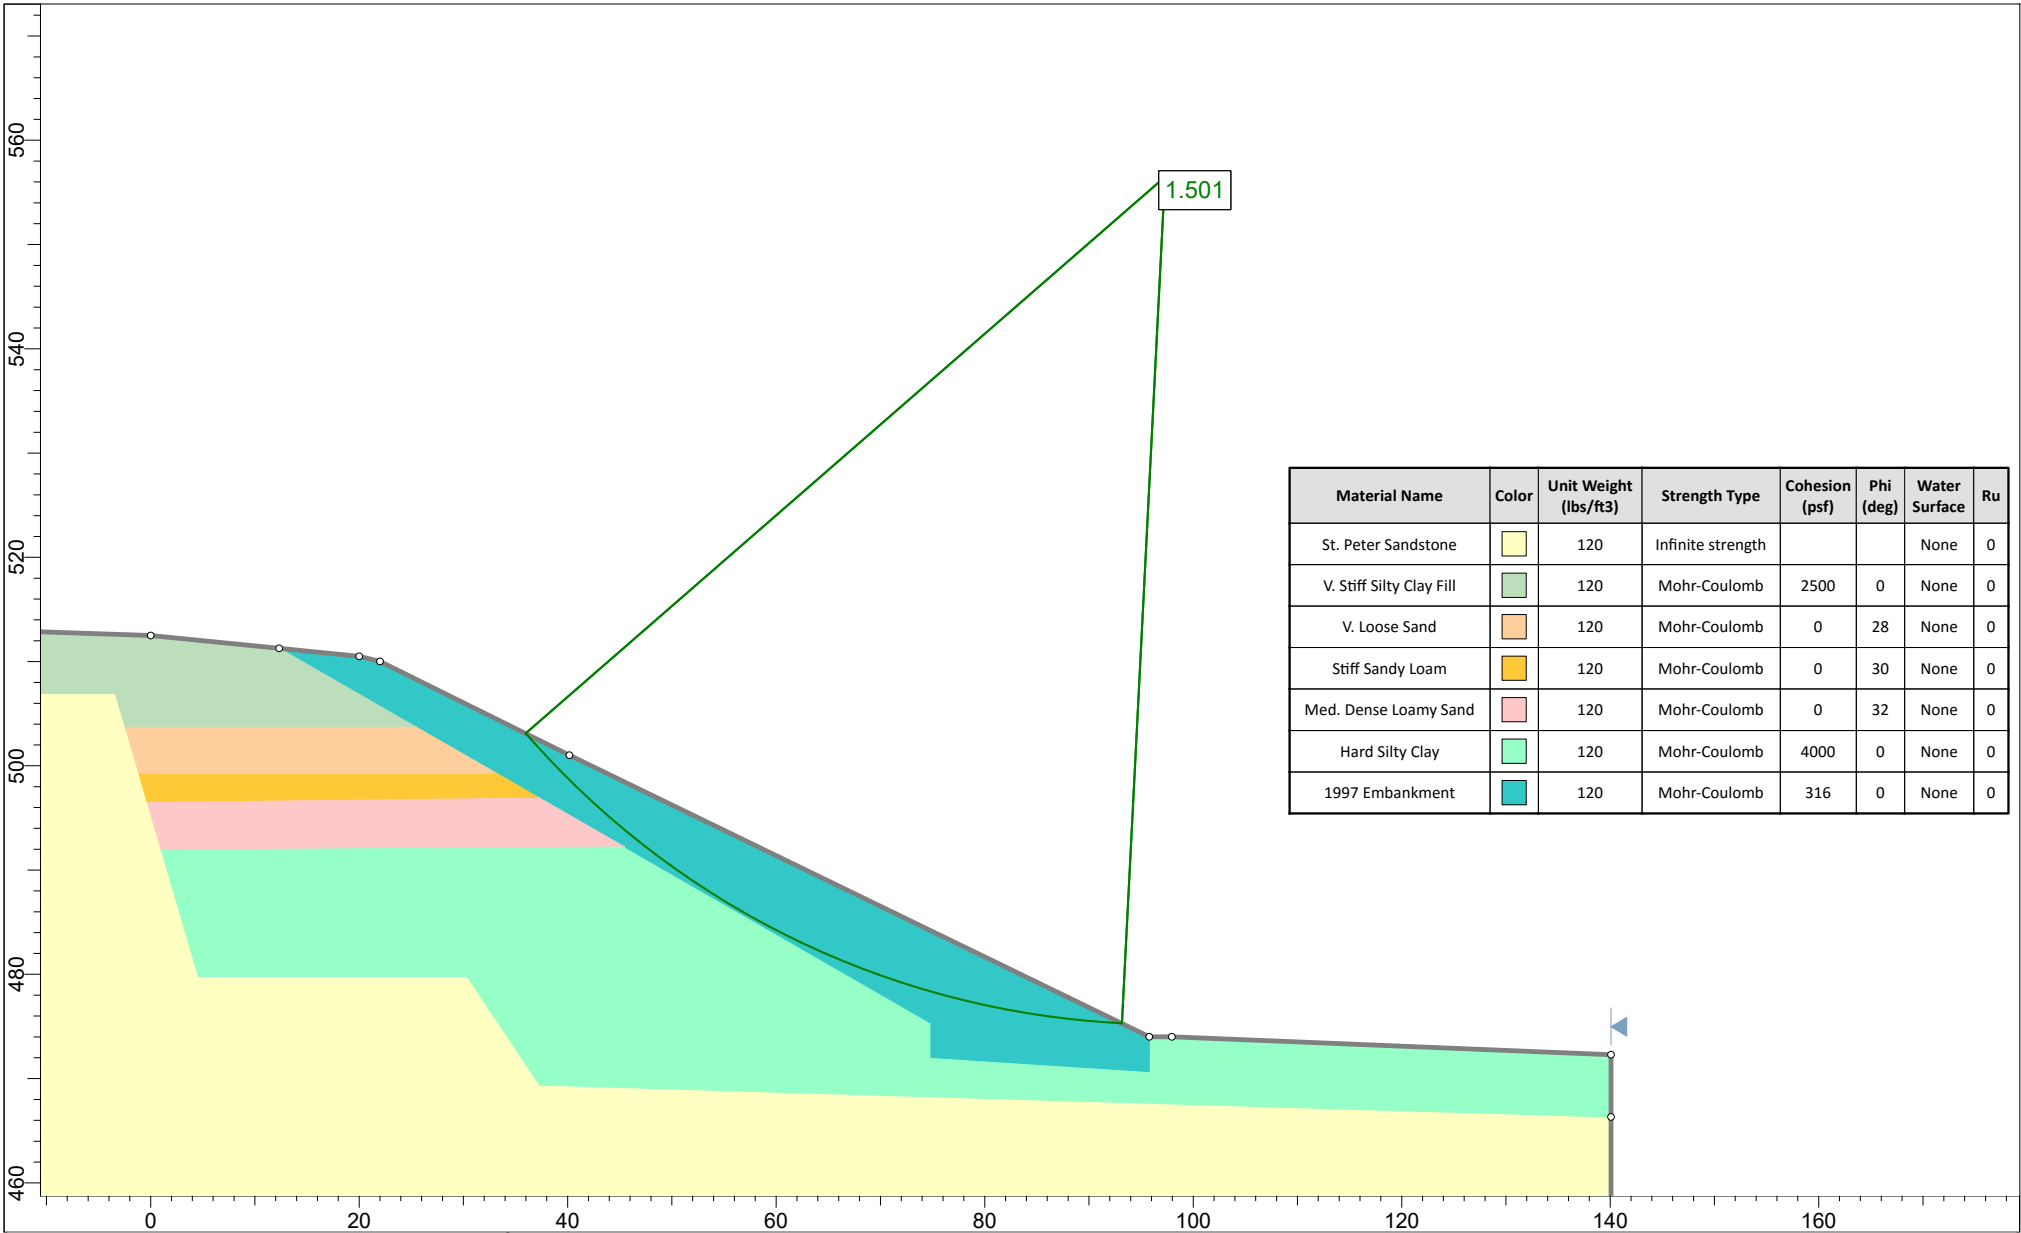
IL 71 - Dimmick Hill	
	Bishop - New Embankment with Undrained Material Properties	
	Drawn By	TLM
	Date	3-4-16
	Company	McCleary Engineering
	File Name	9190 Dimmick Hill with scarp removed and new embankment cohesion slim

The second scenario modeled was the new slope using only cohesion in the soils that would have cohesion in an undrained condition. The sand layers encountered were modeled with friction only. The cohesion of the material labeled “1997 Embankment” was manipulated until the FS of the slope was 1.50.

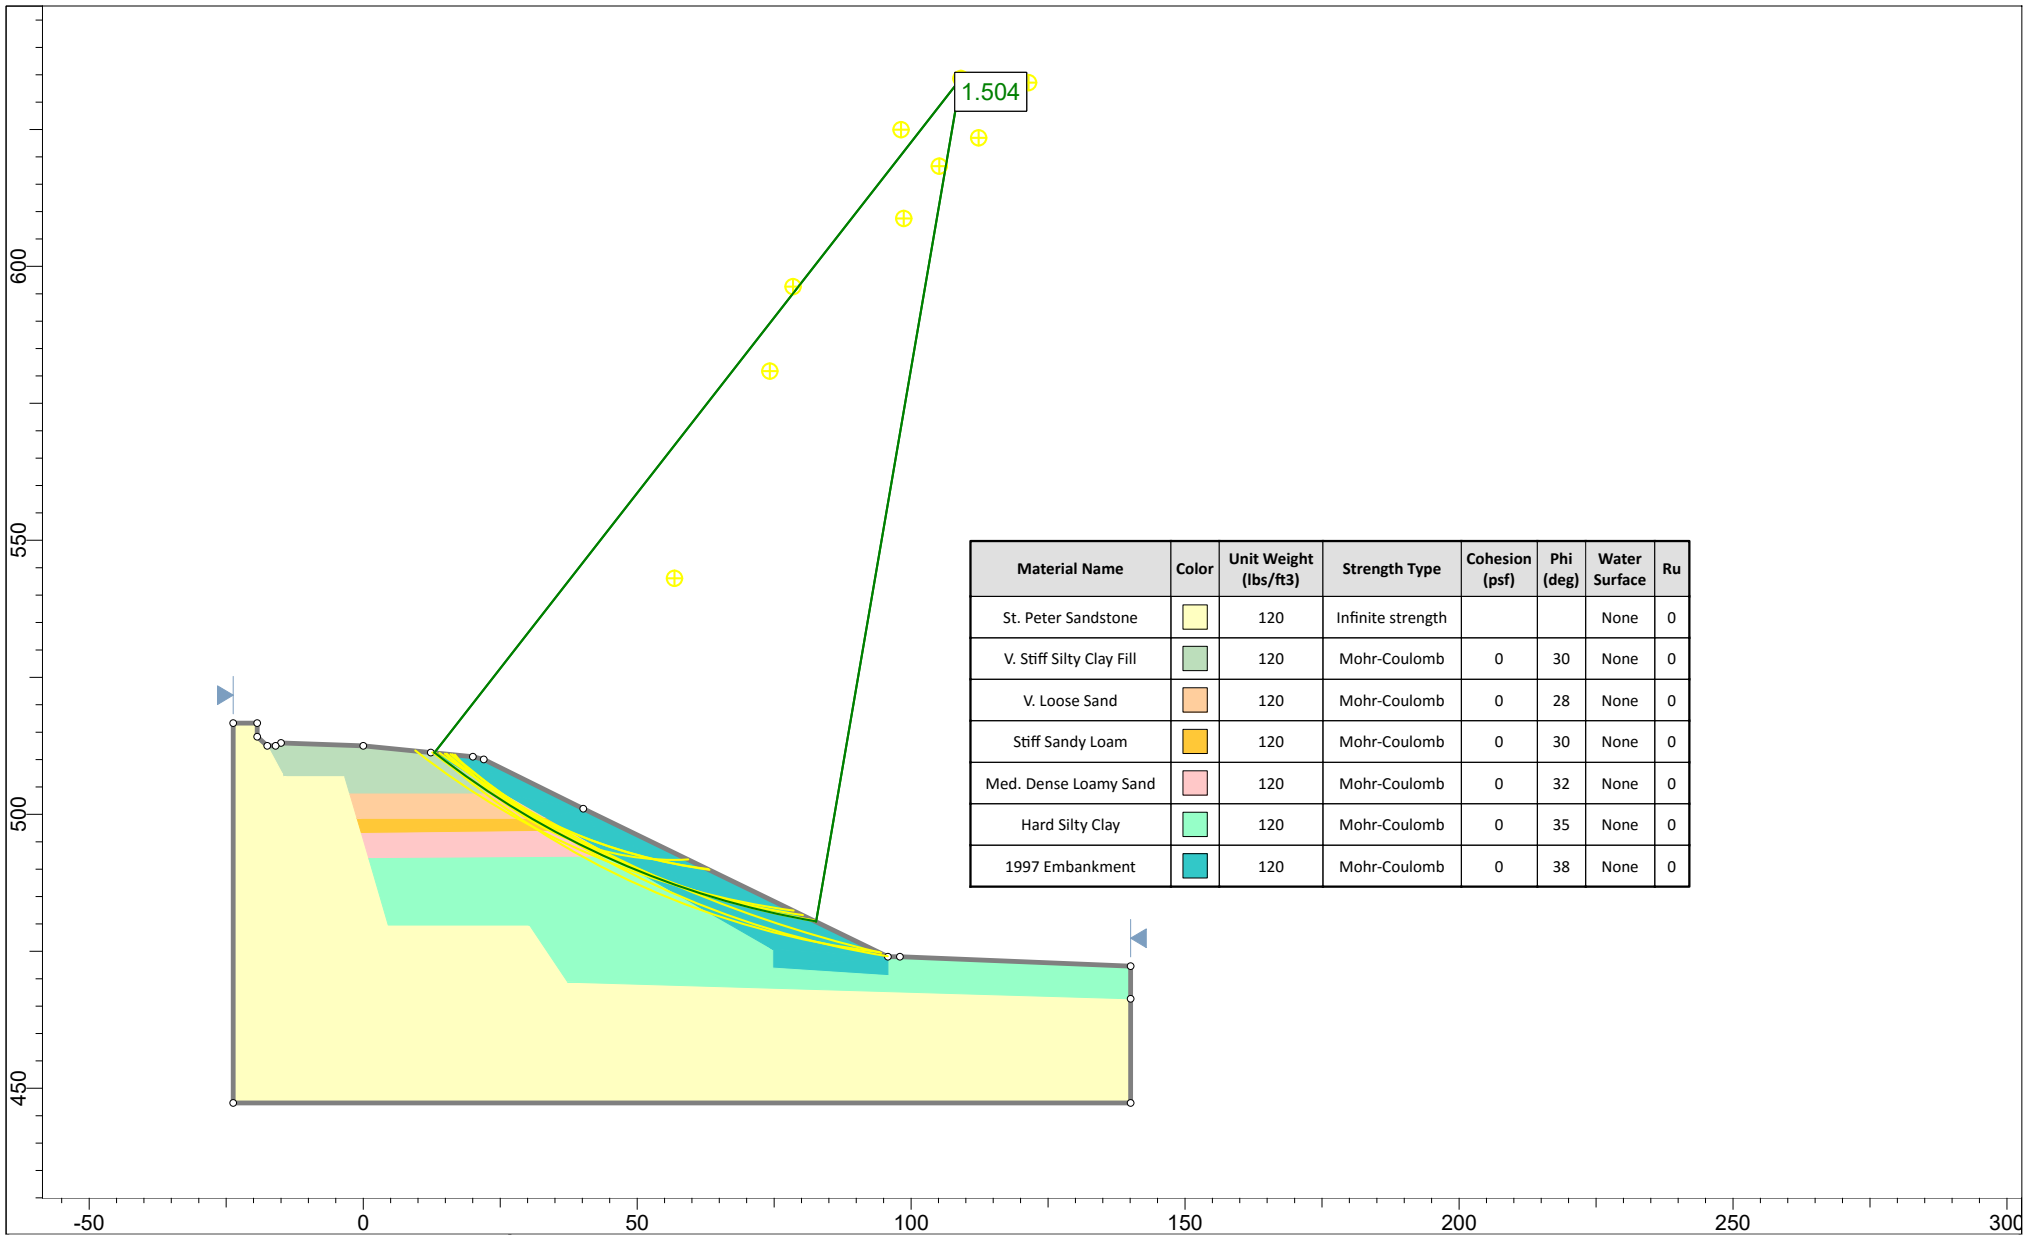
IL 71 - Dimmick Hill	
	Bishop - Drained Conditions with New Embankment	
	Drawn By	TLM
	Date	3-4-16
	Company	McCleary Engineering
	File Name	9490 Dimmick Hill with scarp removed and new embankment.slim

The third scenario modeled was the new slope using only friction in the soils that would have cohesion in an undrained condition. The sand layers encountered were modeled with friction only, as in the previous models. The friction of the material labeled “1997 Embankment” was manipulated until the FS of the slope was 1.50. It is unlikely that the 1997 Embankment material would have a friction angle of 38°.
