STATE OF ILLINOIS
DEPARTMENT OF TRANSPORTATION

ROUTE NO.	SECTION	COUNTY	SHEET	SHEET NO.
FAP 869	105BR-1	SALINE	118	36
PROJECT NO. 78031				18 SHEETS

NORTH ABUTMENT
IL 34 OVER
MIDDLE FORK SALINE RIVER OVERFLOW
FAP ROUTE 869 - SECTION 105BR-1
SALINE COUNTY
STATION 1542+00.00
STRUCTURE NO. 083-0037

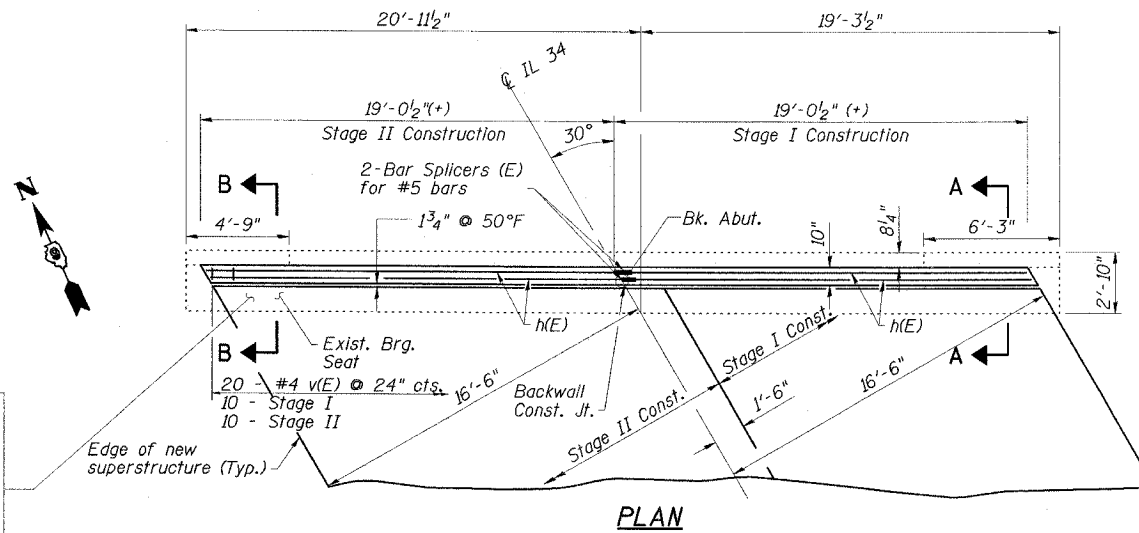
SECTION A-A

EXISTING BEARING SEAT TO BE INSPECTED BY THE ENGINEER AFTER DECK BEAM REMOVAL. DETERIORATED CONCRETE AREAS SHALL BE REPAIRED (ESTIMATED 15 S.F. STRUCTURAL REPAIR OF CONCRETE DEPTH < 5") AND CRACKS SHALL BE SEALED (ESTIMATED 20' EPOXY CRACK INJECTION) IF FOUND. CONCRETE SEALER SHALL BE APPLIED TO CONCRETE REPAIR AREAS.
