STATE OF ILLINOIS
DEPARTMENT OF TRANSPORTATION

Inspection Date: 12/14/06

**SOUTH ABUTMENT
IL 34 OVER BANKSTON CREEK
FAP ROUTE 869 - SECTION (105A)BR-1
SALINE COUNTY
STATION 1582+30.00
STRUCTURE NO. 083-0040**

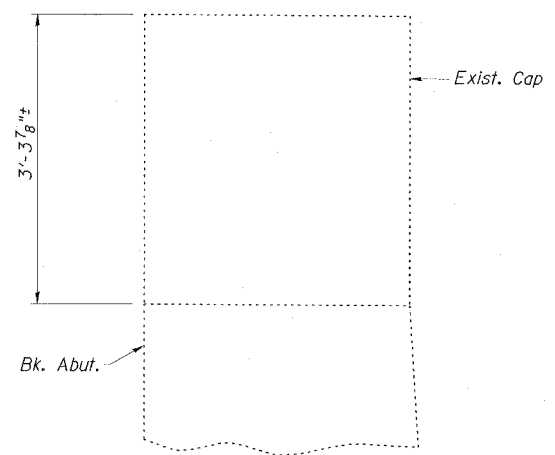
PLAN

EXISTING BEARING SEAT TO BE INSPECTED BY THE ENGINEER AFTER DECK BEAM REMOVAL. DETERIORATED CONCRETE AREAS SHALL BE REPAIRED (ESTIMATED 15 S.F. STRUCTURAL REPAIR OF CONCRETE DEPTH < 5") AND CRACKS SHALL BE SEALED (ESTIMATED 20' EPOXY CRACK INJECTION) IF FOUND. CONCRETE SEALER SHALL BE APPLIED TO CONCRETE REPAIR AREAS.

- C.-6' Crack to be epoxy injected
- S.F. Delaminated or Spalled Area - Use Structural Repair of Concrete

NOTE: ABUTMENT CRACK REPAIR LENGTHS AND STRUCTURAL REPAIR OF CONCRETE AREAS ARE ESTIMATED FROM 12-14-06 SURVEY WORK. ACTUAL LOCATIONS AND QUANTITIES OF REPAIRS SHALL BE SHOWN BY THE ENGINEER ON THE AS-BUILT PLANS FOR THIS SECTION.
