ASBESTOS SURVEY REPORT

**Asbestos Survey for Building Demolition (I-80) at Gardner Road Bridge
615 Gardner Street, Joliet, Illinois
Region One/District One**

Asbestos Survey Report
PTB 198-003
FAI-80 (I-80) over Des Plaines River Bridge
Job N. D-91-204-19
615 Gardner Street, Joliet, IL
Parcel No. 1P10193

615 Gardner Street, Joliet, IL

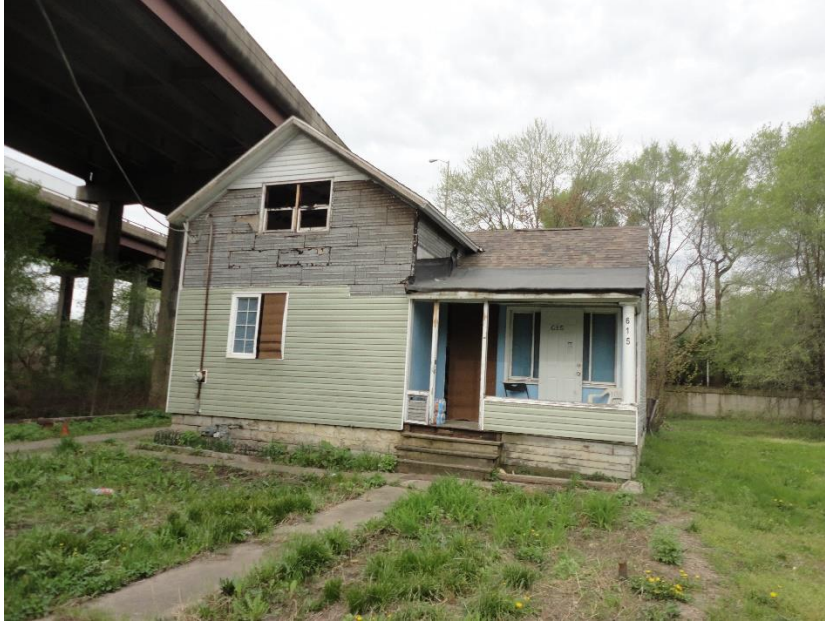
Photo Location:
Front of the house

Material Description:
View of the IDOT surveyed property, 615 Gardner Street, Joliet, IL
