STATE OF ILLINOIS DEPARTMENT OF TRANSPORTATION

Contract Number: 60B16

BEAM STRAIGHTENING DETAILS GLENWOOD-LANSING RD / IL 394 COOK COUNTY SN 016-0918

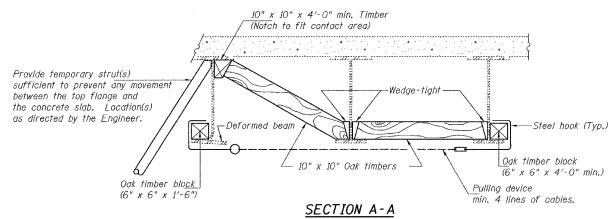
SECTION B-B

EXISTING DEFORMATION TO BE STRAIGHTENED

(Approximate max. deflections) Deflected length of beam to be straightened is approximately 5'-0".

Straightening force shall be maintained on all load transfer blocking during beam straightening.
