# DRAINAGE STRUCTURE IMPROVEMENT DETAIL

## LOCATION #6 STA. 123+20.00

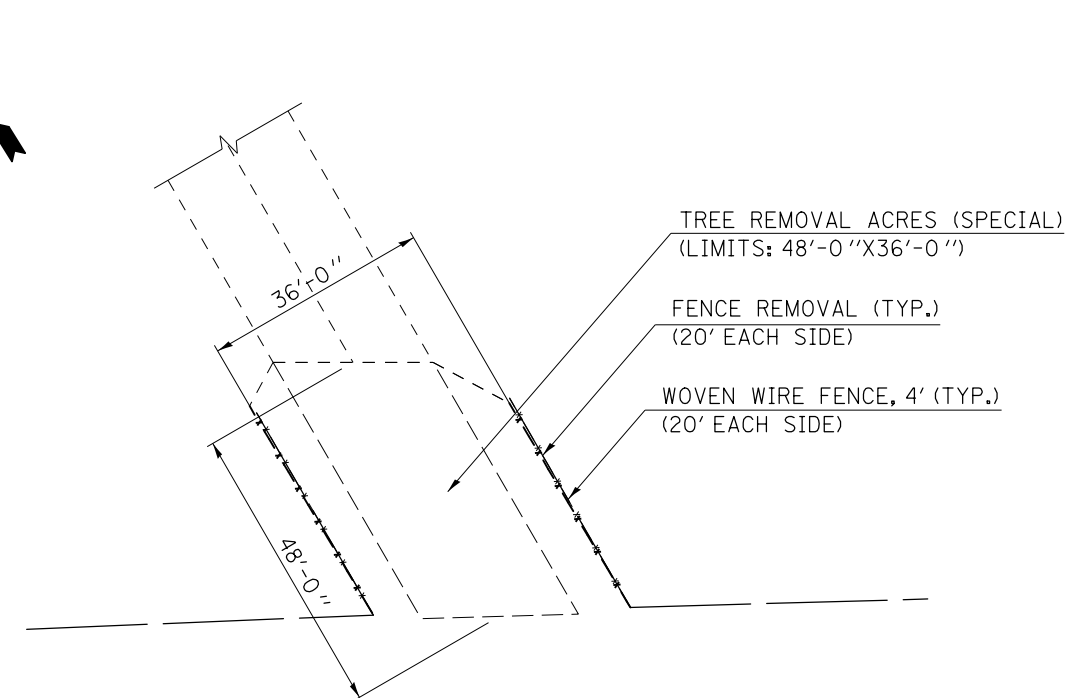
PLAN  
DETAIL "B"

THE EXISTING STRUCTURE AT STATION 123+20.00 CONSISTS OF DUAL MEDIAN INLET BOXES WITH 18" CMP CULVERTS THAT DRAIN INTO A DOUBLE 10' X 6' CONCRETE BOX CULVERT. THE 18" CMP CONNECTING THE OFFSET MEDIAN INLETS TO THE CONCRETE BOX CULVERT IS HEAVILY RUSTED AND IS BEGINNING TO FAIL. THIS FAILURE IS CAUSING SINK HOLES AND DRAINAGE ISSUES AROUND THE MEDIAN INLET BOXES.

THE PROPOSED SCOPE OF WORK IS TO INSERT A CULVERT LINER INTO THE EXISTING CMP TO REMOVE THE CULVERT DEFICIENCY AND TO IMPROVE DRAINAGE. ALL SINK HOLES AROUND THE STRUCTURE SHALL BE FILLED TO FINISH GRADE AND WILL BE PAID FOR SEPARATELY AS FURNISHED EXCAVATION.

OTHER PROPOSED IMPROVEMENTS INCLUDE THE REMOVAL OF ALL TREES AND BRUSH AT THE DOWNSTREAM (SOUTH) END AND TO REPLACE THE EXISTING FENCE WITH WOVEN WIRE FENCE, 4 FT.
