STATE OF ILLINOIS
DEPARTMENT OF TRANSPORTATION

CONTRACT NO. 66561

WEST ABUTMENT
IL 116 OVER KELLY CREEK
FAP ROUTE 681 - SECTION 116BR-1
FORD COUNTY
STATION 60+53.00
STRUCTURE NO. 027-0044

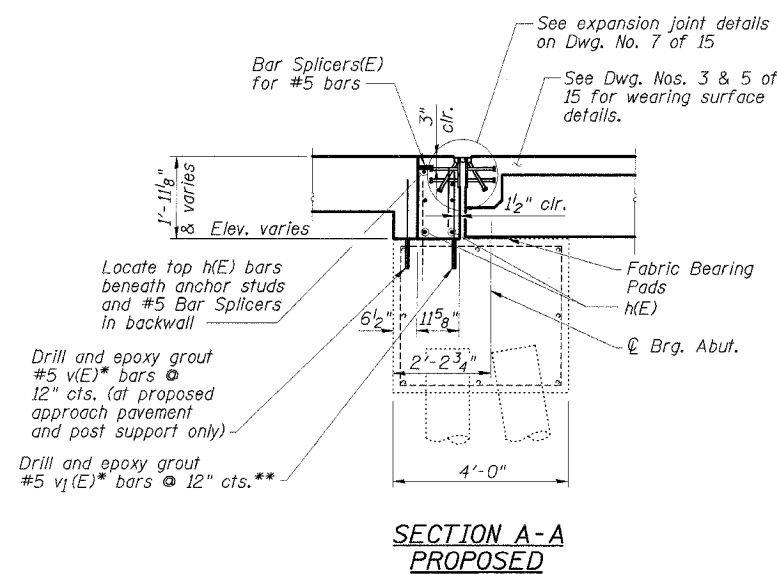
SECTION A-A
PROPOSED

**As directed by the Engineer, the existing #4 vertical bars in the front face of backwall may be cleaned and incorporated into new backwall construction and the #5 v₁(E) bars eliminated from the contract if 1/2" minimum clearance can be maintained from the face of the new backwall
