ROUTE NO.	SECTION	COUNTY	TOTAL SHEETS	SHEET NO.
FAP 681	116BR-1	FORD	37	22
STA.	TO STA.			
FED. ROAD DIST. NO.	ILLINOIS	FED. AID PROJECT-		
DWG. NO. 10 OF 15

CONTRACT NO. 66561

**EAST ABUTMENT**  
IL 116 OVER KELLY CREEK  
FAP ROUTE 681 - SECTION 116BR-1  
FORD COUNTY  
STATION 60+53.00  
STRUCTURE NO. 027-0044

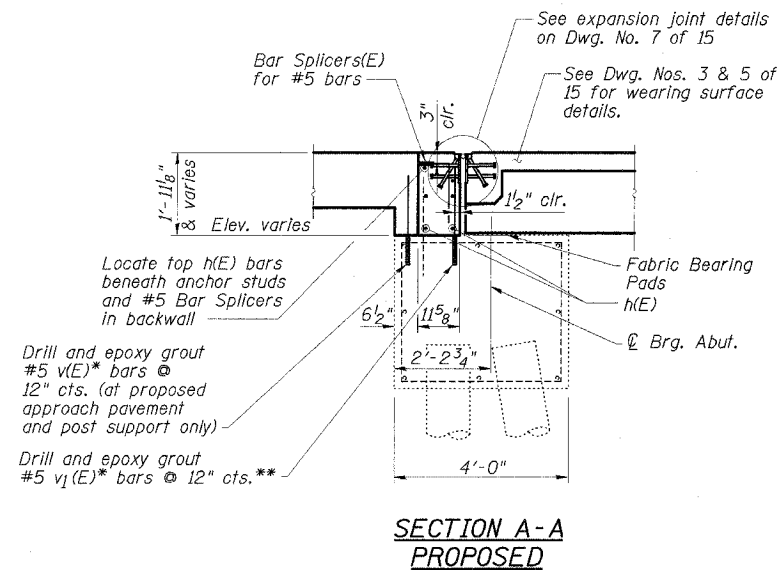
**ELEVATION**  
Cap and Wingwall Repairs

NOTE: ABUTMENT CRACK REPAIR LENGTHS AND FORMED CONCRETE REPAIR AREAS ARE ESTIMATED FROM 4-14-05 SURVEY WORK. ACTUAL LOCATIONS AND QUANTITIES OF REPAIRS SHALL BE SHOWN BY THE ENGINEER ON THE AS-BUILT PLANS FOR THIS SECTION.

EXISTING BEARING SEAT TO BE INSPECTED BY THE ENGINEER AFTER DECK BEAM REMOVAL. DETERIORATED CONCRETE AREAS SHALL BE REPAIRED (ESTIMATED 15 S.F. ADDITIONAL FORMED CONCRETE REPAIR DEPTH < 5") AND CRACKS SHALL BE SEALED (ESTIMATED 20' ADDITIONAL EPOXY CRACK SEALING) IF FOUND. BRIDGE SEAT SEALER SHALL BE APPLIED TO FORMED CONCRETE REPAIR AREAS.
