STATE OF ILLINOIS
 DEPARTMENT OF TRANSPORTATION

BEAM STRAIGHTENING DETAILS
 SN 016-2068

SHEET NO. 2 OF 7 SHEETS

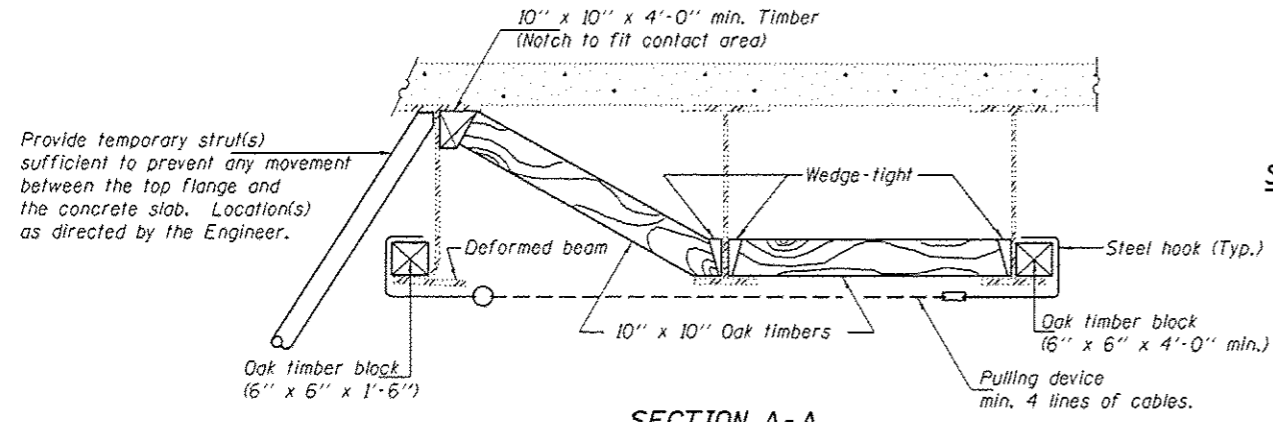
SECTION A-A

EXISTING DEFORMATION TO BE STRAIGHTENED
 (Looking West)
 (Approximate max. deflections)
 Deflected length of beam to be straightened is approximately 4'.

* Edge of plate shall line up with edge of deformation.
 Note:
 Braces and jack assembly shall be placed on same side of web.
 Bent bottom flange shall be straightened before starting any horizontal straightening operations.
