**STATE OF ILLINOIS
DEPARTMENT OF TRANSPORTATION**

**DECK REPAIRS
STRUCTURE NO. 084-0160**

PART B - SHEET 47 of 67

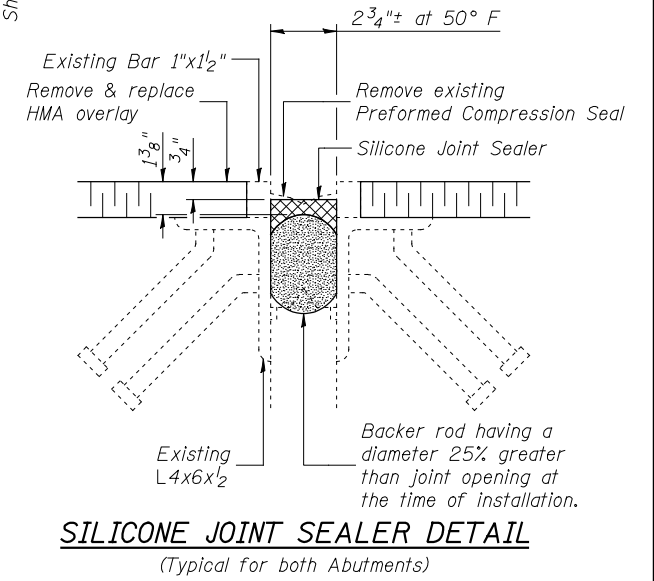
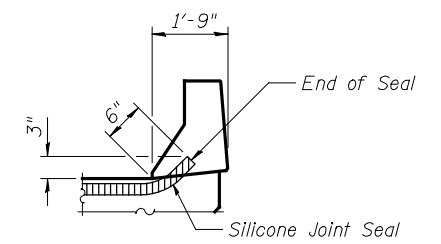
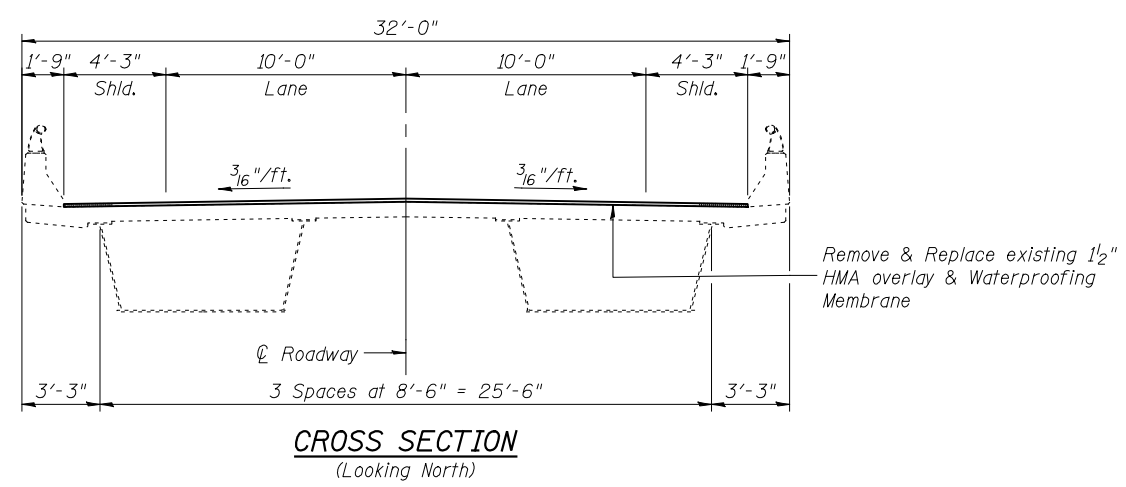
Deteriorated asphalt wearing surface (assumed Deck Slab Repair-Partial)

Notes:
Deck Condition Survey performed 12/22/2010 (by IDOT-D6).
Repair areas are estimated, the Engineer shall determine actual repair locations and record them on the As-Built plans.

Item	Unit	Total
Deck Slab Repair (Partial)	Sq. Yd.	30
Silicone Joint Sealer, 2 3/4"	Foot	59
