**LOAD RATING
INSPECTION REPORT**

Structure Number: 016-0195 District: 1 Date: 02/28/20
 Carried/Crossed: IL 1 over IHB RR Proposed Year of Improvement: FY20
 Inspection Date: 10/9/19 Inspector(s): M.V. Reviewed by: RAD

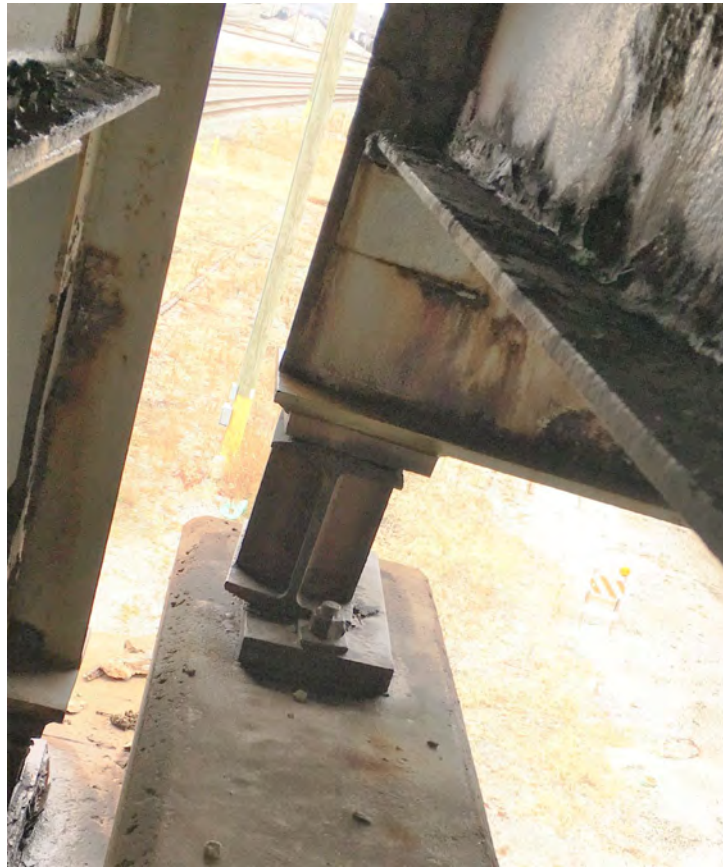
Picture 1: P8; Span 9; Beam 1 Looking W.

Bearings at Pier 8, Span 9: Rocker bearings are moving independent of the top and bottom bearing plates. included please see movement measurements for beams 1 through 5. Cribbing has been installed near the bearings between the concrete cap and diaphragms near beams 1, 2, 3, 8 and 10 at Pier 8, span 9 side. a special feature at 3 months interval has been started to verify that cribbing is staying in place.

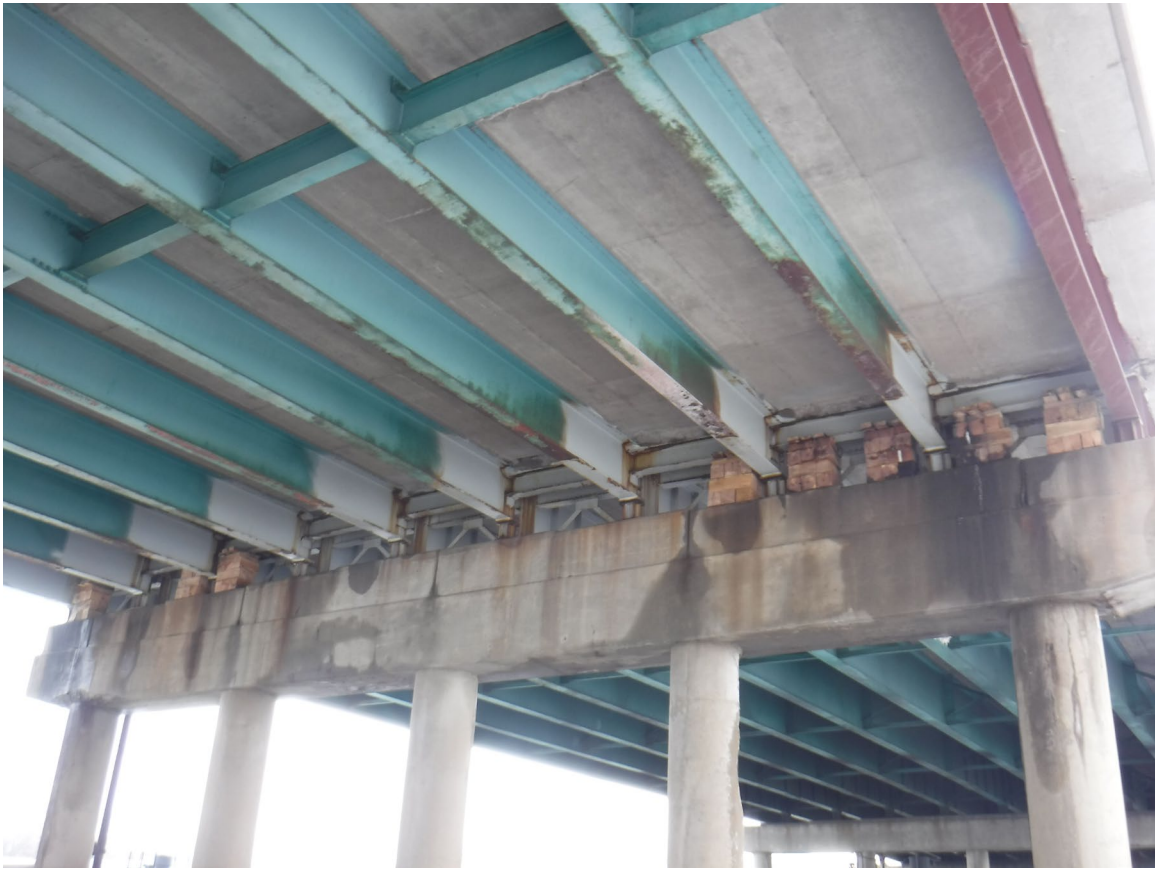
Picture 18: Pier 8; North Face; Looking SE

Remarks: The expansion joints are in very poor condition. The east and west columns of Pier 8 are in very poor condition.
