STATE OF ILLINOIS
DEPARTMENT OF TRANSPORTATION

Inspection Date: 12/10/07

NORTH ABUTMENT
IL 34 OVER
MIDDLE FORK SALINE RIVER
FAP ROUTE 869 - SECTION 105BR-2
SALINE COUNTY
STATION 1561+70.00
STRUCTURE NO. 083-0038

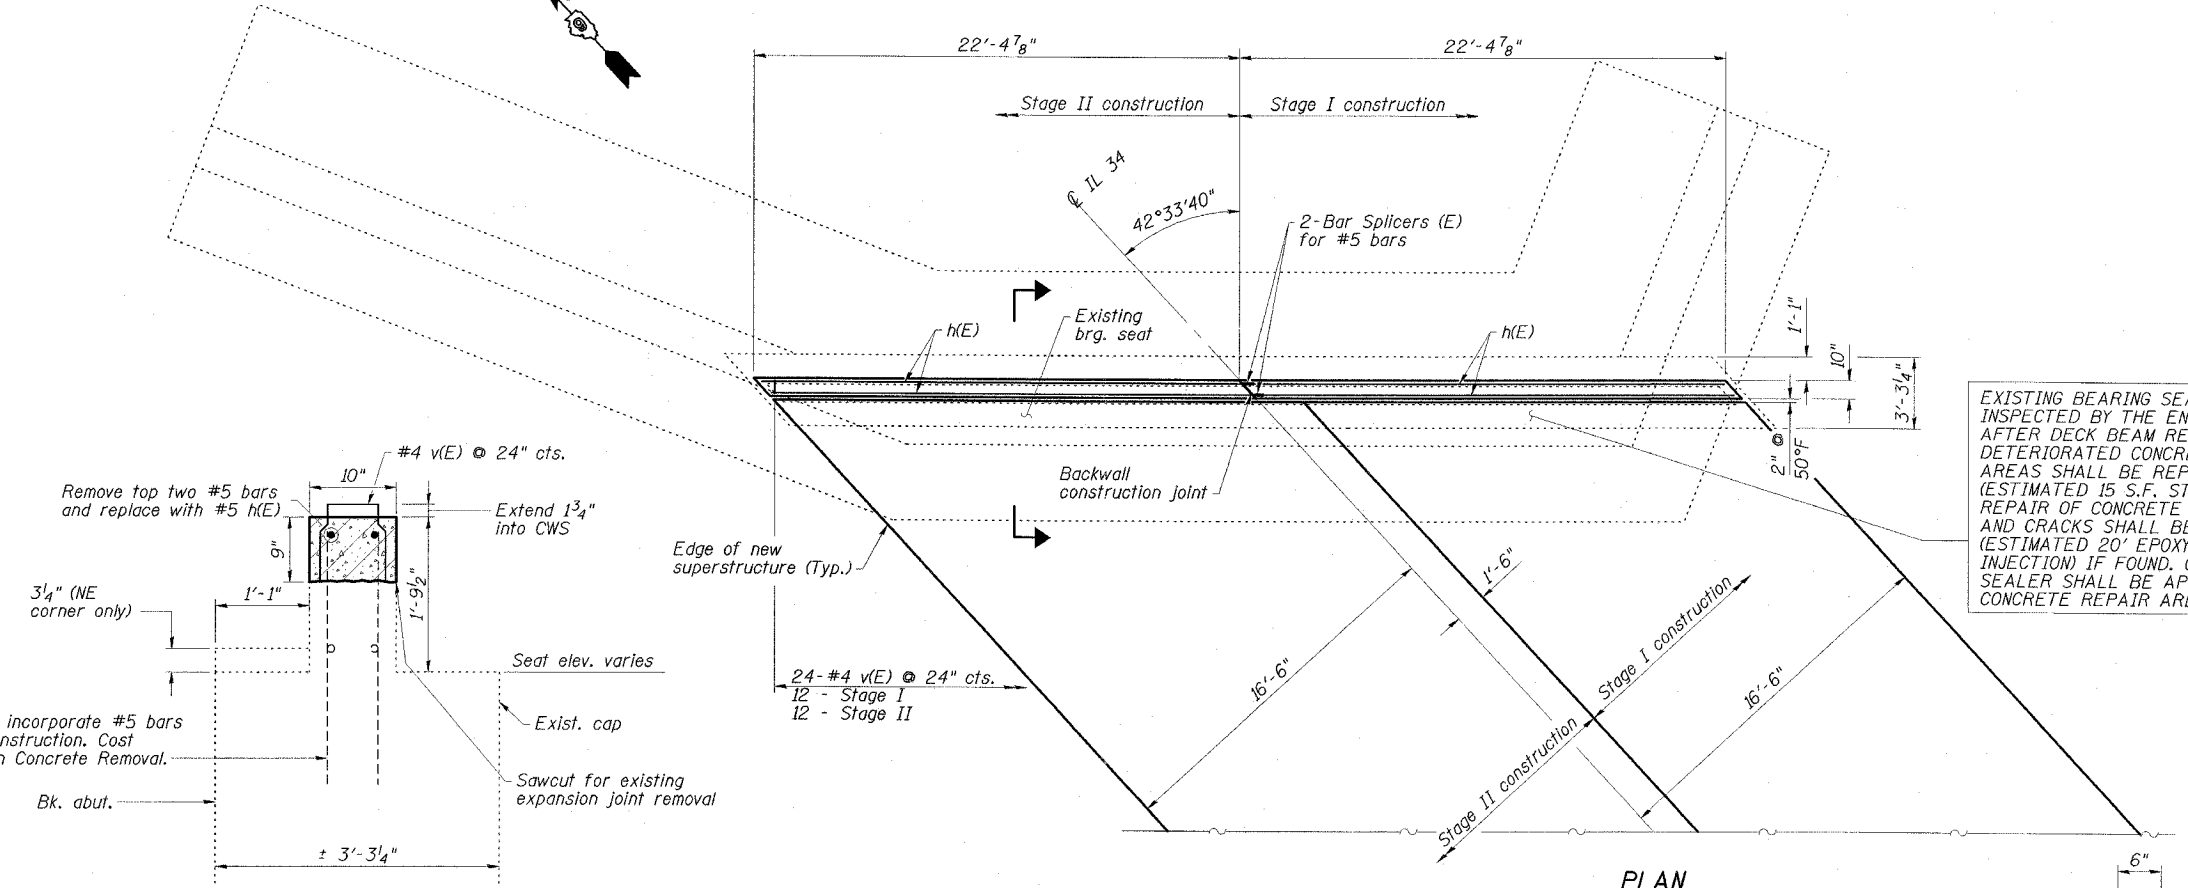
EXISTING BEARING SEAT TO BE INSPECTED BY THE ENGINEER AFTER DECK BEAM REMOVAL. DETERIORATED CONCRETE AREAS SHALL BE REPAIRED (ESTIMATED 15 S.F. STRUCTURAL REPAIR OF CONCRETE DEPTH < 5") AND CRACKS SHALL BE SEALED (ESTIMATED 20' EPOXY CRACK INJECTION) IF FOUND. CONCRETE SEALER SHALL BE APPLIED TO CONCRETE REPAIR AREAS.
