ROUTE NO.	SECTION	COUNTY	POST MILE	SHEET NO.	SHEET NO. 11
FAP 328	*	WHITE	42	22	17 SHEETS
FED. ROAD DIST. NO.	ILLINOIS	FED. AID PROJECT	*(105X)BR		
98997

**SOUTH ABUTMENT
BILL OF MATERIAL**

**SOUTH ABUTMENT
US 45 OVER SKILLET FORK OVERFLOW
FAP ROUTE 328 - SECTION (105X)BR
WHITE COUNTY
STATION 598+76.00
STRUCTURE NO. 097-0019**

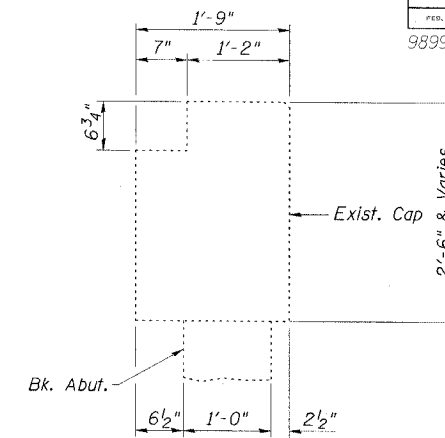
PLAN

- C.-6' Crack to be epoxy injected
- S.F. Delaminated or Spalled Area - Use Structural Repair of Concrete

NOTE: ABUTMENT CRACK REPAIR LENGTHS AND STRUCTURAL REPAIR OF CONCRETE AREAS ARE ESTIMATED FROM 12-14-06 SURVEY WORK. ACTUAL LOCATIONS AND QUANTITIES OF REPAIRS SHALL BE SHOWN BY THE ENGINEER ON THE AS-BUILT PLANS FOR THIS SECTION.

EXISTING BEARING SEAT TO BE INSPECTED BY THE ENGINEER AFTER DECK BEAM REMOVAL. DETERIORATED CONCRETE AREAS SHALL BE REPAIRED (ESTIMATED 15 S.F. STRUCTURAL REPAIR OF CONCRETE DEPTH ≤ 5") AND CRACKS SHALL BE SEALED (ESTIMATED 20' EPOXY CRACK INJECTION) IF FOUND. CONCRETE SEALER SHALL BE APPLIED TO CONCRETE REPAIR AREAS.
