SN 099-0009
I-55 NB over the Des Plaines River
Smith Bridge

2021 Bridge Inspection Report

Bridge Inspection By: Illinois Department of Transportation

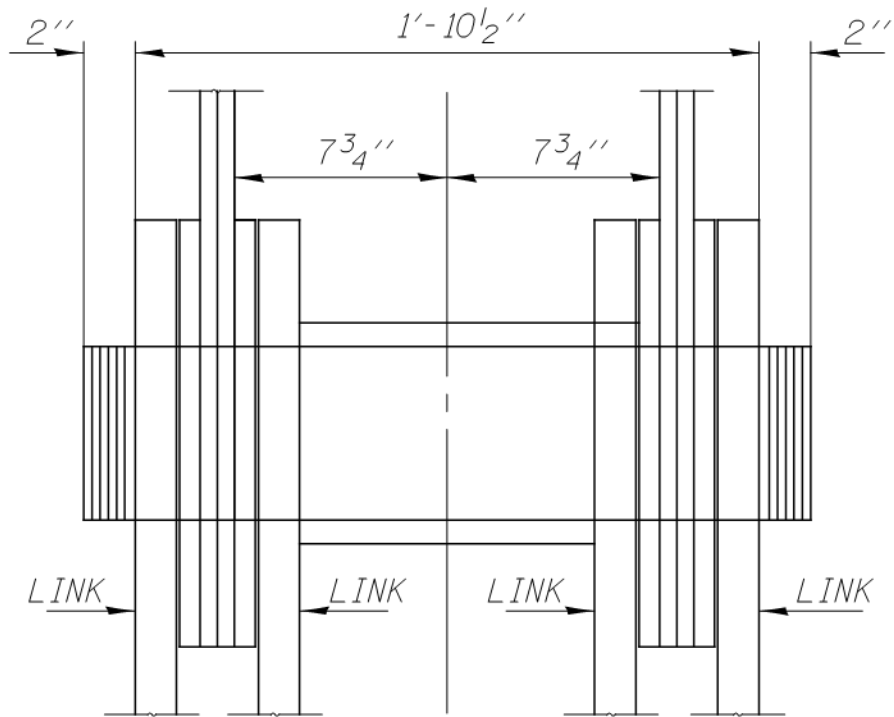
BEARING PINS

@ L0 & L0'

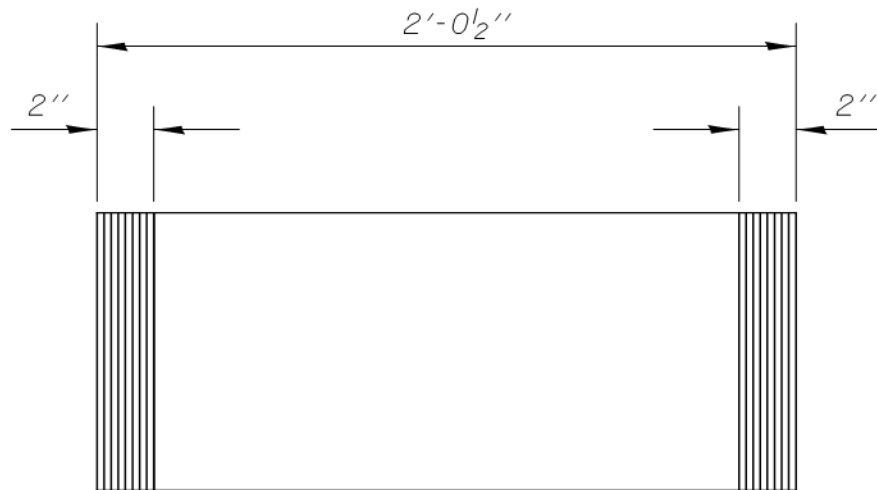
TRUSS PINS

@ PP 13 & 13'
UPPER & LOWER

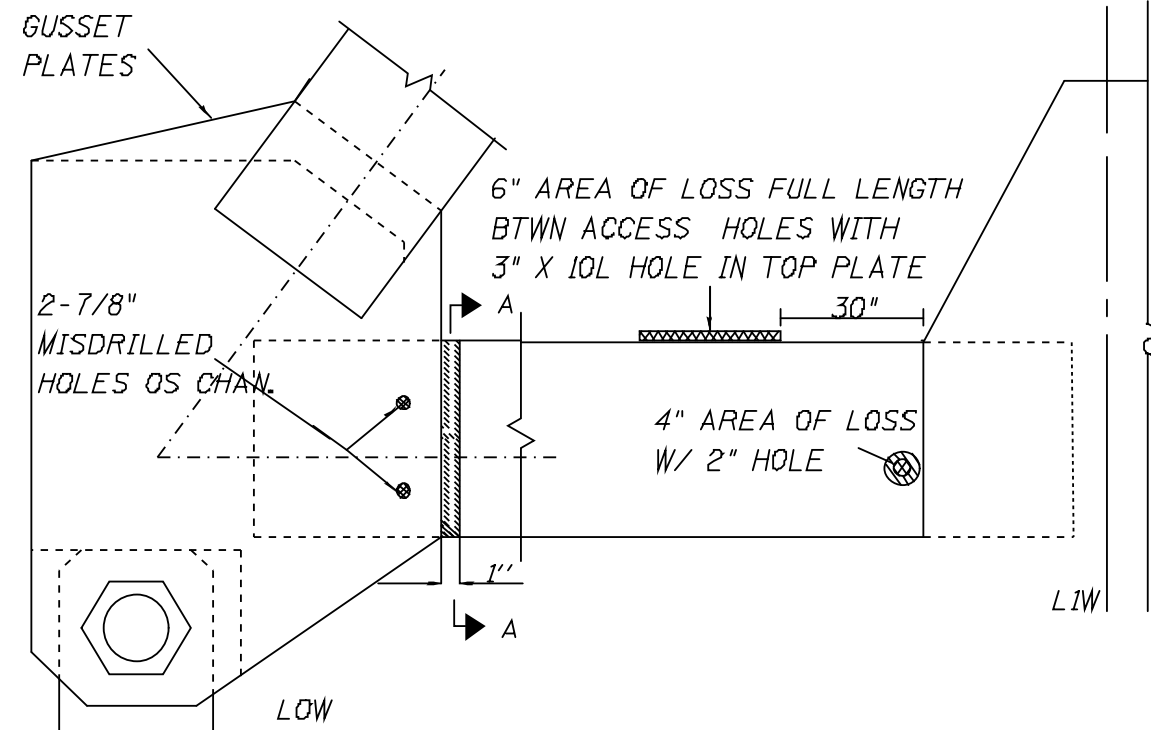
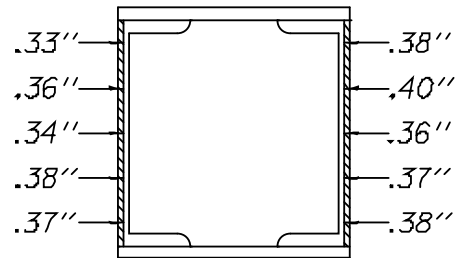
099-0009
ITEM# 25
DETAIL 2

15" x 3/8"
PLATES TOP & BOT.
w/6" x 12"L HOLES

- HOLE
- SECTION LOSS
- FULL SECTION

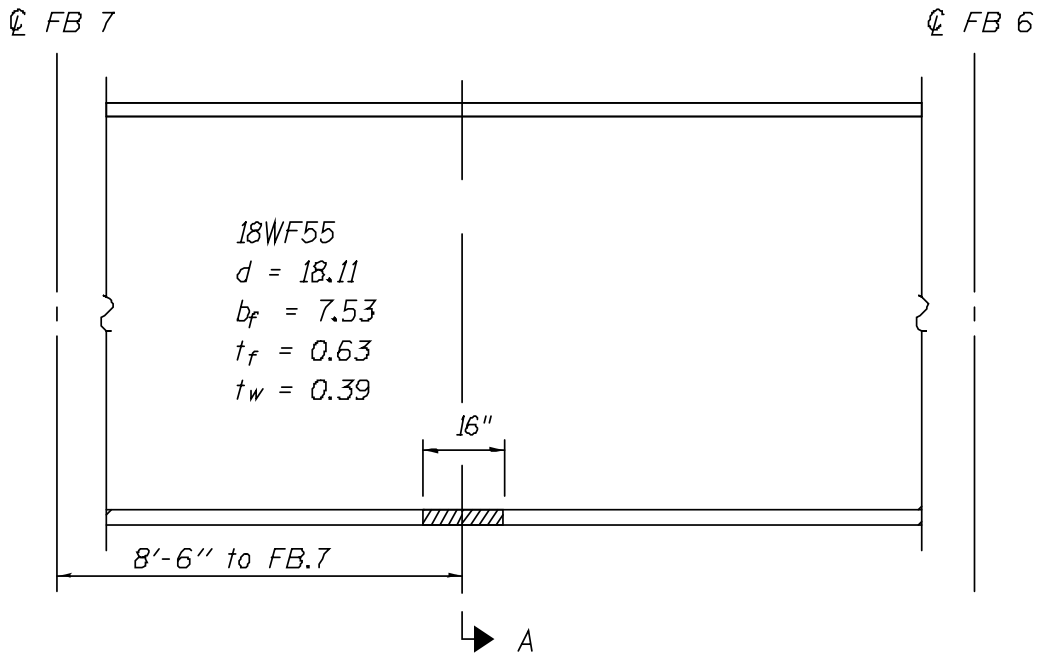
099-0009
 ITEM# 34
 DETAIL 5

SPAN 4
 S9
 FLOORBEAM 7, PANEL 7

SP. 4
 S9 PAN. 7

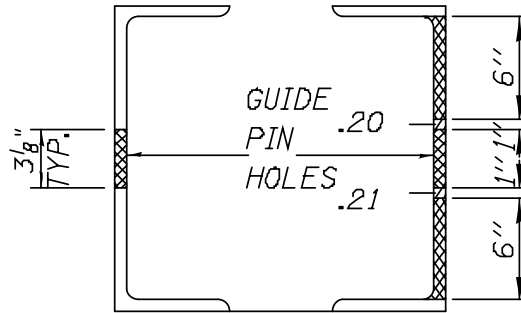
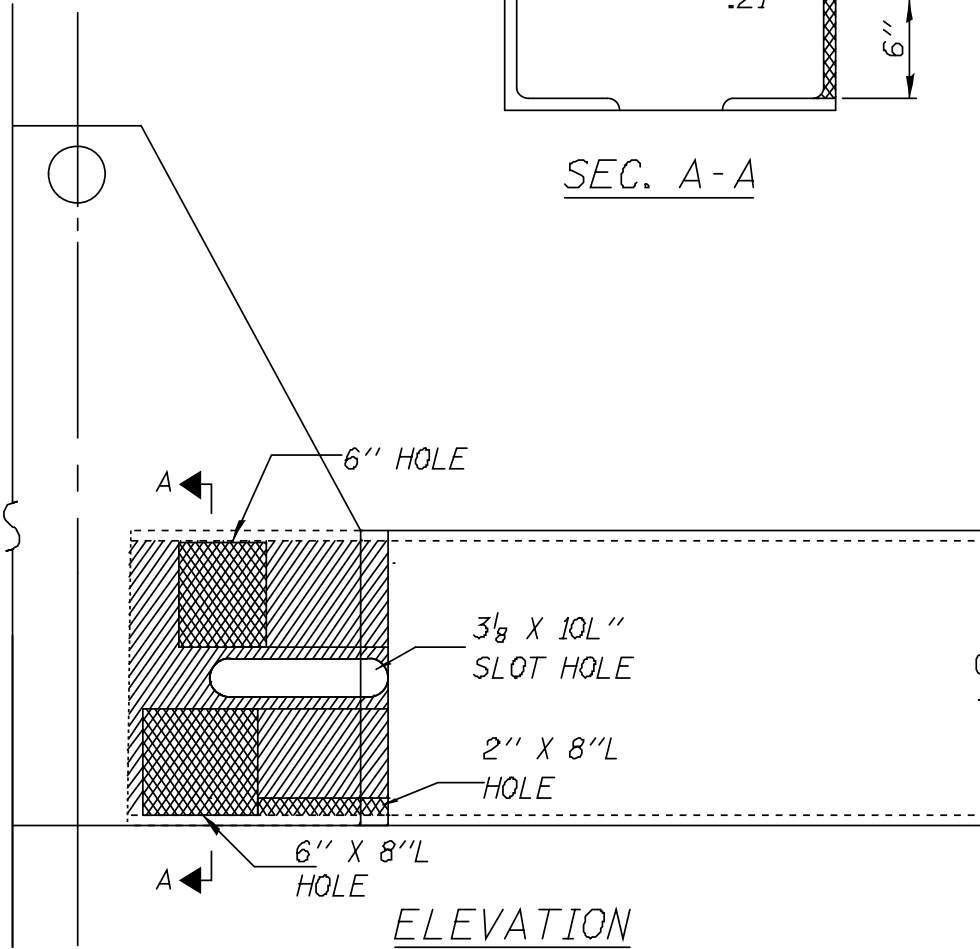
099-0009
 ITEM# 42
 DETAIL 6

f
 w
 $15'' \times \frac{3}{8}''$
 PLATES TOP & BOT.
 w/6'' x 12'' L HOLES

- L13E
- HOLE
 - SECTION LOSS
 - FULL SECTION

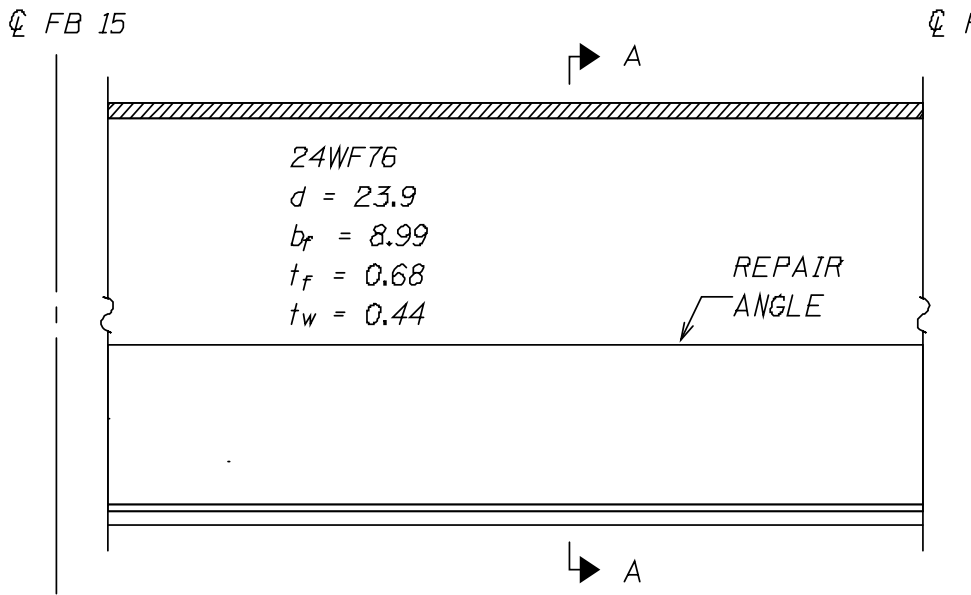
099-0009
ITEM# 49
DETAIL 7

SPAN 5, S3
THROUGHOUT PANEL 16

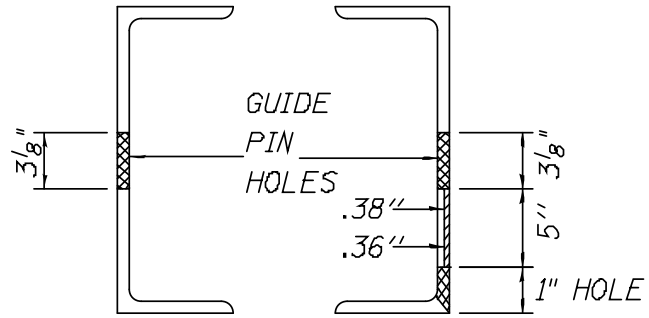
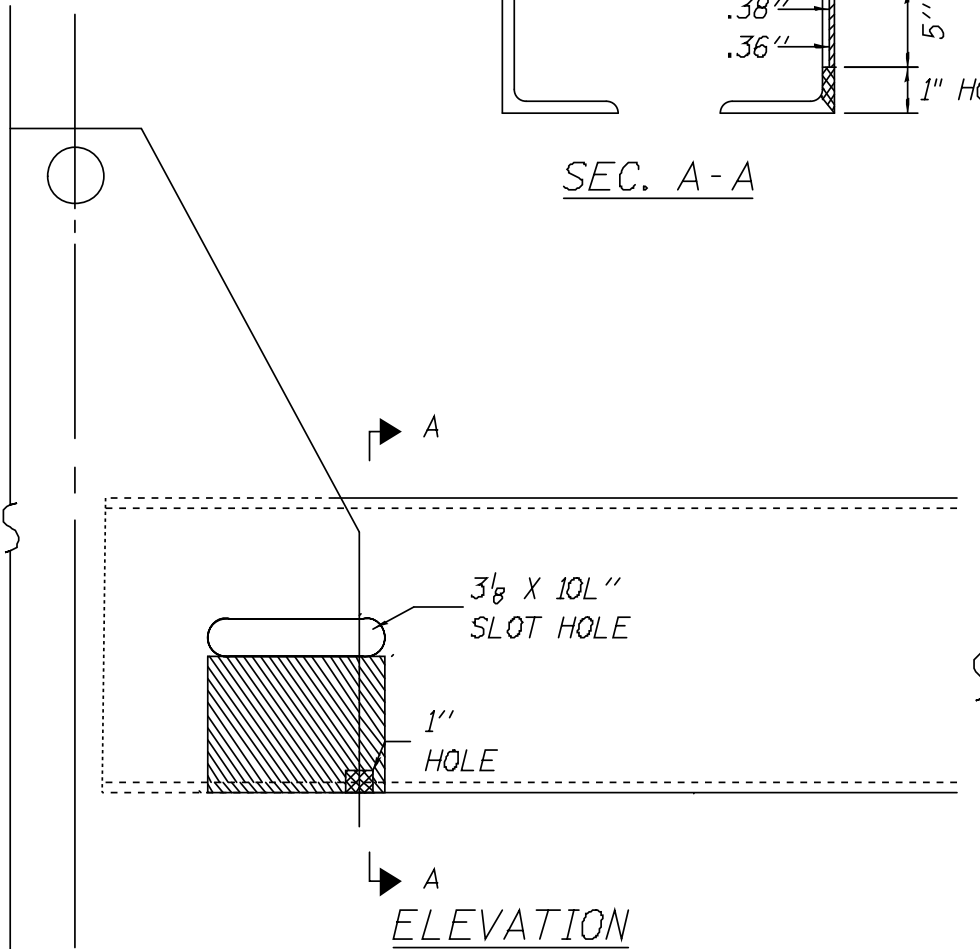
099-0009
ITEM# 62
DETAIL 9

f
 w
 $15'' \times \frac{3}{8}''$
PLATES TOP & BOT.
w/6'' x 12'' L HOLES

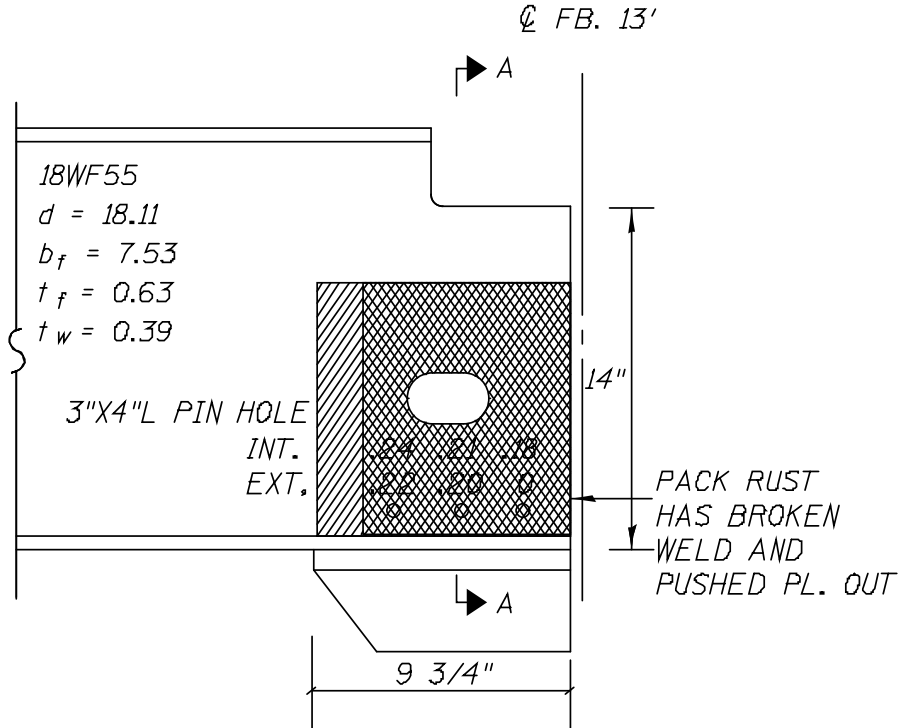
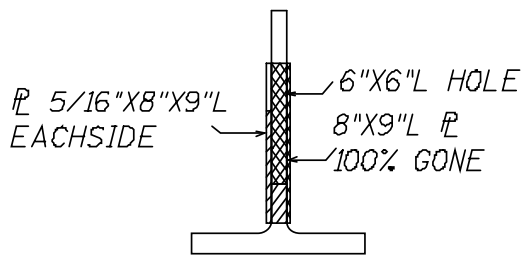
099-0009
 ITEM# 106
 DETAIL 10

SP. 5
 S1
 @FB. 13', PAN. 13'

- HOLE
- SECTION LOSS
- FULL SECTION

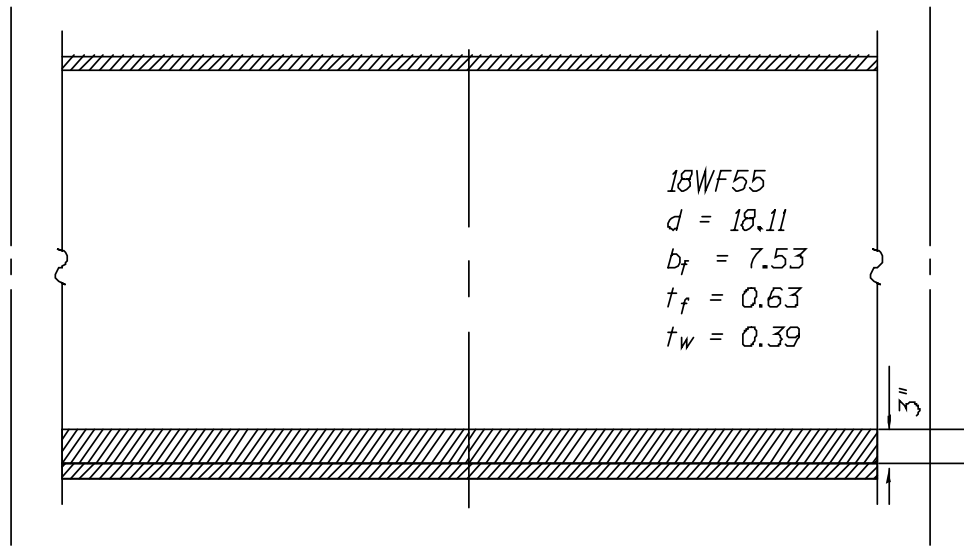
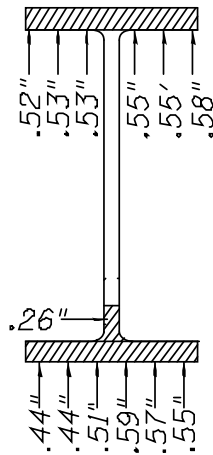
099-0009
 ITEM# 74
 DETAIL 14
 C FB 5'

SP. 6
 S8 PAN. 6'

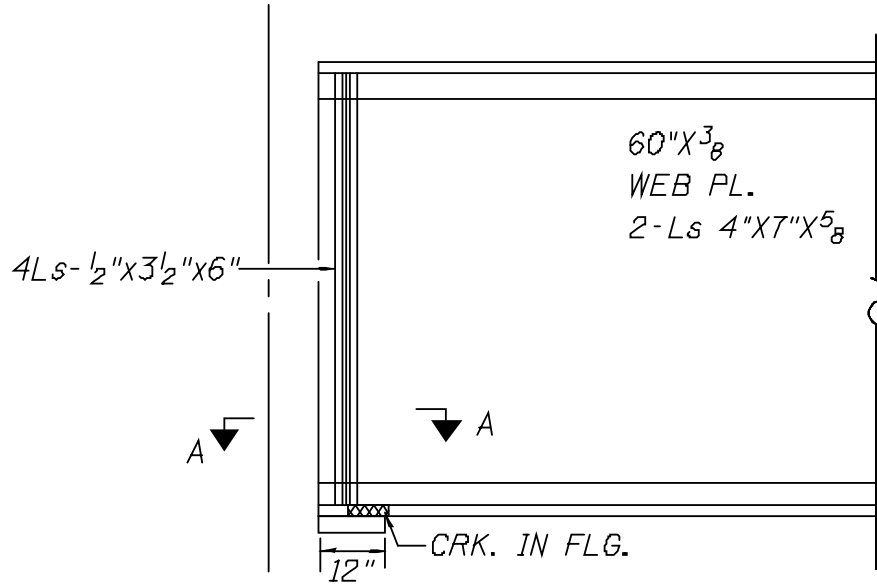
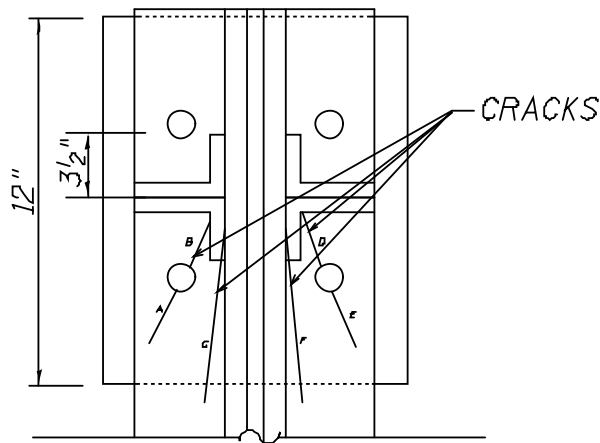
099-0009
 ITEM# 90
 DETAIL 15

CRK. SIZE

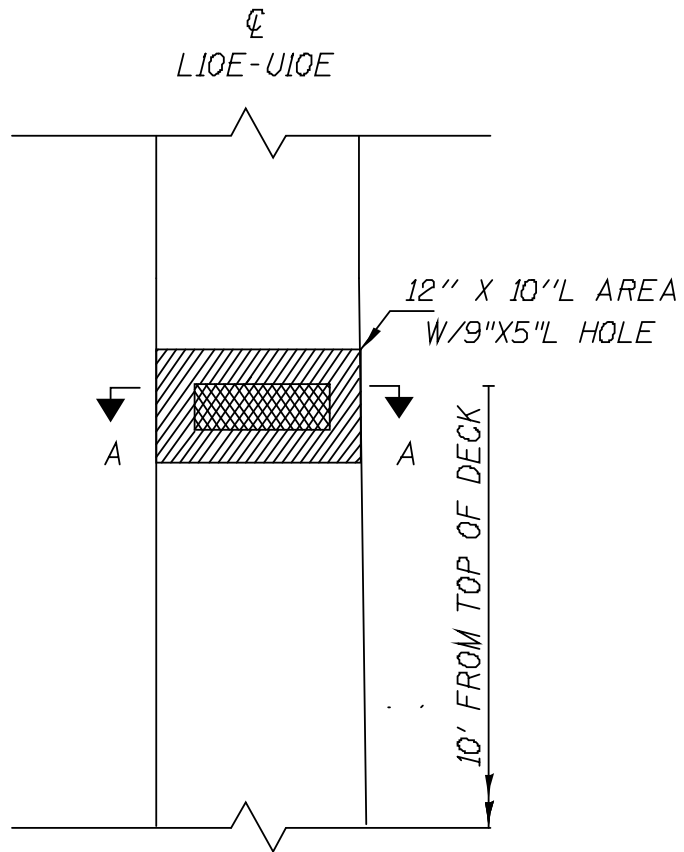
099-0009
 ITEM# 97
 DETAIL 17

C12 x 20.7#
 $d = 12.0$
 $b_f = 2.94$
 $t_w = .282$
 15" x $\frac{3}{8}$ "
 PLATES TOP & BOT.
 W/6" x 12" L HOLES

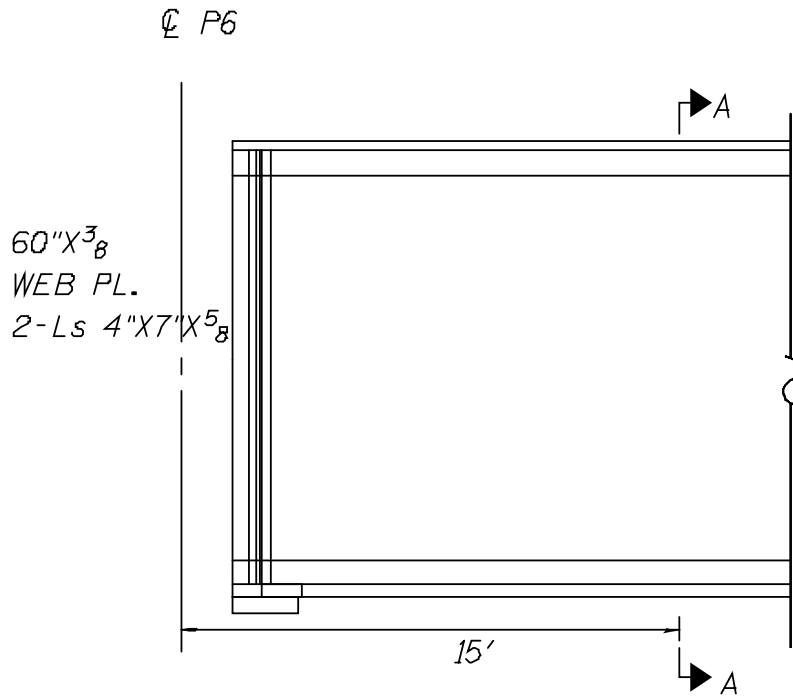
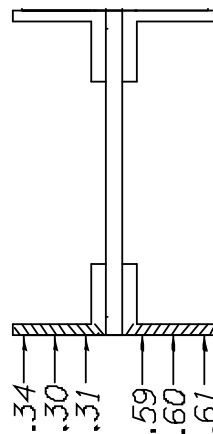
099-0009
 ITEM# 129
 DETAIL 18

SPAN 7
 GIRDER 1
 15' SOUTH OF PIER 6

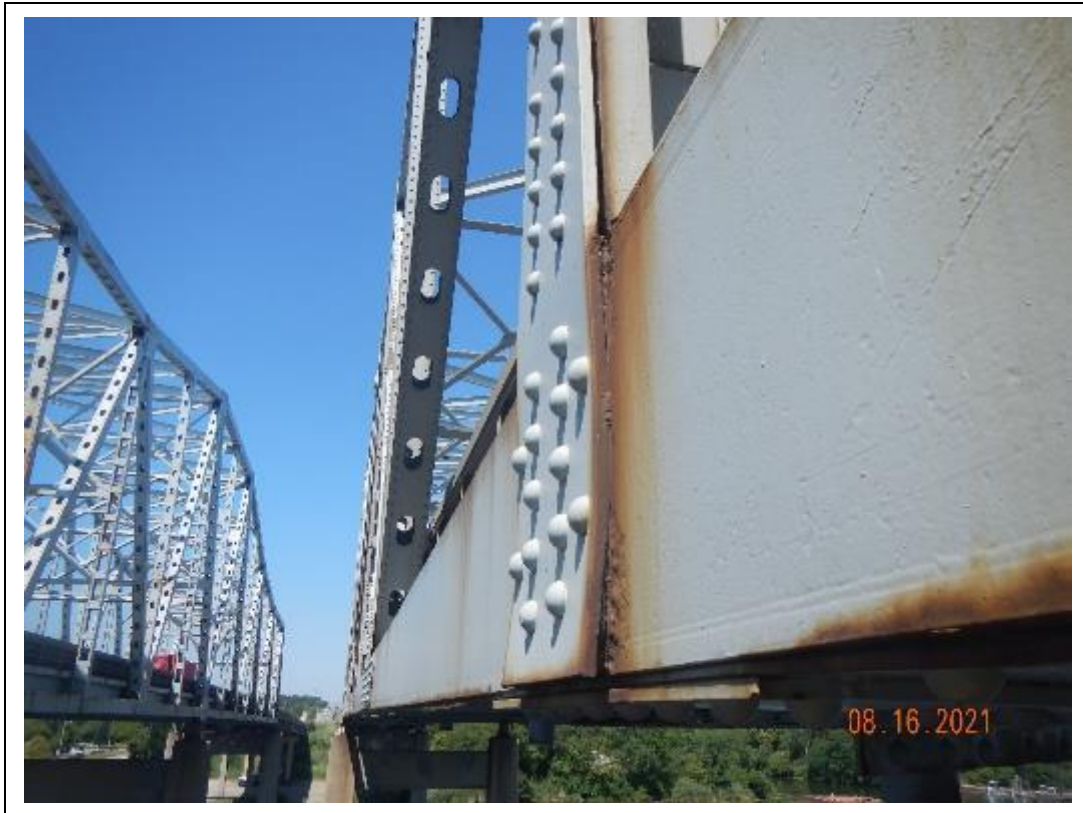
PHOTO 61

ITEM#	Span(s)	Member(s)	Location(s)	Photo(s)	Deficiency(ies)	Corrective Action	Year	Load Cap. Re-Eval.
99	5	Lateral Bracing	L13W to Mid-Point Floorbeam 14, Last 12' From L13W	54 LSW	50% SL, 2-4" holes, 3-3" cracks	Repair	2017	
45	5	Portal Frame	Between Panel Point 13 & 14	116 LE	6" X ¼" offset centerline driving lane (Lane 2)	N/A	2001	
100	5	Joint	@ Panel Point 15	55 LE	10' of Joint failed, 6' east end & 4' West end	Repair	2017	
46	5	L15E-U15E	2' Above L15E	56 LSW	0% SL, 2" Hole in North plate (Between access holes)	N/A	2015	
47	5	Gusset Plate	U15E (inside)	57 LE	1 ½" X 1" Torch cut hole	N/A	2009	
48	5	L15W-L16W	6'S OF L15W	58 LSE	0% SL, 1" X 3"L hole in top plate (Between Access Holes)	N/A	2015	
49	5	Stringer 3	Throughout, Panel 16	59 LNE.	21% Top flange, (See Detail 7)	N/A 21% SL Top Flange IRF = 1.453	2013	
119	5	Gusset Plate	@ U16E I.S. Plate	60 LE	¾ " Misdrilled hole	N/A	2019	
50	5	L16E-U16E	18" from L16E	61 LE	<3% SL, 2" X 3"L Area of loss W/ 1" Hole	N/A	2009

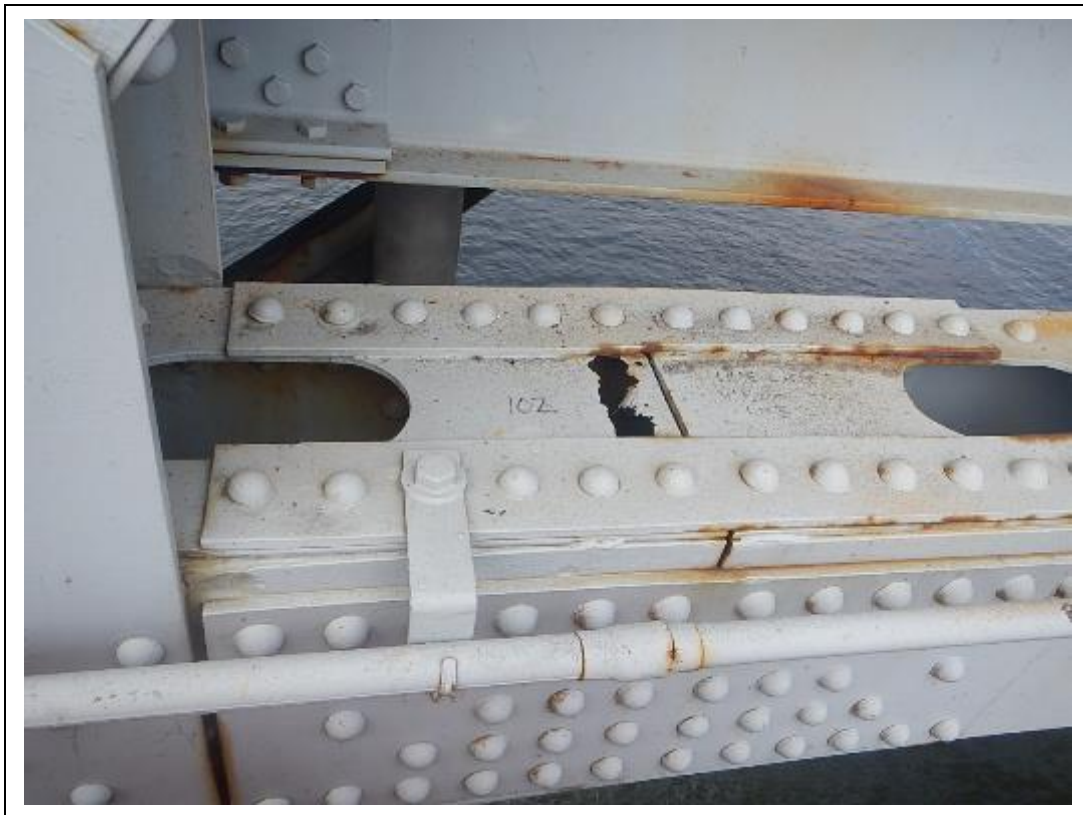
PHOTO 65

ITEM#	Span(s)	Member(s)	Location(s)	Photo(s)	Deficiency(ies)	Corrective Action	Year	Load Cap. Re-Eval.
56	5	U16'E-U15'E	@ U15'E	65 LSE	Partial crack tack weld	N/A	2015	
102	5	L16'E-L15'E	4' from L15'E	66 LE	0% SL 6" X 2"L hole in top plate @ Splice	N/A	2017	
127	5	L16'W -L15'E	5' from L15'E	<u>120</u> LE	50% SL to angle	N/A	2021	
103	5	Diaphragm	Between Stringer 6-& 7, @ Floorbeam 15'	67 LSW	20% SL, 1" hole in top of web 1" X 3"L hole in bottom of web	N/A	2017	
57	5	L15'E-U14'E	@ L15'E	68 LNW	0% SL, 2" hole in bottom Cover plate & 2 -15/16" Misdrilled holes 1 each side (Not in Line with Access Hole)	N/A	2015	
104	5	L15'W-L14'W	@ L14'W	69 LE	2% SL, 3" area of loss with 1" hole in channel web	N/A	2017	
128	5	Floorbeam 13'	@ Stringer 9, Panel 14'	<u>121</u> LSW	1" Hole in Bearing Stiffener	N/A	2021	
105	5	L13'E- Mid-Point Floorbeam 14'	3' from L13'E	70 LS	2- Broken Bolts	N/A	2017	
61	5	Gusset Plate	U13'W (Outside)	71 LSE	1" Misdrilled Hole	N/A	2009

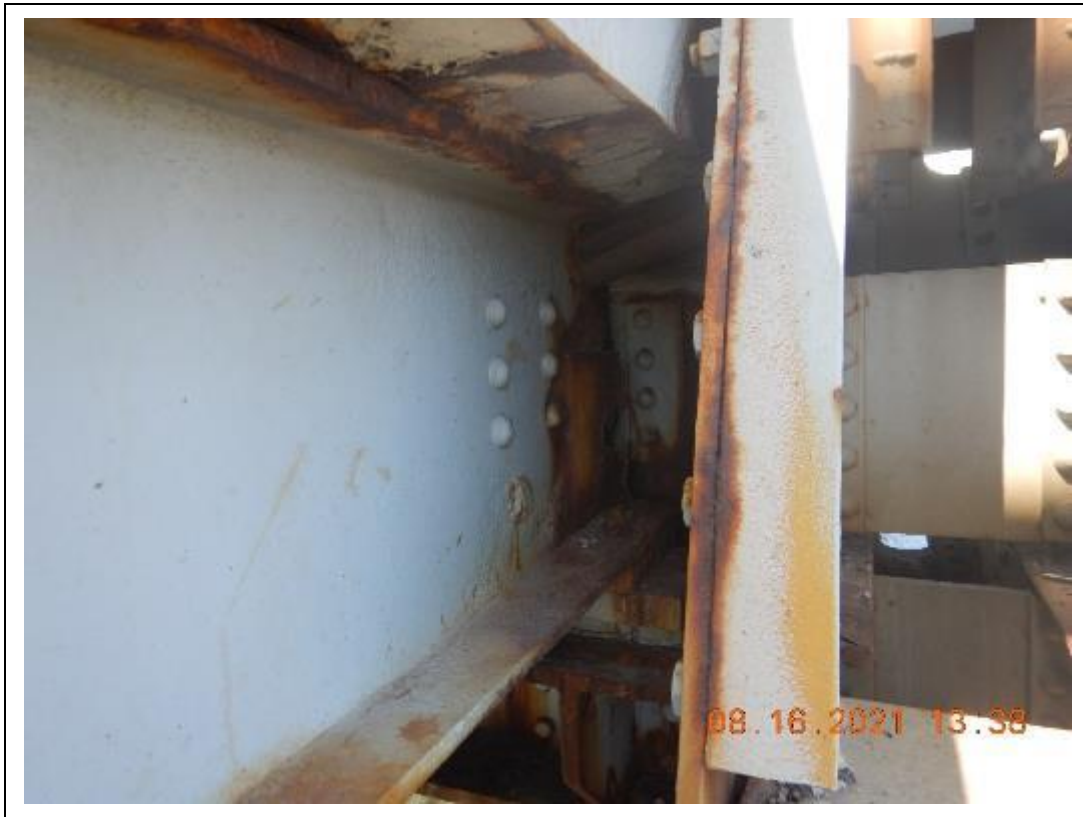
PHOTO 72

106	5	Stringer 1	@ Floorbeam 13' Panel 13'	72 LE, 73LN	49% SL in Web, 27% Web Bearing Loss (See Detail 10)	N/A Zero Force Member	2017	X
60	5	L13'E-L12'E	@ L13'E	74 LNW	7% SL (See Detail 8)	N/A Zero Force Member	2005	
62	5	L13'W-L12'W	@ L13'W	75 LNE	3% SL (See Detail 9)	N/A Zero Force Member	2013	
63	5	Stringer 1-9	@ Floorbeam 13', Panel 13'	76 LNW	0% SL Web, 2" Holes Drilled into Web (Abandoned, Reinforced)	N/A	2011	
120	5	Joint	@ P.P. 13'	77 LE	5' Failed East end	Repair	2019	
59	5	Stringer 1	@ Floorbeam 13', Panel 13'	<u>122</u> LE	10" X 1/2" Offset bottom flange	N/A	2001

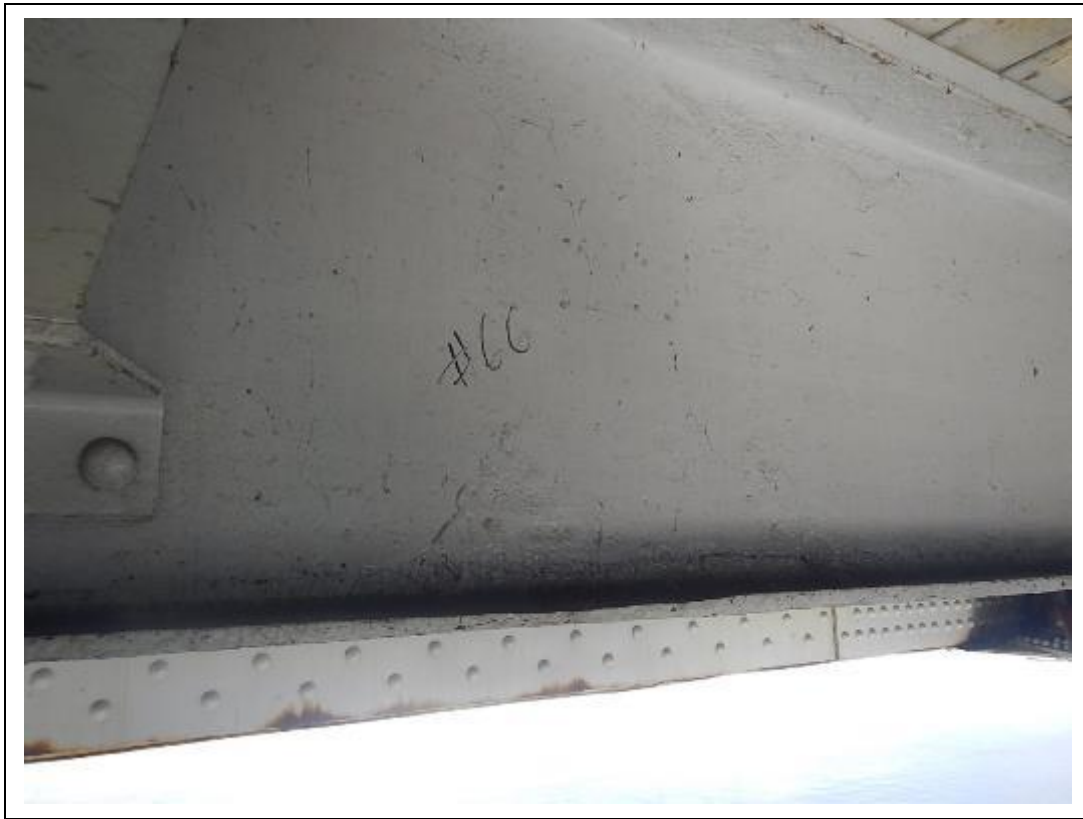
PHOTO 78

ITEM#	Span(s)	Member(s)	Location(s)	Photo(s)	Deficiency(ies)	Corrective Action	Year	Load Cap. Re-Eval.
58	5	Portal Frame	Mid-Point., Between Panel Point 12' & Panel Point 13'	?	6" X 1/2" Offset	N/A	2015	
64	5	U13'E-U12'E	@ U12'E	78 LNE	Partial crack tack weld	N/A	2001	
66	5	Stringer 7	Full Length, Panel 10'	79 LNW	37% SL in Bottom Flange, 24% SL in Top Flange 3% SL in web (See Detail 11)	N/A 37% SL in Bottom Flange, 24% SL in Top Flange 3% SL in web IRF = 1.21	2015	
107	5	L9'W-U9'W	@ L9'W	80 LSE	4% SL 2-15/16" Misdrilled holes (@ Gus. Pl. 1 Per Section)	N/A (1 Per Section)	2017	
67	5,6	L8'W-U8'W	L8'W	81 LNE	4% SL, 6 1/2" X 3"L area of loss in outside channel 0.255" Avg. Rem., 0.387" Nom.	N/A	2009	
108	5,6	L8'W-U8'W	20' from U8'W	123 LS	7% SL, 2-15/16" Misdrilled Holes	N/A	2017	
68	5,6	Sway Brace	P.P. 8'E	124 LS	12" X 1" Offset	N/A	2011	
109	6	L8'E-L7'E	10' from L8'E	82 LNW	0% SL 2" X 9"L hole in top plate (Between Access Holes)	N/A	2017

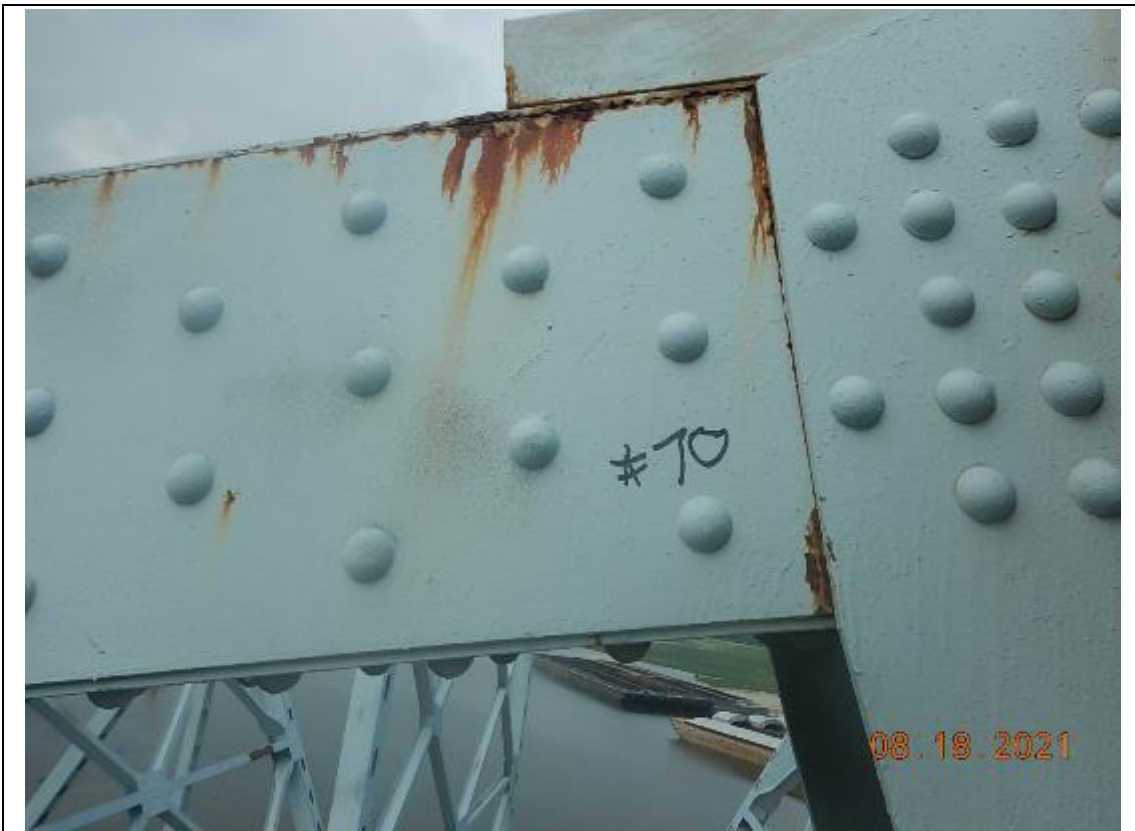
PHOTO 83

69	6	U7'E-U6'E	U7'E	83 LN	<3 % SL 2 - 1" Misdrilled holes in top angle (1 Per Section)	N/A	2009	
70	6	U7'W-U6'W	@ U7'W	84 LE	2 - Partial crack tack weld (tension member)	N/A	2001	
110	6	L7'W-L6'W	@ L6'W	85 LS	0% SL 6" X 12"L area of loss with up to 3" hole in lower chord (Between access holes)	N/A	2017	
71	6	U7'E-L6'E	@ L6'E	86 LE	6% SL, 6" area of loss W/ 2" X 1"L hole in outside channel	N/A	2009	
121	6	Diaphragm	@ Floorbeam 6', Panel 7 Between Stringer 6 & 7	87 LE	1" X 5" Hole in web	N/A	2019	
72	6	Gusset Plate	L6'E (Outside)	88 LN	22% SL (See Detail 12)	N/A 22% SL -IRF = 1.58	2015

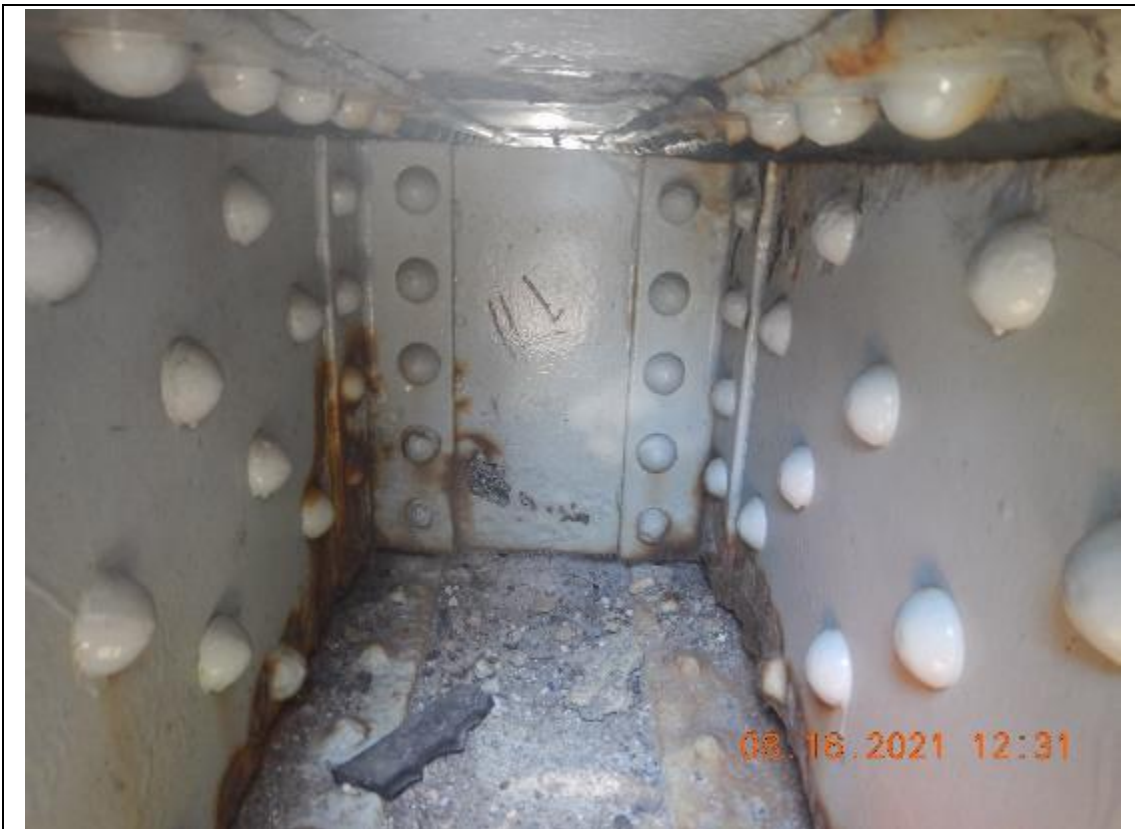
PHOTO 89

ITEM#	Span(s)	Member(s)	Location(s)	Photo(s)	Deficiency(ies)	Corrective Action	Year	Load Cap. Re-Eval.
73	6	Gusset Plate	L6'E (Inside)	88 LN	6% SL (See Detail 13)	N/A 6% SL -IRF = 1.58	2009	
74	6	Stringer 8	Full Length, Panel 6'	89 LE	19% SL in Bottom Flange, 14% SL in Top Flange 6% SL in web (See Detail 14)	N/A 19% SL in Bottom Flange, 14% SL in Top Flange 6% SL in Web IRF = 1.69	2015	
111	6	L6'W-L5'W	@ L6'W	90 LN	35% SL 6" Hole in diaphragm, 0% SL, 3" hole in top cover plate	N/A	2017	
75	6	L6'E-L5'E	3' from L6'E	91 LE	0% SL, 2" Hole in Top Plate (Between Access Holes)	N/A	2013	
76	6	U5'E-L4'E	L4'E	92 LE	4% SL, 6" X 1" L area of loss in exterior channel; 0.395" Avg. Rem., 0.6" Nom.	N/A	2009	
77	6	L4'E-U4'E	5' from L4'E	93 LS	3% SL, 2- 7/8" Misdrilled holes in North plate	N/A	2013	
78	6	Stringer 1	@ Floorbeam4', Panel 4'	94 LE	7% SL, 1" hole in web (13 5/8" cope)	N/A	2015	
112	6	L4'W-U4'W	@ L4'W	95 LSE	3% SL, 3" X 1" l area with 1" hole in Web	N/A	2017

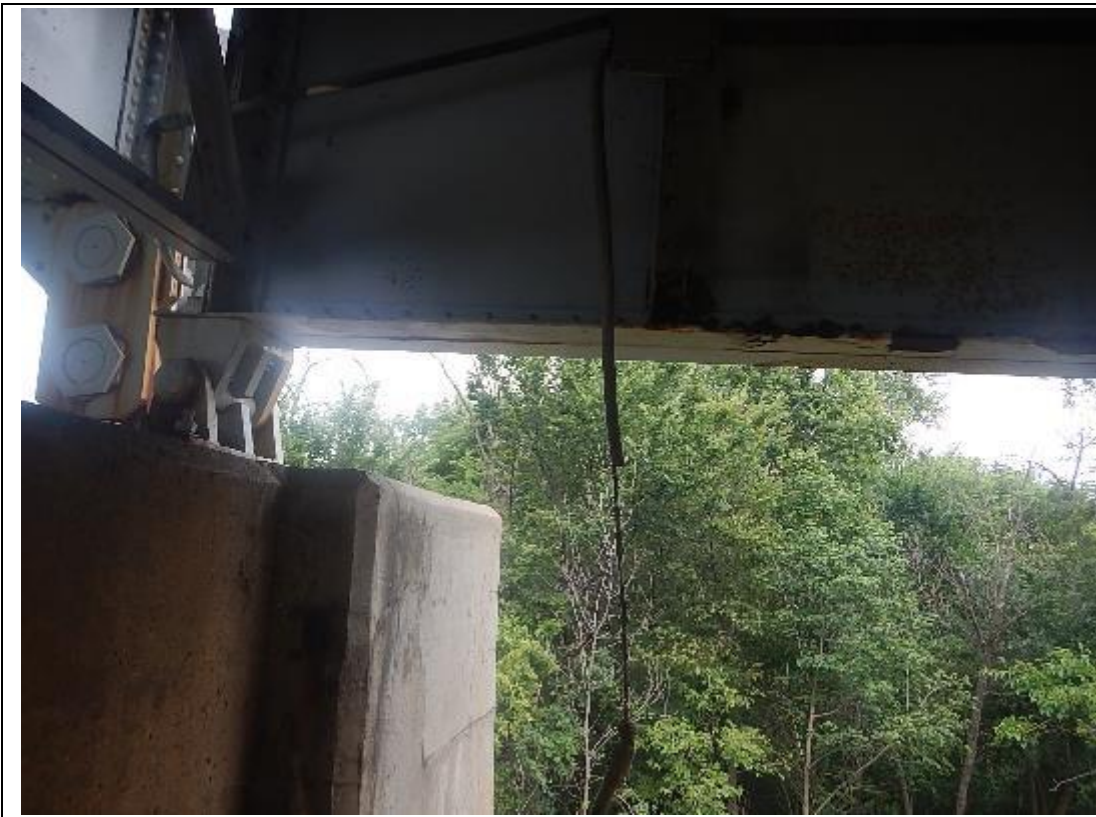
PHOTO 102

ITEM#	Span(s)	Member(s)	Location(s)	Photo(s)	Deficiency(ies)	Corrective Action	Year	Load Cap. Re-Eval.
					0.45" Nom.			
82	6	U2'E-U1'W	Panel 2', 11' from East Truss	125 LN	7 1/2" X 1/2" Offset	N/A	2009	
115	6	L2'E-L1'W	@ L1'W	102 LN	10% SL, 2" area with 1" Hole in angle	N/A	2017	
83	6	L1'E-U1'E	5' Above L1'E	126 LE	5" X 5/8" Offset	N/A	2011	
84	6	Stringer 3	3' South of Floorbeam 1', East Face	127 LN	15" X 7/8" Offset on angle bottom flange	N/A	2009	
85	6	Floorbeam 0'	South Face	128 LS	8 - Welded attachments on bottom flange	N/A	2009	
123	7	Conduit	@ P. 6	103 LE	Broken conduit	Repair	2019	
86	7	Girder 2	10 TH Stiffener from Pier 6, East Face	129 LE	7" X 1/2" Offset	N/A	2013	
129	7	Girder 1	15' South of Pier 6	130 LNE	18% SL, Bottom Flange (See Deta;l 18)	Repair	2021	X
87	7	Cross Frame	3rd Cross Frame from P. 6, Between Girder 3 & Girder 4 @ Girder 3	104 LE	12 3/4" Crack in stiffener	Repair	2015	
88	7	Cross Frame	4 th Cross Frame from P. 6, Between Girder 1 & Girder 2	131 LS	18" X 1/2" Offset	N/A	1999

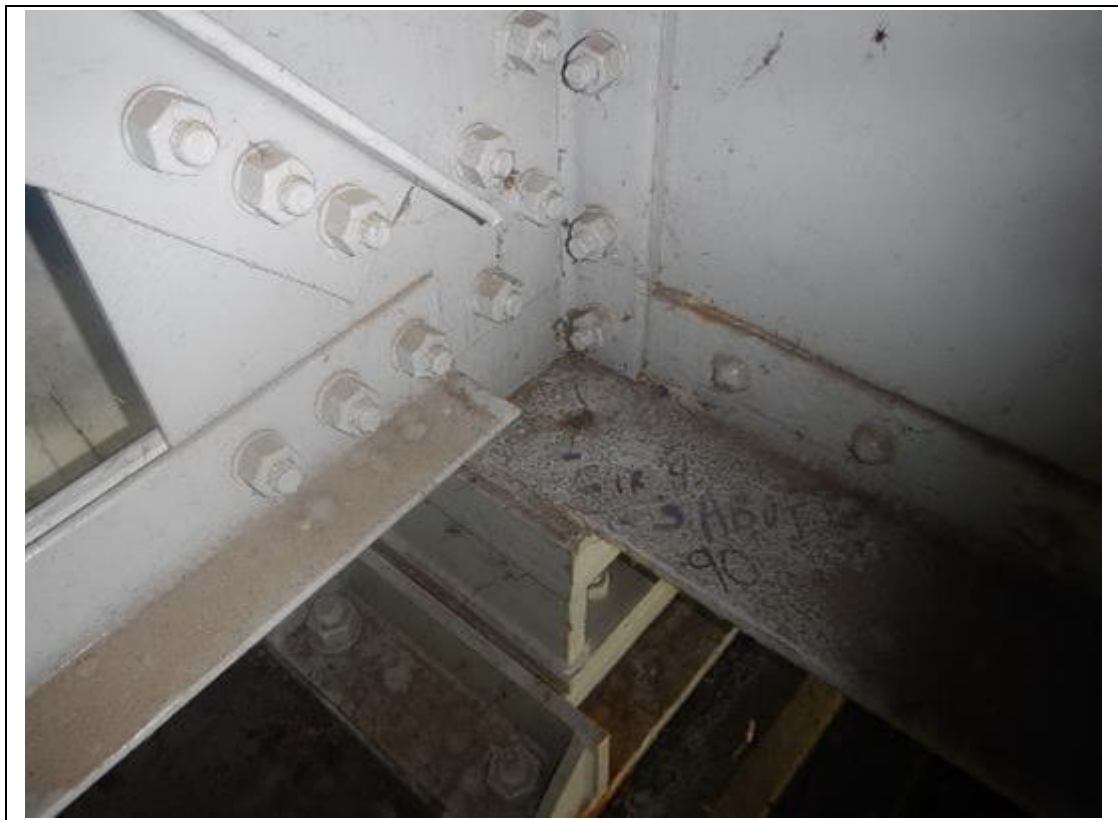
PHOTO 105 (2020)

89	7	Cross Frame	4th Cross Frame From P. 6, Between Girder 3 & Girder 4 @ Girder 3	105 LN	1 Missing bolt & 1 loose bolt	Repair (Need A 3"- 3 1/2 " Bolt)	2015	
90	7	Girder 4	@ South Abutment	106 LSW	Cracks in bottom flange angles (See Detail 15)	Repair	2015	
91	7	South Abutment	Cap	107 LSE	10 Square Feet delamination/spalled cap	N/A	2013

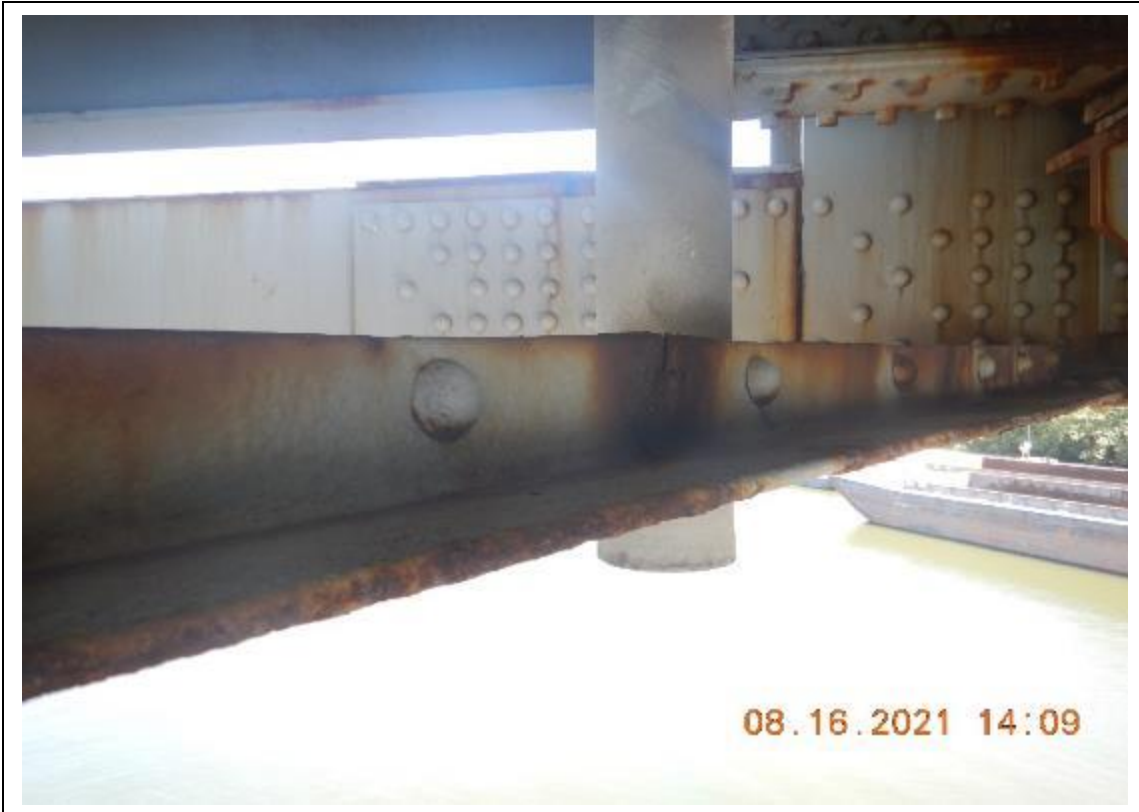
PHOTO 119

51	5	Sway Brace	Panel Point 16, West lane	117 LSE	15' X 4" Offset (Lane 1)	N/A	1999	
52	5	Gusset Plate	L16W (Outside)	62 LN	18" X ½" Offset due to pack rust	N/A	2009	
101	5	L17W-U17W	8' from deck, East web, 1' from U17W, West web	63 LN 64 LN	2 – 1'1 X ¼"D X 1/8"w torch cuts, 3 ½" X ½" Offset West channel, 5" X ¾" Offset North cover plate	N/A	2009	
54	5	Sway Brace	P.P. 16'	118 LE	8" X ½" Offset	N/A	2005	
55	5	Diaphragm	Floorbeam 15', Panel 16' Between Stringer 5 & 6	119 LS	18" X 1" Offset bottom flange	N/A	2001
