Orangeville Road  
Stephenson County, IL  
Sampling Report

# Orangeville Road; Stephenson Co, IL - Sampling Report Summary

# Sampling and Testing Locations Orangeville Road – Stephenson Co, IL

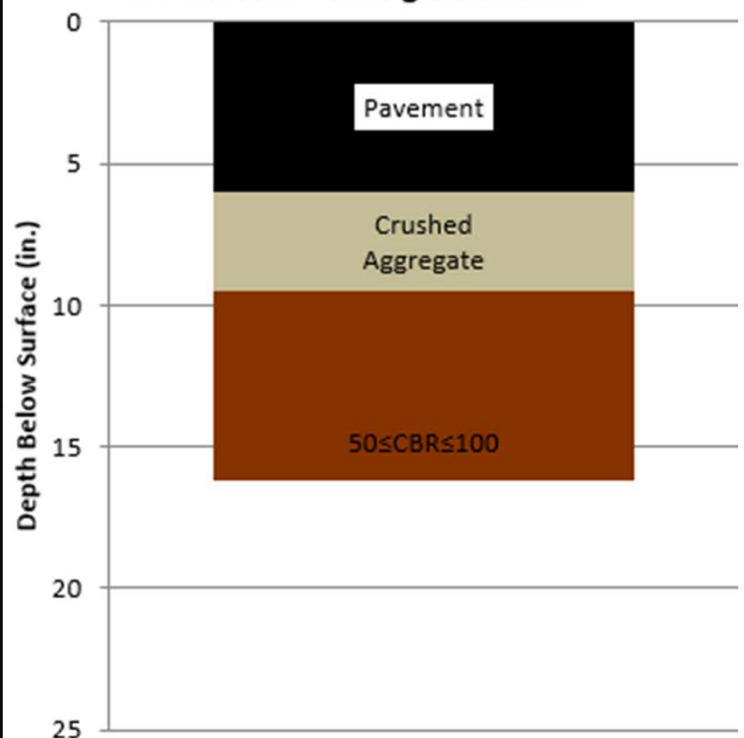
##### Location #1 - Orangeville Road

- Transverse cracking was observed
- Block cracking was observed
- An average of 6.0 inches of bituminous material was observed at this location
- Debonding in core #2 and 3 was observed at a depth of 3.8 inches
- A crushed aggregate base was observed directly below the bituminous material past a depth of 9.5 inches

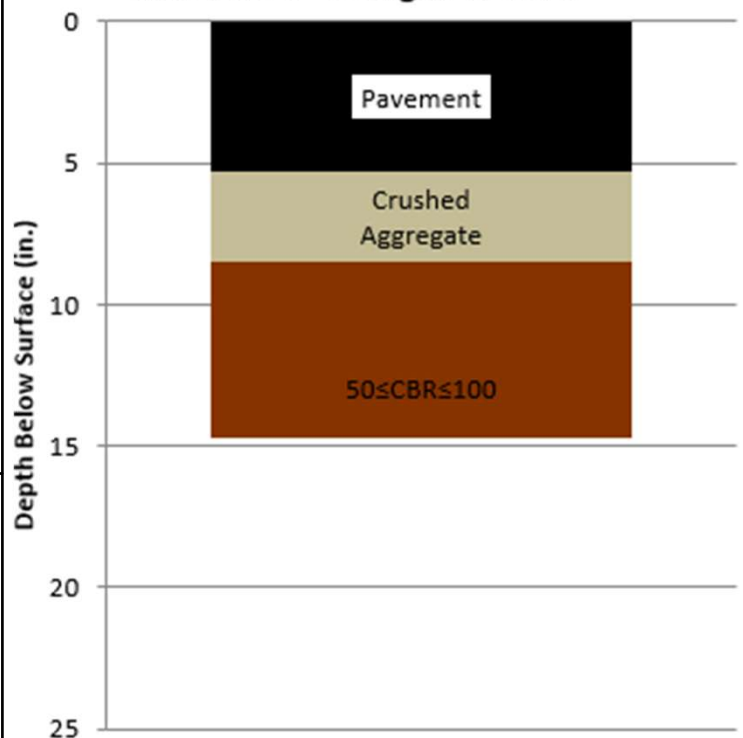
##### Location #2 - Orangeville Road

- Longitudinal and transverse cracking was observed
- Alligator cracking was observed
- An average of 5.5 inches of bituminous material was observed at this location
- Full depth cracking was observed in core #3
- A crushed aggregate base was observed directly below the bituminous material past a depth of 8.5 inches

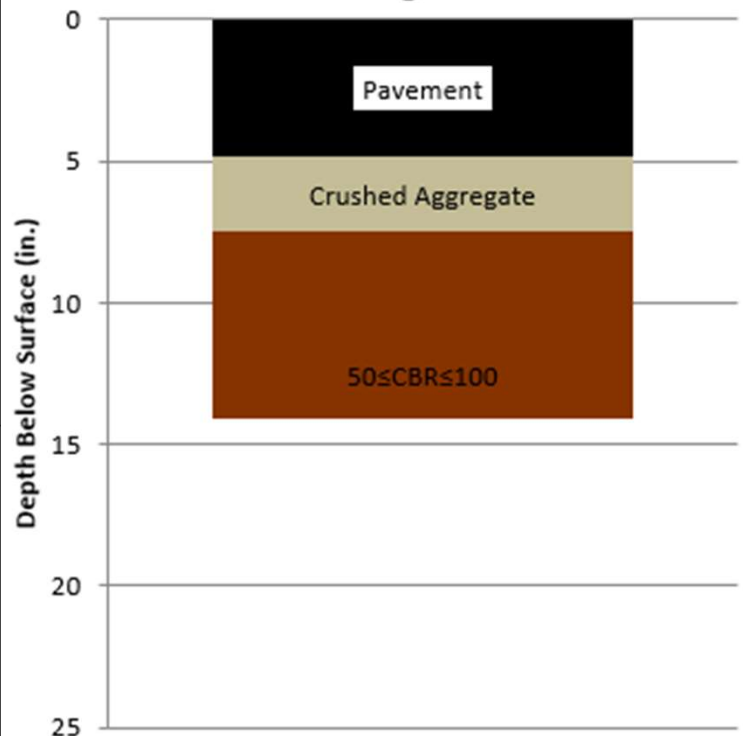
#### CBR vs. Depth Below Surface (in.) Location #3 - Orangeville Road

- Alligator cracking was observed
- An average of 5.1 inches of bituminous material was observed at this location
- Debonding was observed at depth of 3.0 inches
- A crushed aggregate base was observed directly below the bituminous material past a depth of 7.5 inches

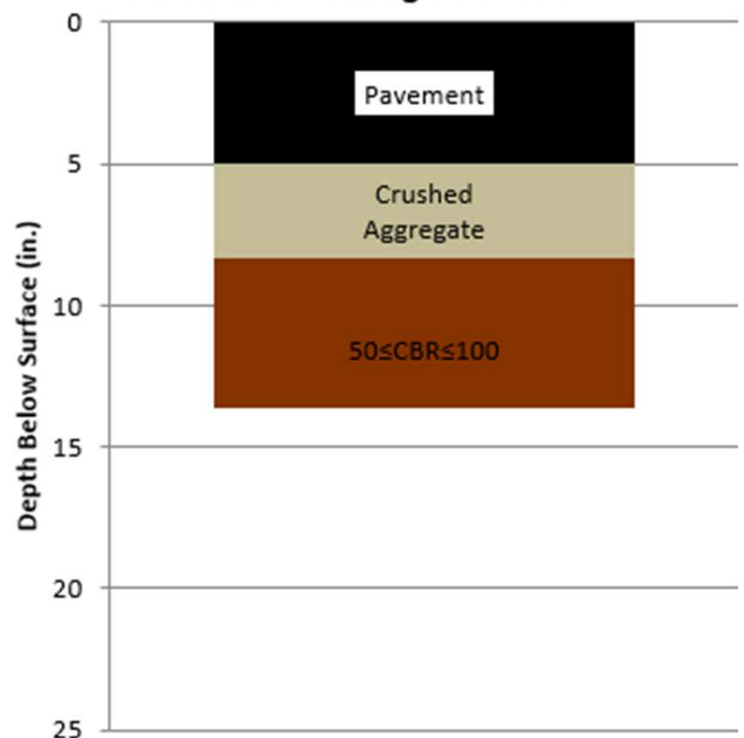
#### CBR vs. Depth Below Surface (in.) Location #4 - Orangeville Road

- Longitudinal and transverse cracking was observed
- An average of 5.1 inches of bituminous material was observed at this location
- Full depth samples unable to be extracted intact due to stripping was observed
- Full depth cracking was observed in cores #1 and 2
- A crushed aggregate base was observed below the bituminous material past a depth of 8.3 inches

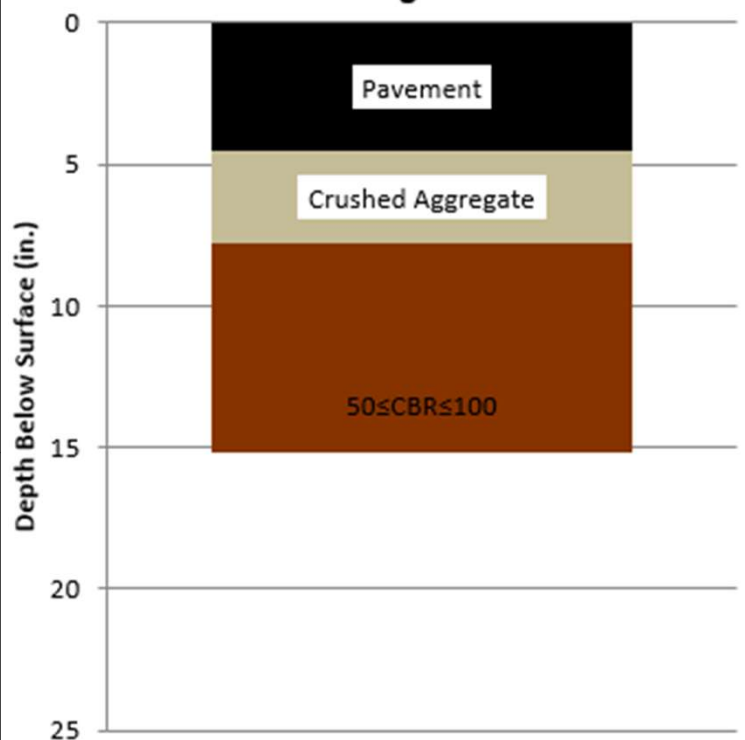
#### CBR vs. Depth Below Surface (in.) Location #5 - Orangeville Road

- Longitudinal and transverse cracking was observed
- Loss of surface material was observed
- Loss of edge material was observed
- An average of 4.5 inches of bituminous material was observed at this location
- A crushed aggregate base was observed below the bituminous material past a depth of 8.3 inches

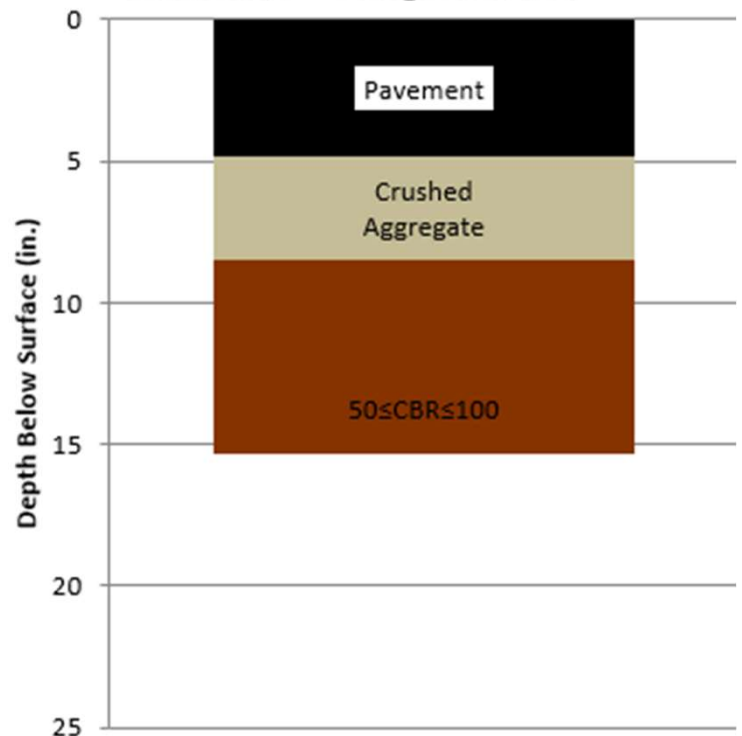
#### CBR vs. Depth Below Surface (in.) Location #6 - Orangeville Road

- Longitudinal and transverse cracking was observed
- An average of 4.9 inches bituminous material was observed at this location
- A crushed aggregate base was observed directly below the bituminous material past a depth of 8.5 inches

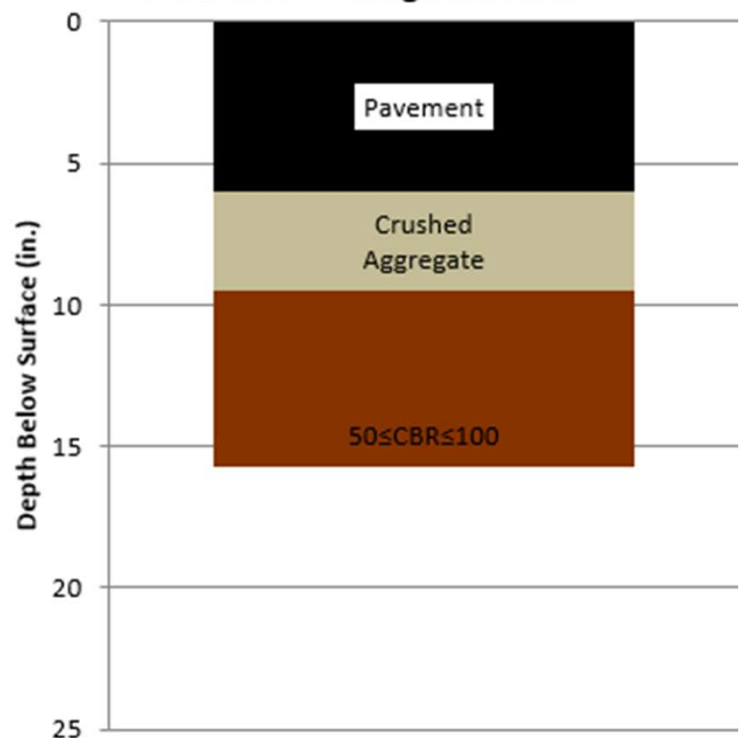
CBR vs. Depth Below Surface (in.)  
Location #7 - Orangeville Road

- Longitudinal and transverse cracking was observed
- A total of 6.0 inches of bituminous material was observed at this location
- Bottom-up cracking was observed to a depth of 4.0 inches in cores #2 and 3
- A crushed aggregate base was observed below the bituminous material past a depth of 9.5 inches

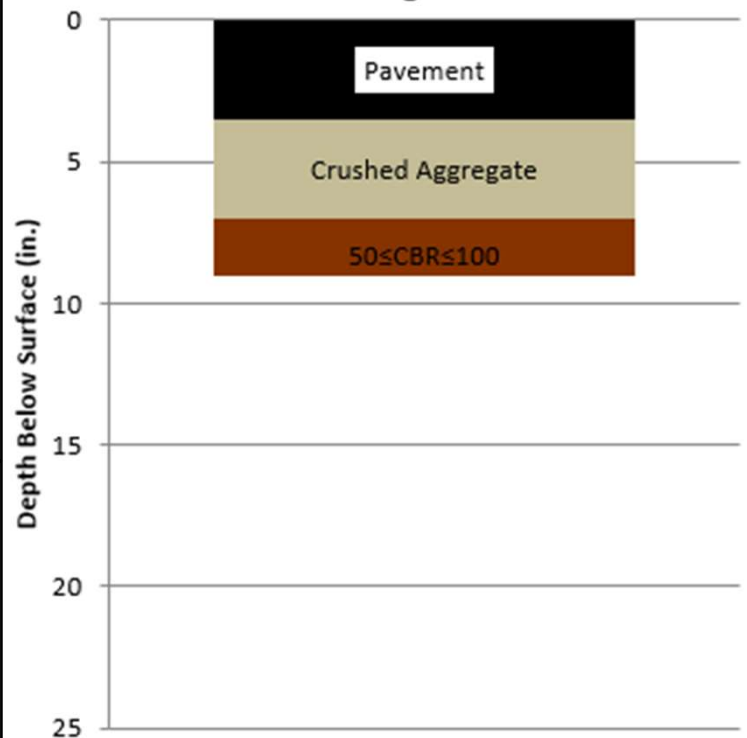
#### CBR vs. Depth Below Surface (in.) Location #8 - Orangeville Road

- Alligator cracking was observed
- A total of 3.5 inches of bituminous material was observed at this location
- Full depth cracking was observed in core #1 and 2
- A crushed aggregate base was observed directly below the bituminous material past a depth of 7.0 inches

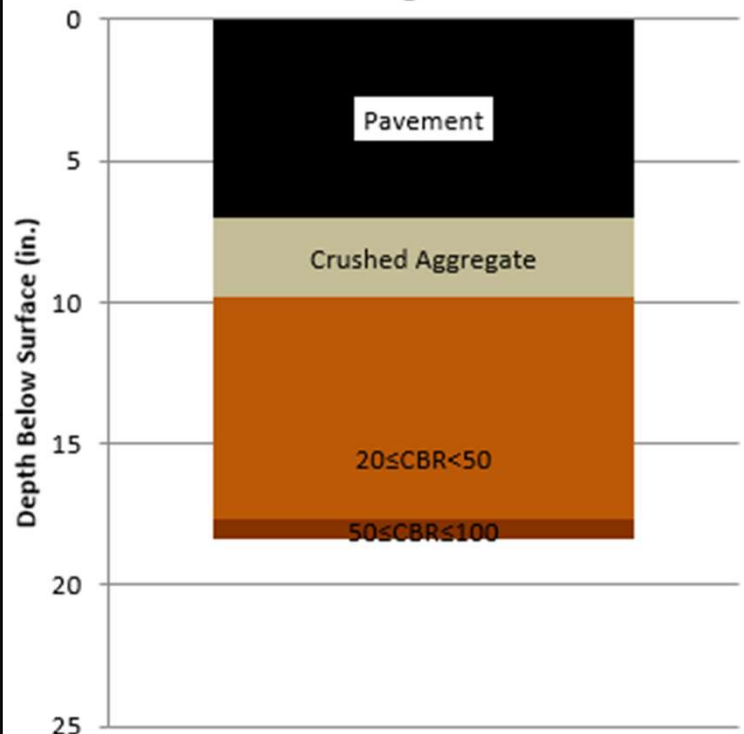
#### CBR vs. Depth Below Surface (in.) Location #9 - Orangeville Road

- Longitudinal and transverse cracking was observed
- A total of 7.0 inches of bituminous material was observed at this location
- A crushed aggregate base was observed directly below the bituminous material past a depth of 9.8 inches

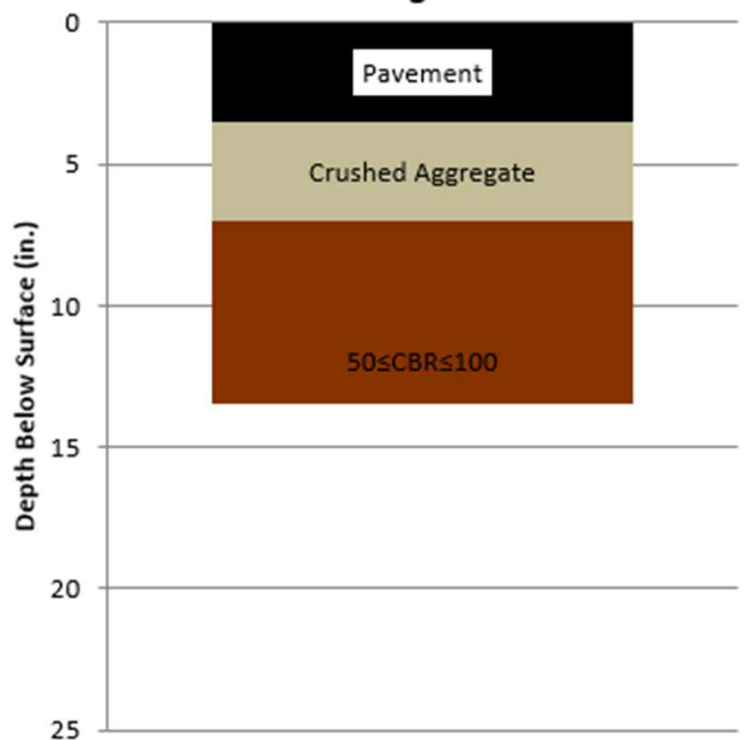
CBR vs. Depth Below Surface (in.)  
Location #10 - Orangeville Road

- Longitudinal and transverse cracking was observed
- A total of 3.5 inches of bituminous material was observed at this location
- Top-down cracking was observed to a depth of 1.0 inches
- A crushed aggregate base was observed below the bituminous material past a depth of 7.0 inches

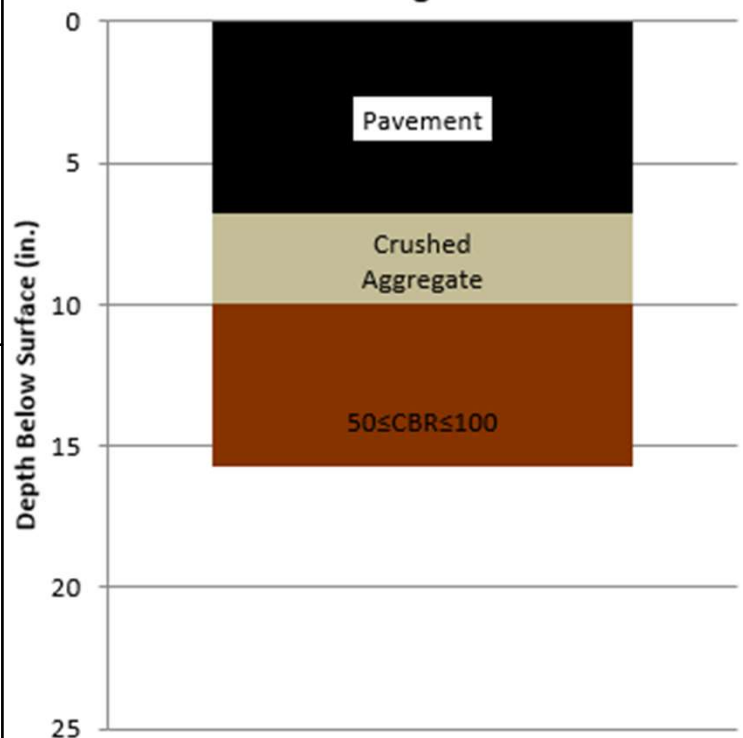
#### CBR vs. Depth Below Surface (in.) Location #11 - Orangeville Road

- Loss of surface material was observed in the westbound lane
- A total of 6.8 inches of bituminous material was observed at this location
- Stripping and cracking was observed below 4.0 inches in the cores
- A crushed aggregate base was observed directly below the bituminous material past a depth of 10.0 inches

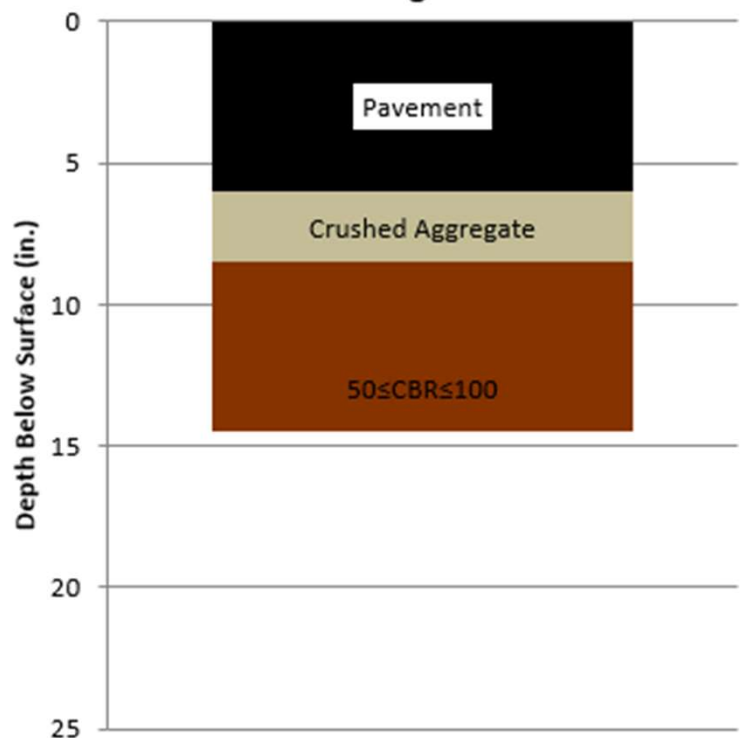
#### CBR vs. Depth Below Surface (in.) Location #12 - Orangeville Road

- Longitudinal and transverse cracking was observed
- An average of 6.0 inches of bituminous material was observed at this location
- Full depth samples unable to be extracted intact
- Full depth cracking was observed in core #3
- A crushed aggregate was observed directly below the bituminous material past a depth of 8.5 inches

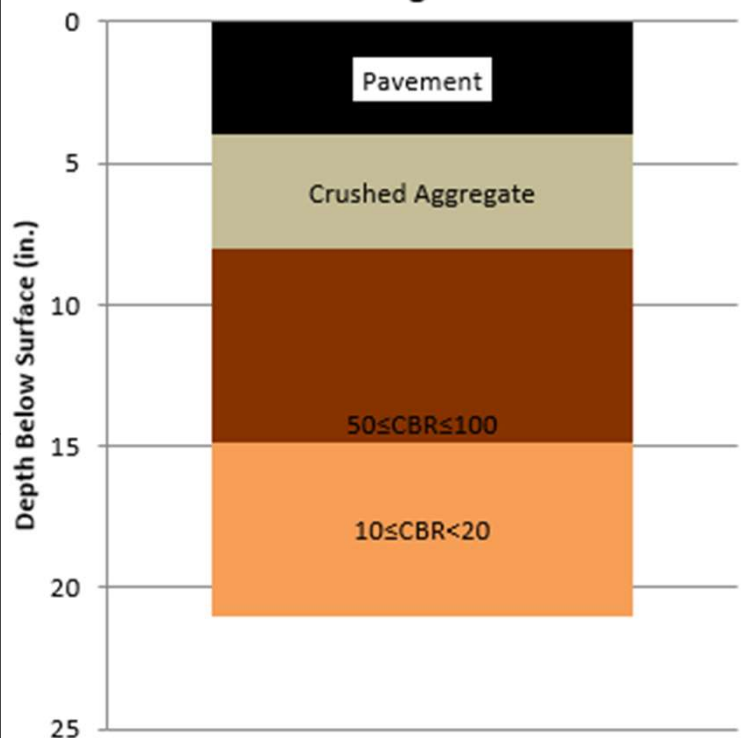
#### CBR vs. Depth Below Surface (in.) Location #13 - Orangeville Road

- Alligator cracking was observed
- An average of 4.0 inches of bituminous material was observed at this location
- Full depth samples unable to be extracted intact due to stripping past a depth of 2.0 inches in core #1 and 2
- A crushed aggregate was observed directly below the bituminous material past a depth of 8.0 inches
