## BUILDING REMOVAL WITH ASBESTOS ABATEMENT (BDE)

**ACM SURVEY RESULTS - Parcel No. 8810023**  
**Single-family Residence**  
**2010 S. Main Street**  
**Dupo, Illinois**

RE: Asbestos Survey Activities  
Dupo Interchange Phase 2 Engineering  
2014 S. Main Street (White Residence)  
Dupo, Illinois  
SCI No. 2005-3284.25

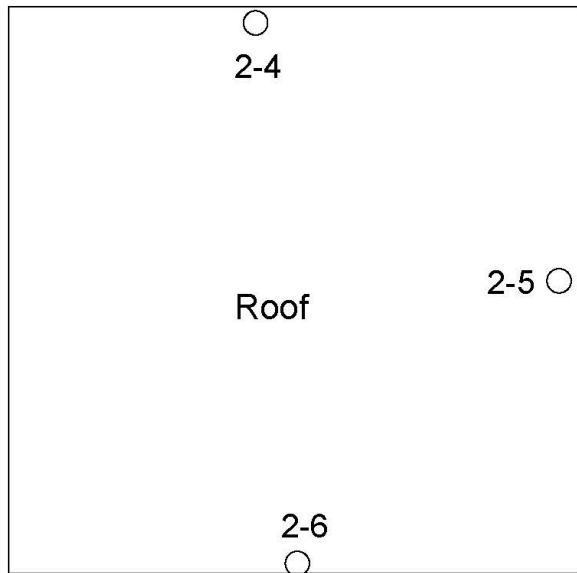
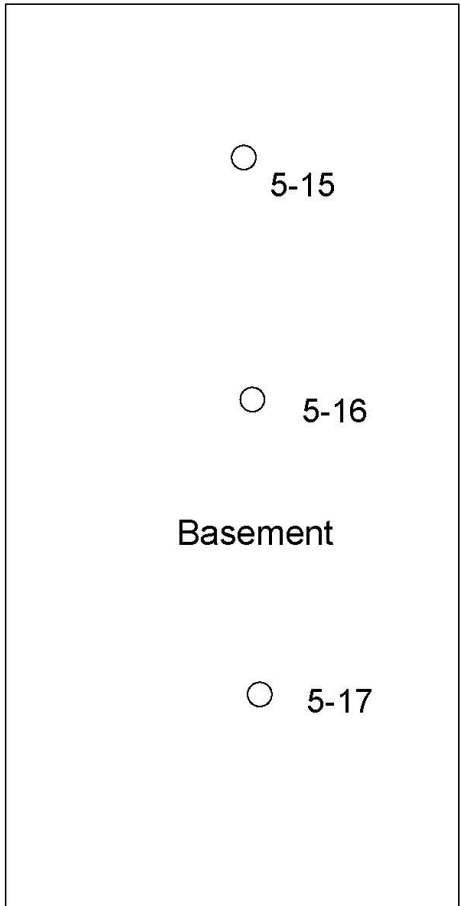
Roof and Basement Layout Map (not to scale) ↑N

2-4 2-5 2-6	ND
Roofing Shingles

5-15 5-16 5-17	ND
Wire Covering

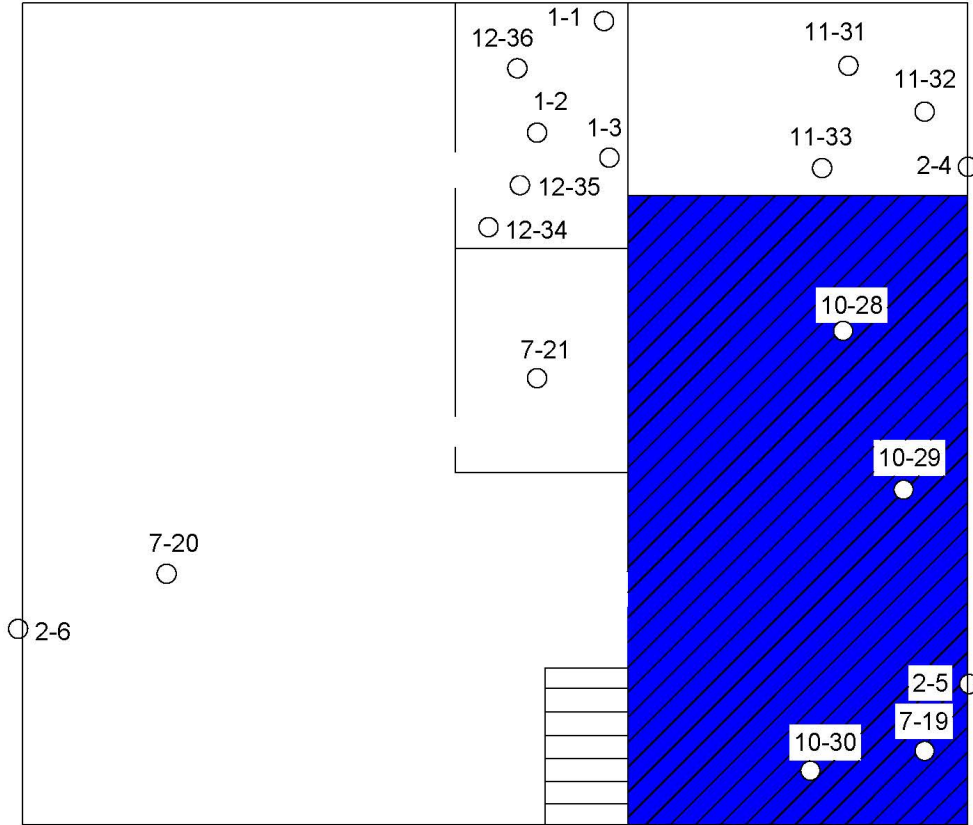
**Basement Layout Map (not to scale)** ↑N

1-1 1-2 1-3	ND
2' x 4' White Ceiling Tile

2-4 2-5 2-6	ND
Window Glazing

9" x 9" Multicolor Floor Tile

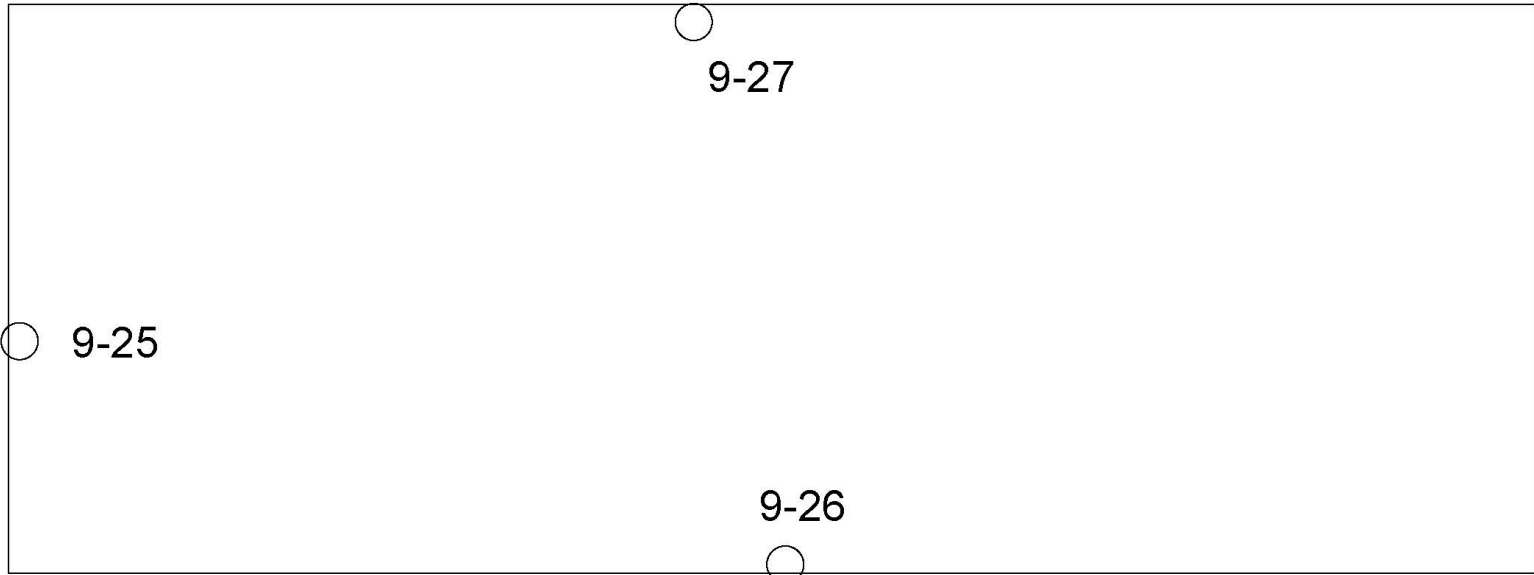
<b>Roof Layout Map</b> (not to scale)		↑N
803 IMBS Station Road Dupo, IL Parcel No: 8810027		
Project # 928.19 IDOT Work Order 675	Intertek-PSI Project # 0047-4021

9-25	9-26	9-27	<b>ND</b>
Roofing Shingles

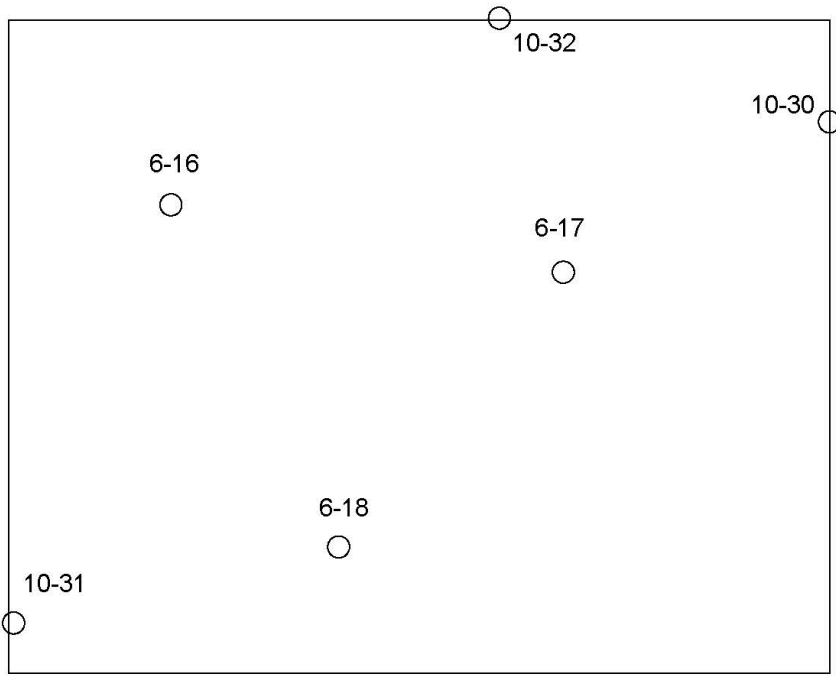
**Attic/Roof Layout Map** (not to scale) ✓ N

6-16 6-17 6-18	ND
Wire Coating

10-30 10-31 10-32	ND
Roofing Material

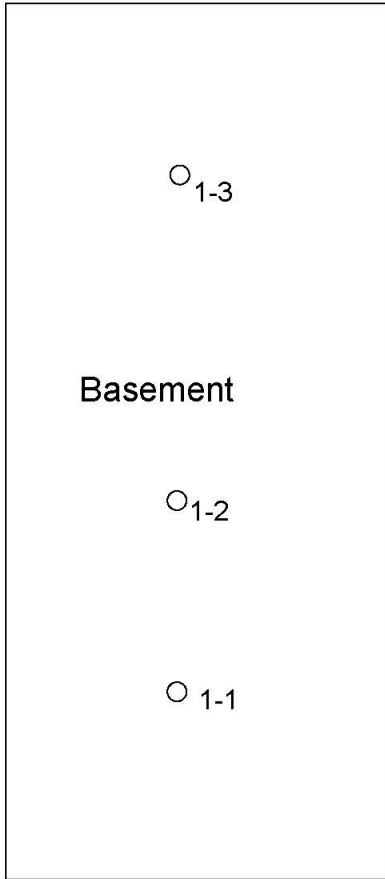
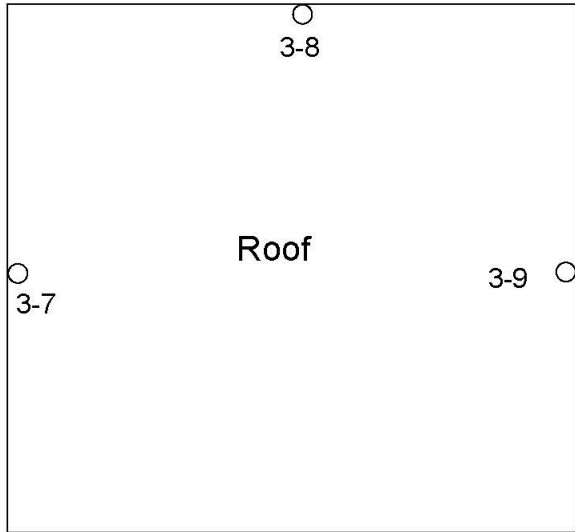
**Basement and Roof Layout Map (not to scale)**

1-1 1-2 1-3	<b>ND</b>
Wire Covering

3-7 3-8 3-9	<b>ND</b>
Roofing Shingles

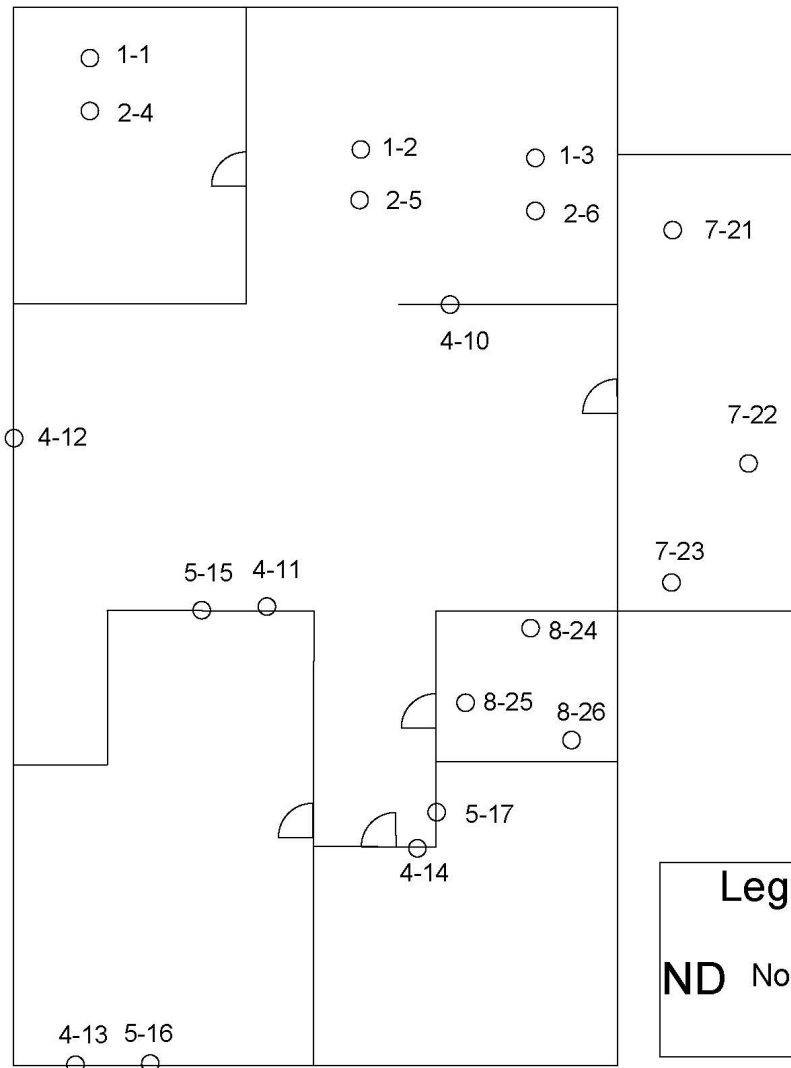
**First Floor Map** (not to scale)

1-1 1-2 1-3	ND
Tan Linoleum Flooring	
2-4 2-5 2-6	ND
12" x 12" Speckled Tile and Mastic Flooring	
4-10 4-11 4-12 4-13 4-14	ND
Plaster	
5-15 5-16 5-17	ND
Drywall and Joint Compound	
7-21 7-22 7-23	ND
Gold Linoleum Flooring	
8-24 8-25 8-26	ND
12" x 12" Gray Ceramic Tile and Grout

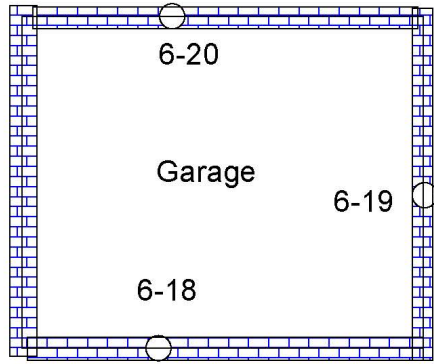
**Roof and Garage Map (not to scale)**

3-7 3-8 3-9	ND
Asphalt Shingles

6-18 6-19 6-20	POS
Transite Siding

Transite Siding

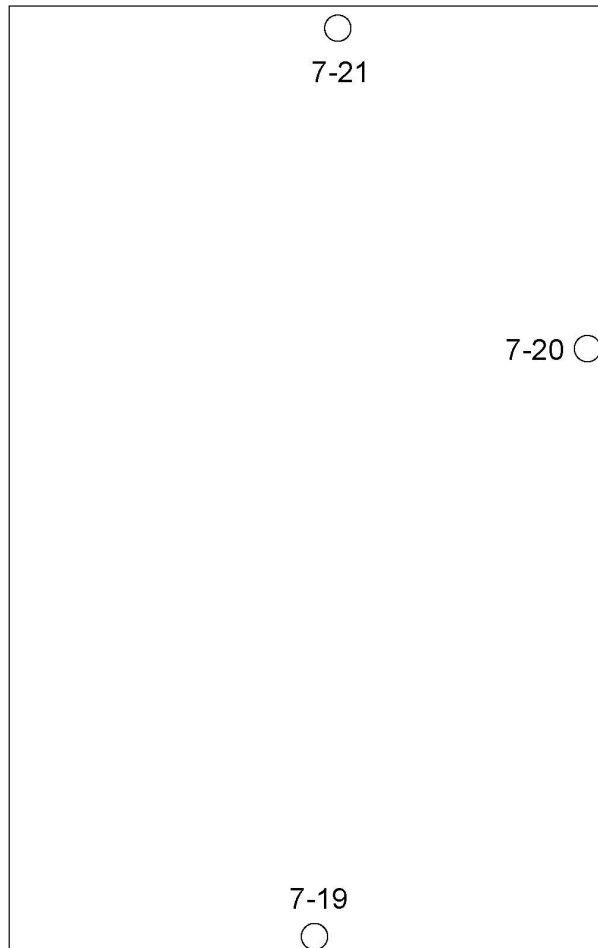
**Garage Layout Map (not to scale)**

7-19 7-20 7-21	<b>ND</b>
Roofing Shingles

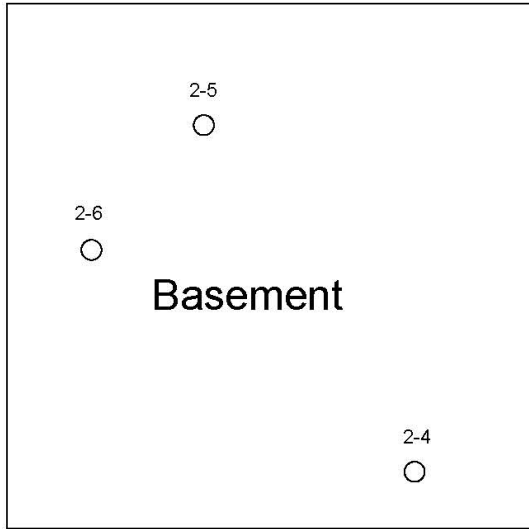
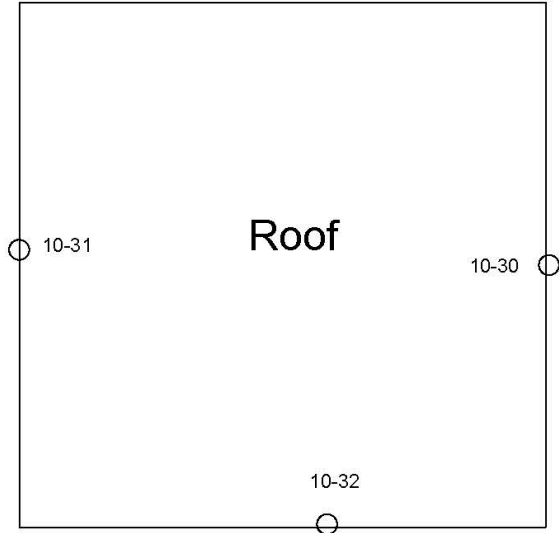
**Basement/Roof Layout Map (not to scale)** N↖

2-4 2-5 2-6	ND
Wire Covering

10-30 10-31 10-32	ND
Roofing Material

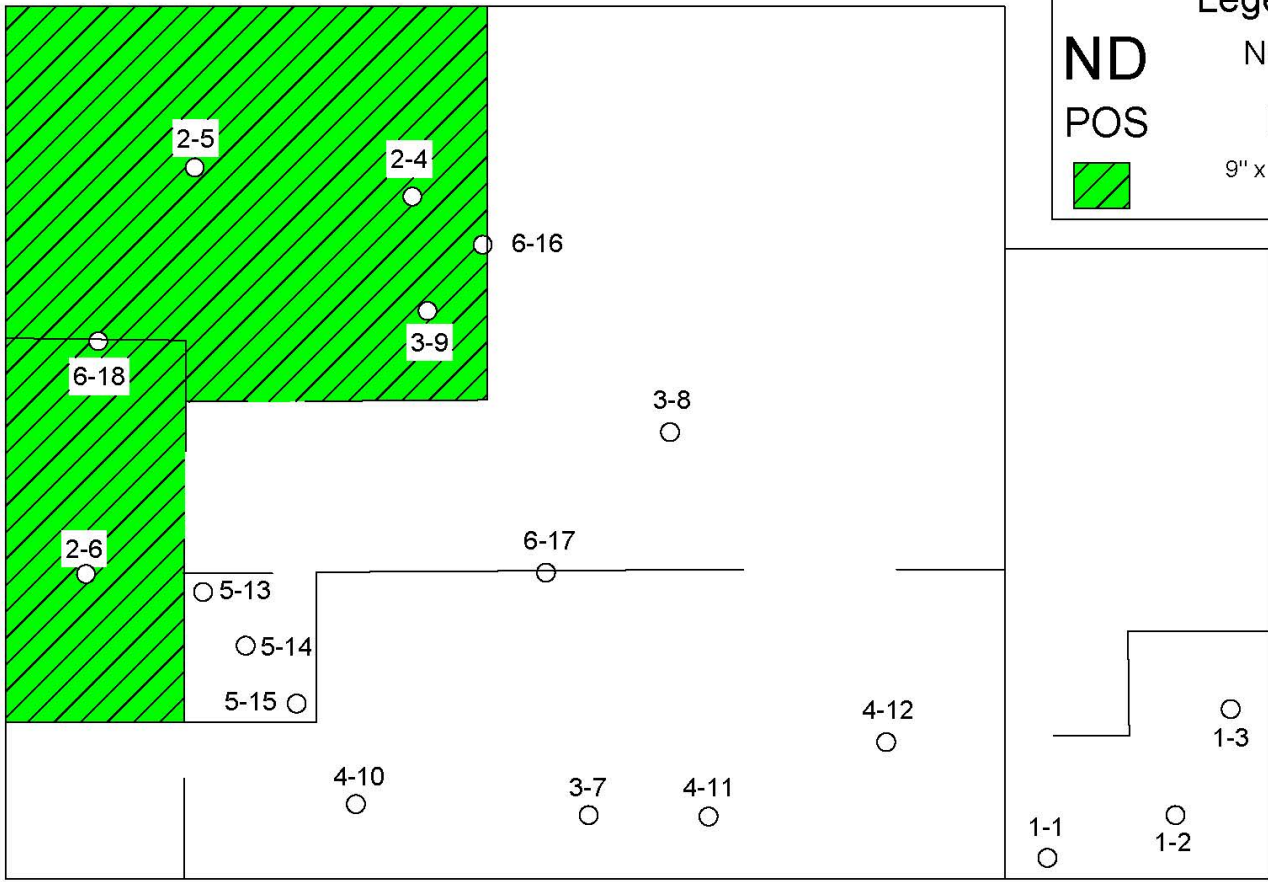
9" x 9" Tan Floor Tile and Mastic

3-7 3-8 3-9	ND
1' x 1' White Ceiling Tile

4-10 4-11 4-12	ND
12" x 12" Self Stick Floor Tile

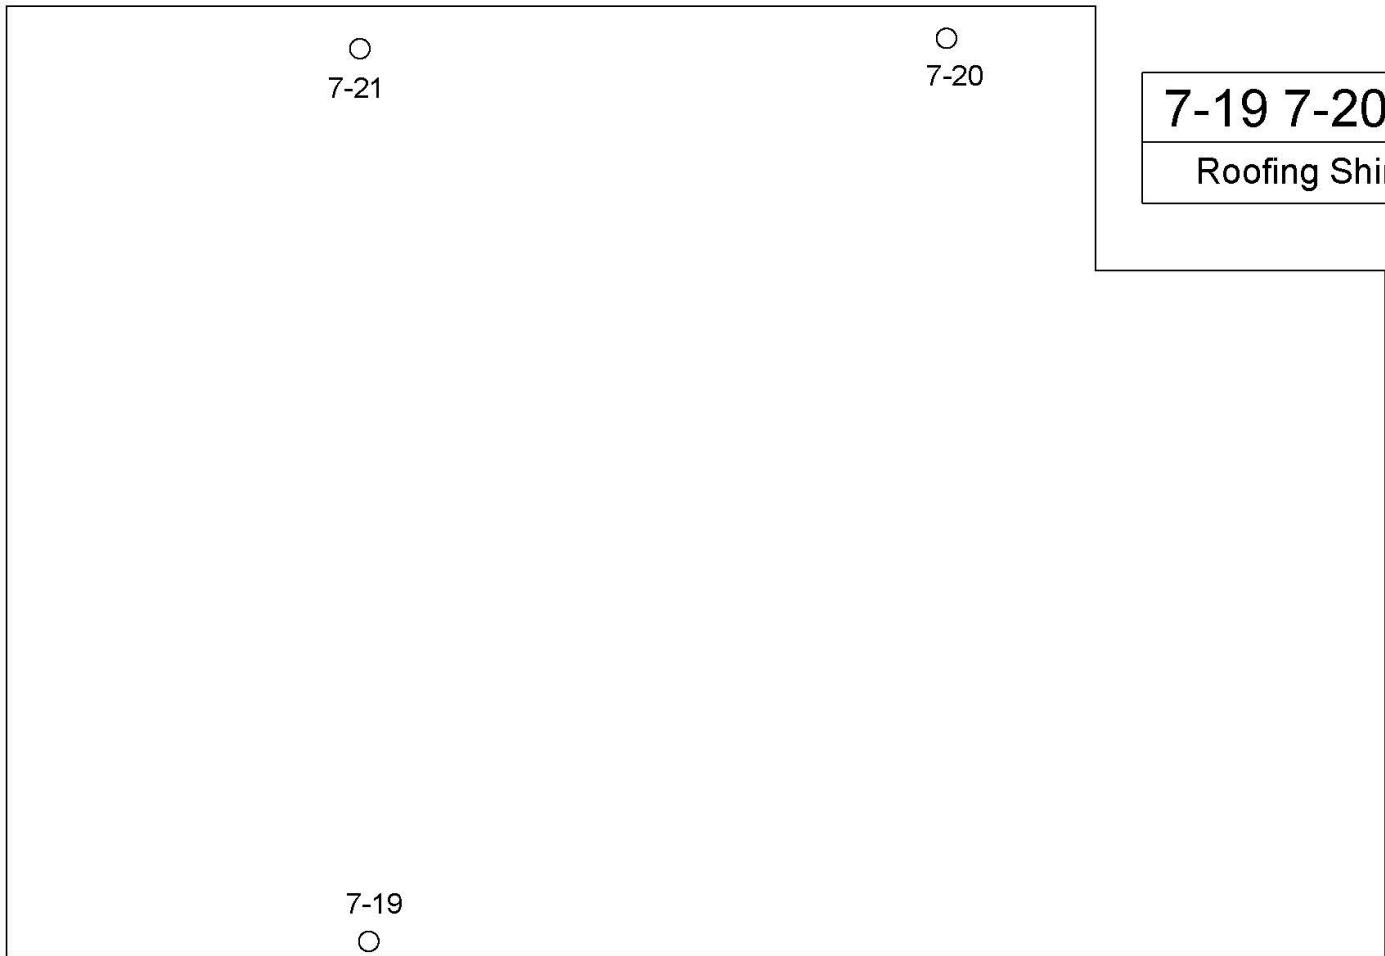
7-19	7-20	7-21	<b>ND</b>
Roofing Shingles
